DEPARTMENT OF THE ARMY
CORPS OF ENGINEERS, PORTLAND DISTRICT
PO BOX 2946
PORTLAND OR 97208-2946

SUBJECT: Routine Inspection Results, Sauvie Island Flood Damage Reduction System, U.S. Army Corps of Engineers (USACE) Assigned System Rating.

Flood Damage Reduction Segment / System Inspection Report

1. Levee segment / system and district: (name of the segment / system and levee district) Multnomah Channel Segment, Sauvie Island Flood Damage Reduction Project, Sauvie Island Drainage Improvement Company

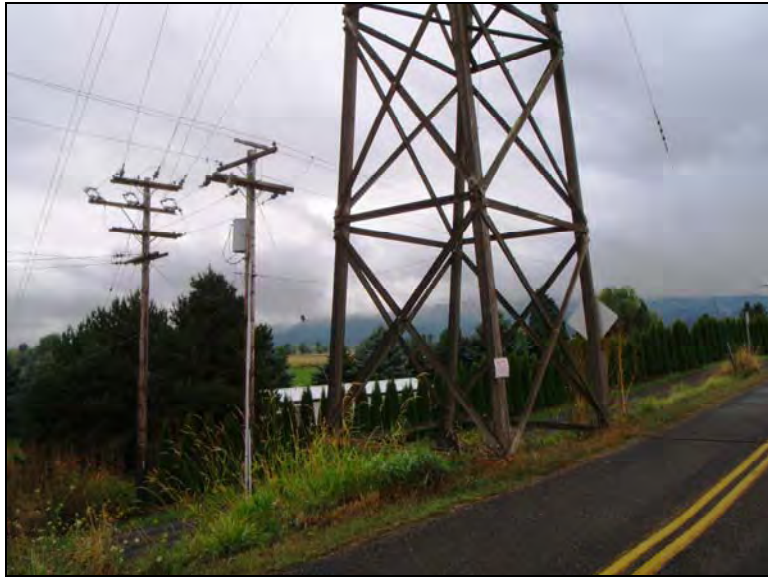
Inspect ID: SAUA_2011_a_0027 **Title:** USACE_CENWP_SAU_2011_a_0027_1.jpg
Caption: View of the transmission tower. Station 727+00

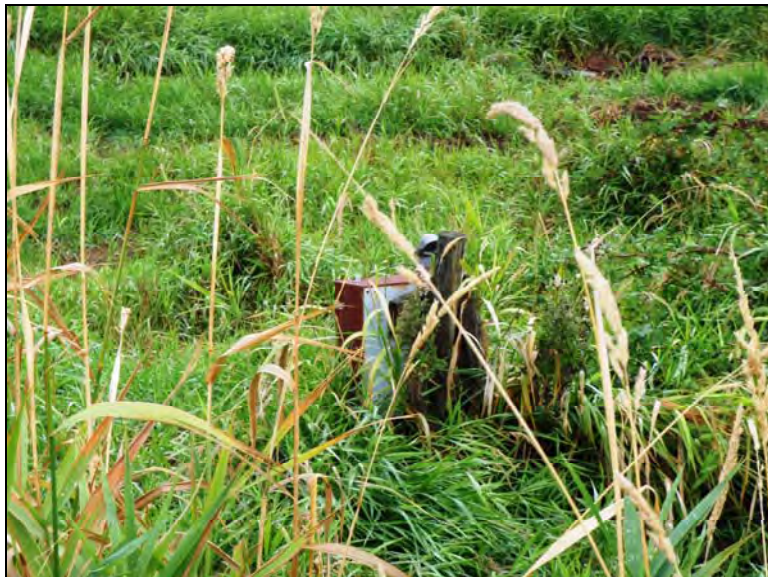
Inspect ID: SAUA_2011_a_0031 **Title:** USACE_CENWP_SAU_2011_a_0031_1.jpg
Caption: View of the power panel. Station 729+00

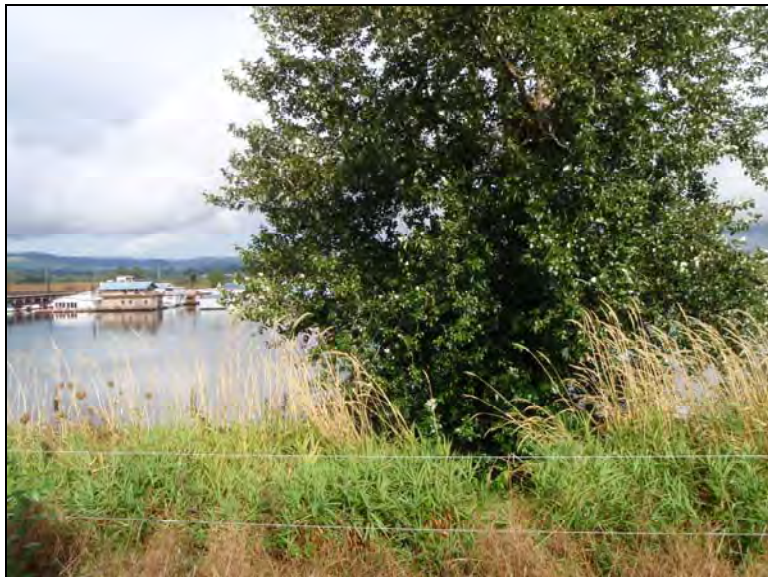
Inspect ID: SAUA_2011_a_0038 **Title:** USACE_CENWP_SAU_2011_a_0038_1.jpg
Caption: View of two cotton wood trees located 12 feet from the riverward toe of the levee. Station 730+50

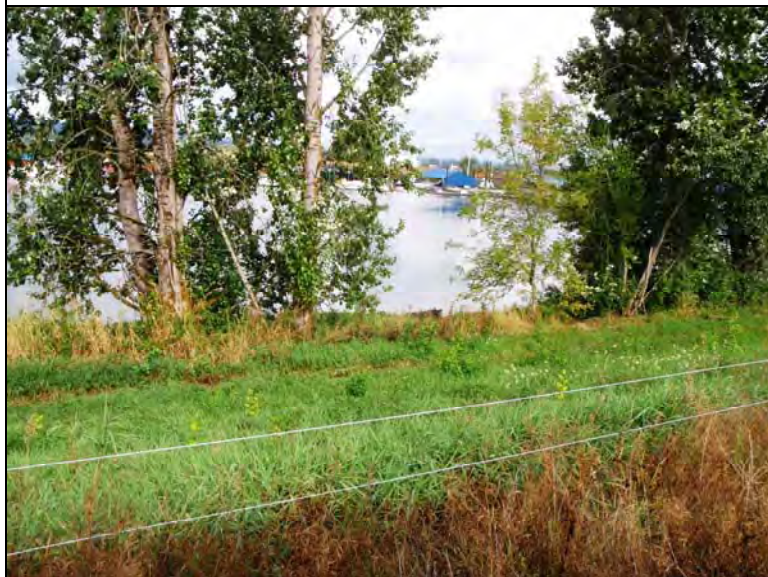
Inspect ID: SAUA_2011_a_0040 **Title:** USACE_CENWP_SAU_2011_a_0040_1.jpg
Caption: Stump and debris within 15 feet of the riverward levee toe noted during the 2010 inspection have been removed. Station 746+00

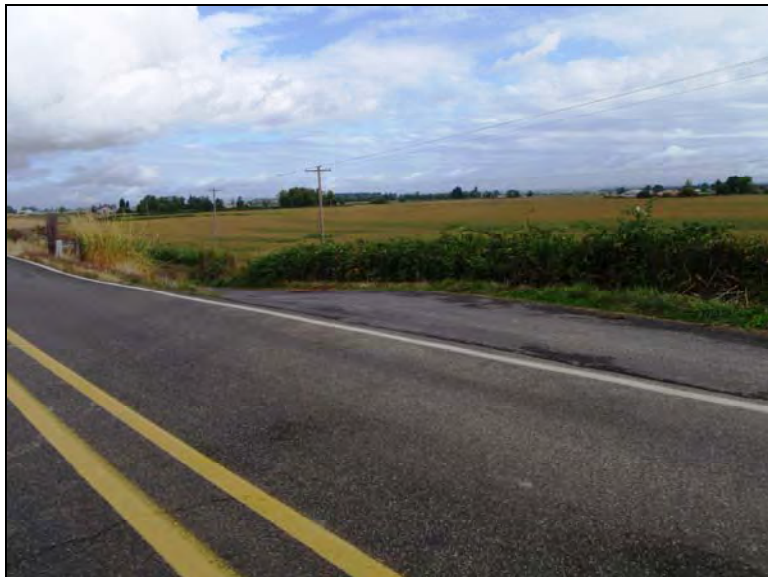
Inspect ID: SAUA_2011_a_0064 **Title:** USACE_CENWP_SAU_2011_a_0064_1.jpg
Caption: View of ramp to farm driveway at 26750Sauvie Island Road. Station 823+00

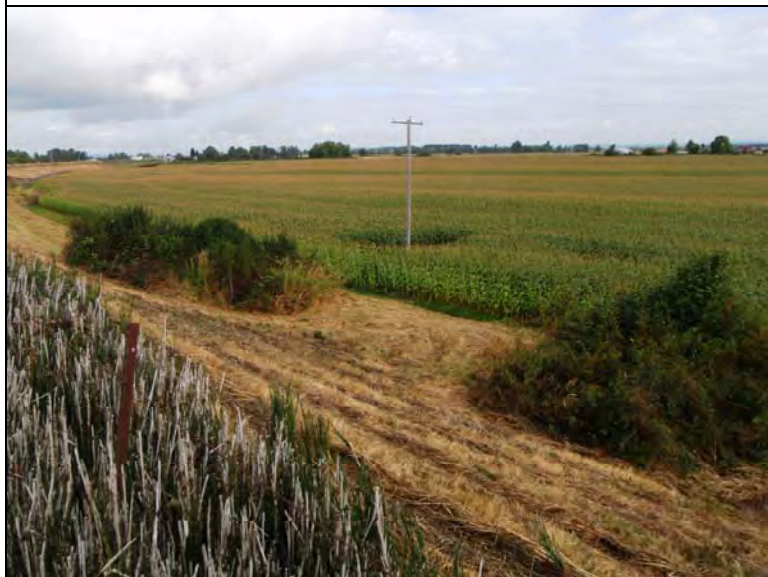
Inspect ID: SAUA_2011_a_0065 **Title:** USACE_CENWP_SAU_2011_a_0065_1.jpg
Caption: View of brush and tree debris along land side levee toe. Station 827+00

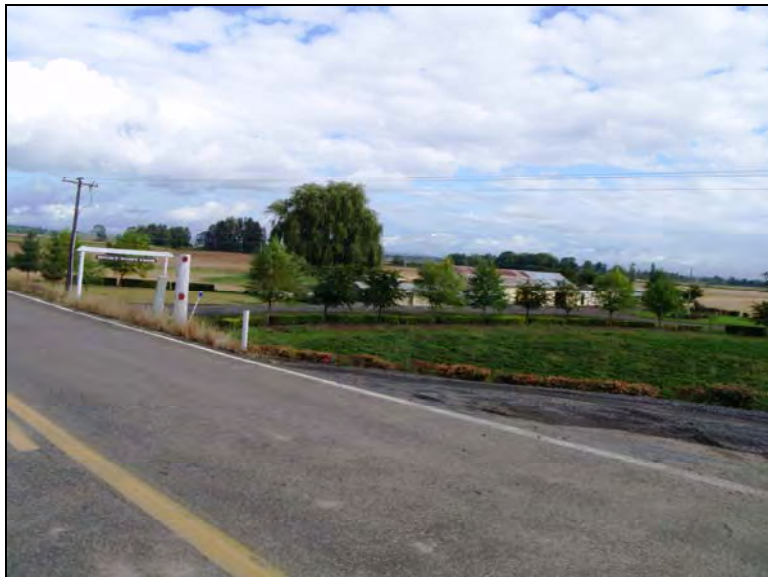
Inspect ID: SAUA_2011_a_0074 **Title:** USACE_CENWP_SAU_2011_a_0074_1.jpg
Caption: View of the Rocky Point Farm driveway on land side of the levee. Station 864+00

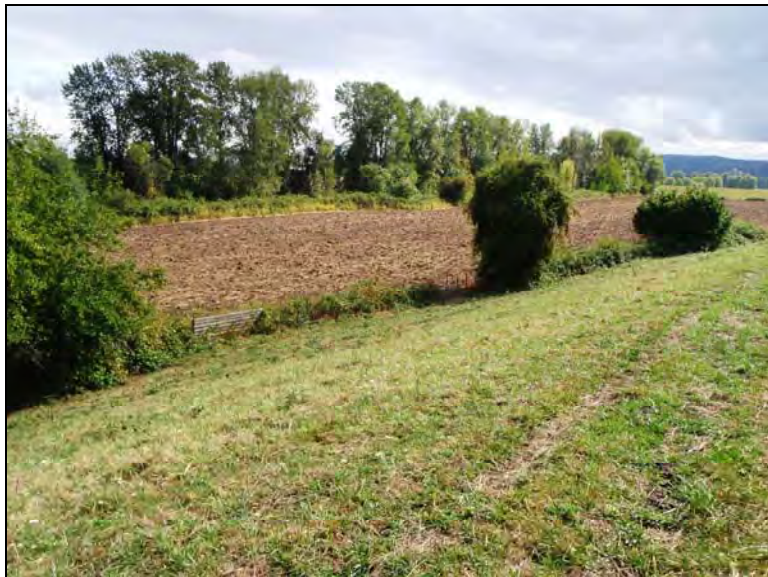
Inspect ID: SAUA_2011_a_0089 **Title:** USACE_CENWP_SAU_2011_a_0089_2.jpg
Caption: View of the overgrown fence line along the landward levee toe. Station 930+00 to 958+00

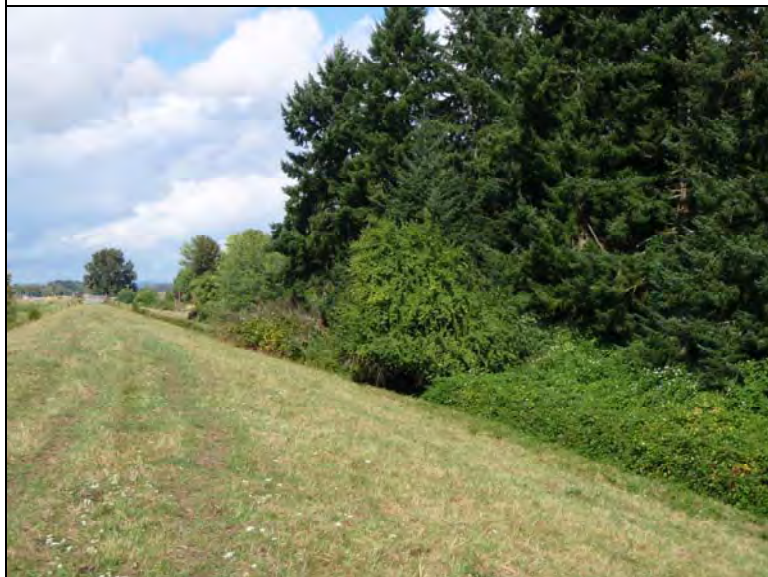
Inspect ID: SAUA_2011_a_0092 **Title:** USACE_CENWP_SAU_2011_a_0092_1.jpg
Caption: View of two large trees and dense blackberry vines within 15 feet of the landward levee toe. Station 935+00

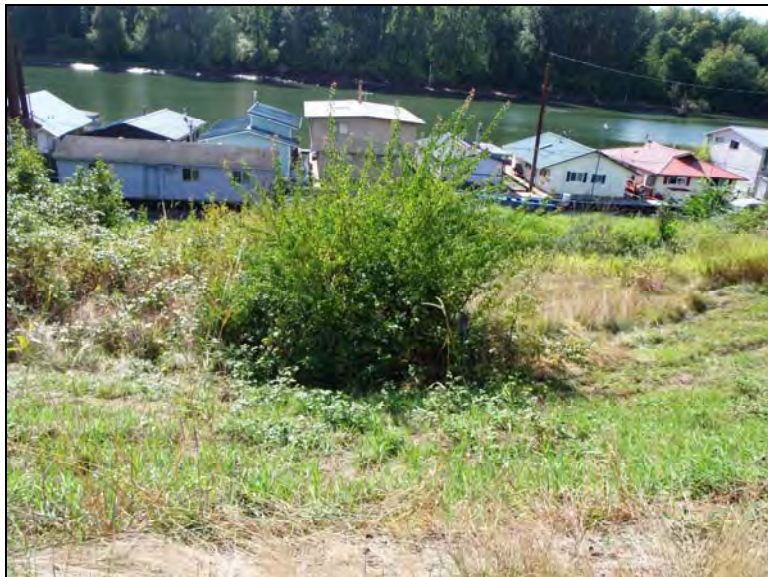
Inspect ID: SAUA_2011_a_0096 **Title:** USACE_CENWP_SAU_2011_a_0096_1.jpg
Caption: View of small tree on riverward levee slope. Station 4+00

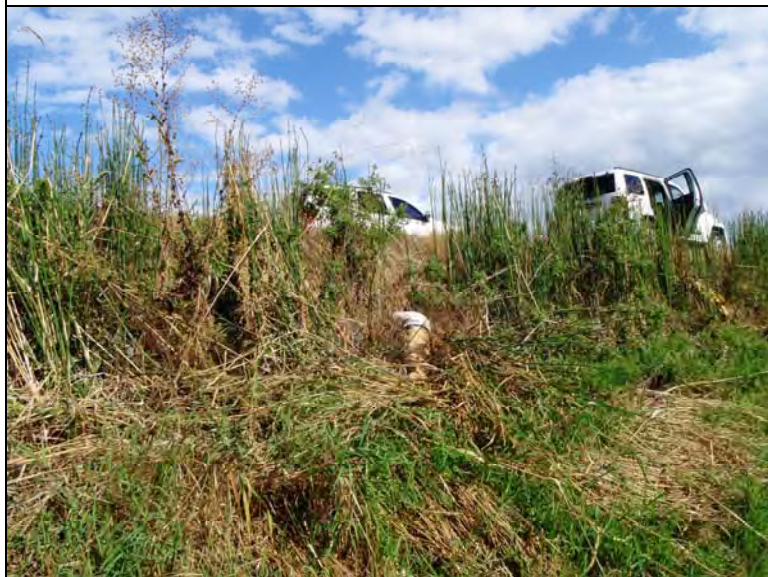
Inspect ID: SAUA_2011_a_0097 **Title:** USACE_CENWP_SAU_2011_a_0097_1.jpg
Caption: View of 8" plastic irrigation pipe at it's riverside exposure. Station 10+00

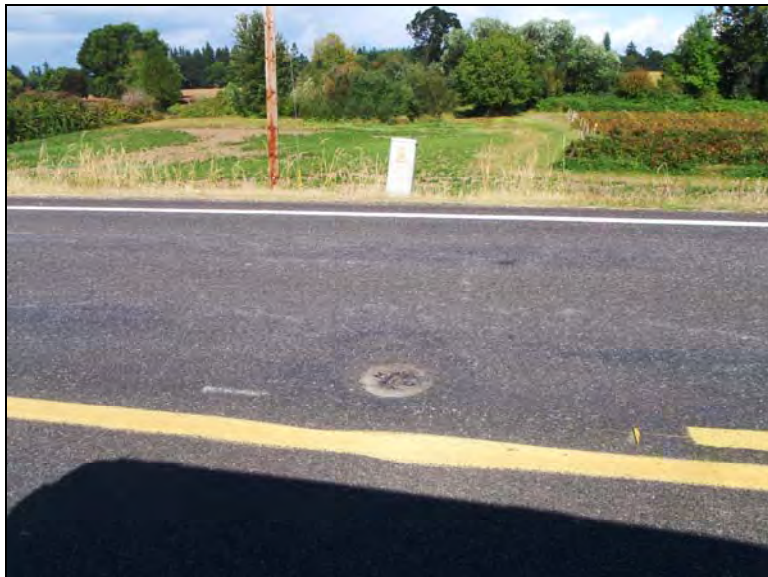
Inspect ID: SAUA_2011_a_0100 **Title:** USACE_CENWP_SAU_2011_a_0100_1.jpg
Caption: View of monitoring well cover or drill hole cover in pavement near centerline of levee. Station 12+50

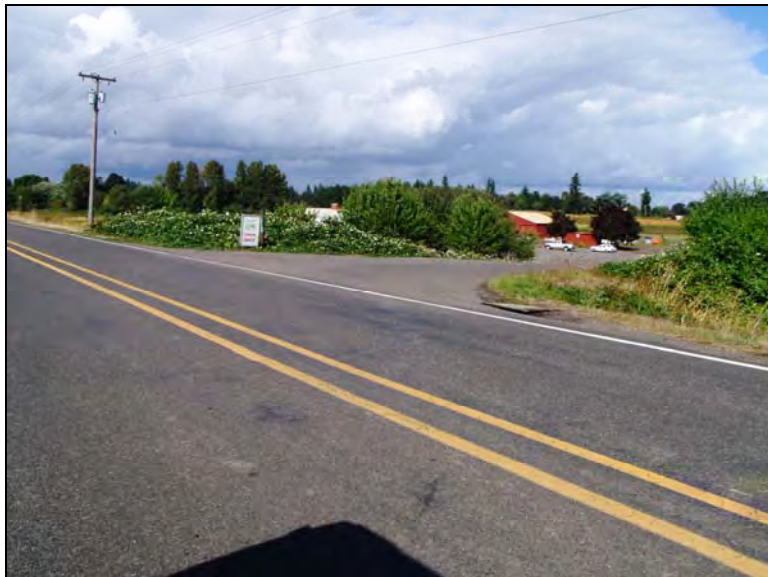
Rated Item	Rating	Rating Guidelines	Location/Remarks/Recommendations
			<p>pavement near centerline of levee: Review and permit per current guidelines (M)</p> <p>SAUA_2011_a_0103: Paved access road from land side of levee. Levee is overbuilt with road section.: Review and permit per current guidelines (M)</p> <p>SAUA_2011_a_0105: Monitoring well or drill hole cover in pavement near centerline of levee: Review and permit per current guidelines (M)</p> <p>SAUA_2011_a_0106: Access road paved and gravel surfaced in overbuild section on land side of levee. Indicated on design drawing CLW-99-42/2.: No action req'd. (A)</p> <p>SAUA_2011_a_0107: Stations 0+00 to 42+00; Power poles within 15 feet of toe.: Review and permit per current guidelines (M)</p> <p>SAUA_2011_a_0109: NW Howell Park Rd to Bybee-Howell Park on land side of levee; gas meter at side of access road near edge of land side levee crest. Road indicated on design drawing CLW-99-42/2.: No action required. (A)</p> <p>SAUA_2011_a_0108: Natural gas line crossing levee to valve pressure meter, no record of gas encroachment permits in this section of the levee: Review and permit per current guidelines. (M)</p> <p>SAUA_2011_a_0110: Main Sauvie Island Road drops off to the land side of the levee embankment. Top of levee becomes sod-covered at this location.: No action required. (A)</p> <p>SAUA_2011_a_0111: Main gate to levee.; Review and permit per current guidelines (M)</p> <p>SAUA_2011_a_0112: Fence on land side of levee from gate for 300 feet. Fence cuts across slope diagonally from crest to beyond 15 foot limit at toe.: Remove or review and permit per current guidelines. (M)</p> <p>SAUA_2011_a_0115: Fence at lardward toe of levee.: Review and permit per current guidelines (M)</p> <p>SAUA_2011_a_0118: Residential garage structure at land side toe of levee.: Review and permit per current guidelines (U)</p> <p>SAUA_2011_a_0120: Fence along land side toe of levee, Stations 74+00 to 90+00. Drawings CLW-99-42/22 and CLW-99-42/3 shows the ROW line to be above the toe of the levee.: NA (A)</p>

Inspect ID: SAUA_2011_a_0103 **Title:** USACE_CENWP_SAU_2011_a_0103_1.jpg
Caption: View of paved to gravel access road on land side of levee. Station 24+50

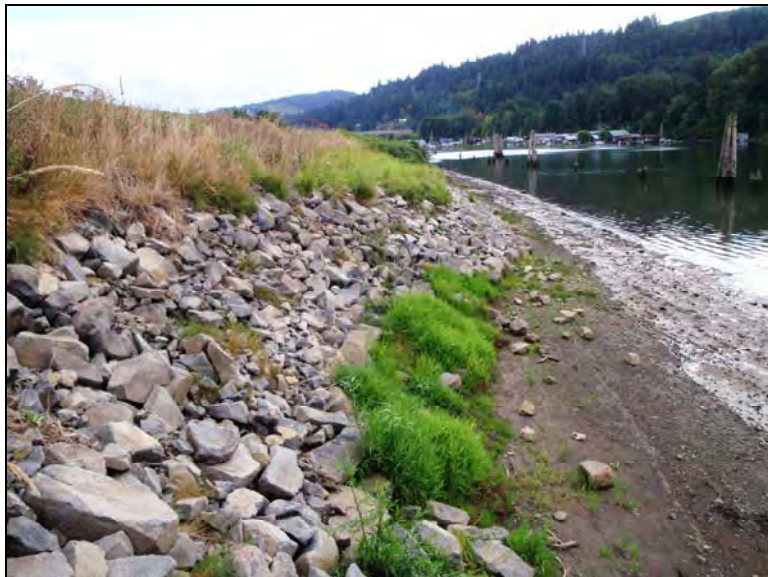
Inspect ID: SAUA_2011_a_0114 **Title:** USACE_CENWP_SAU_2011_a_0114_1.jpg
Caption: Upstream view of riprap revetment, standing near its downstream end. Station 63+00

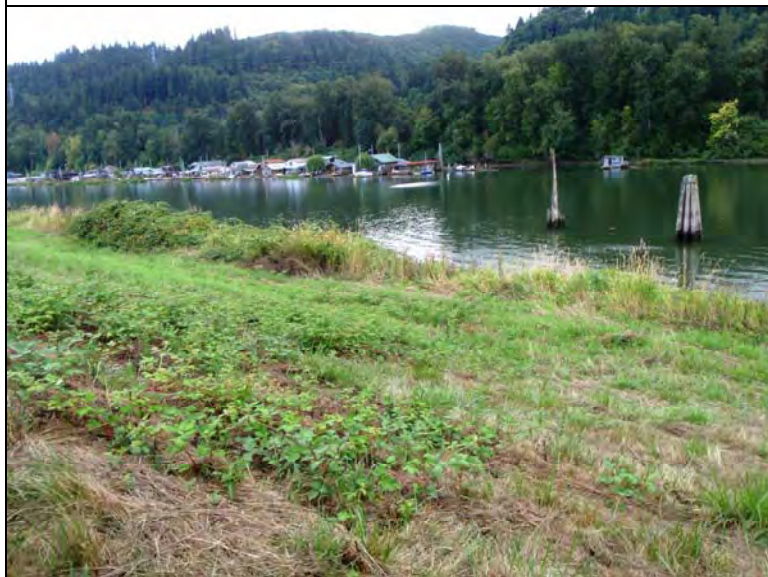
Inspect ID: SAUA_2011_a_0116 **Title:** USACE_CENWP_SAU_2011_a_0116_1.jpg
Caption: View of mowed blackberry vines on riverward levee slope. Station 70+50

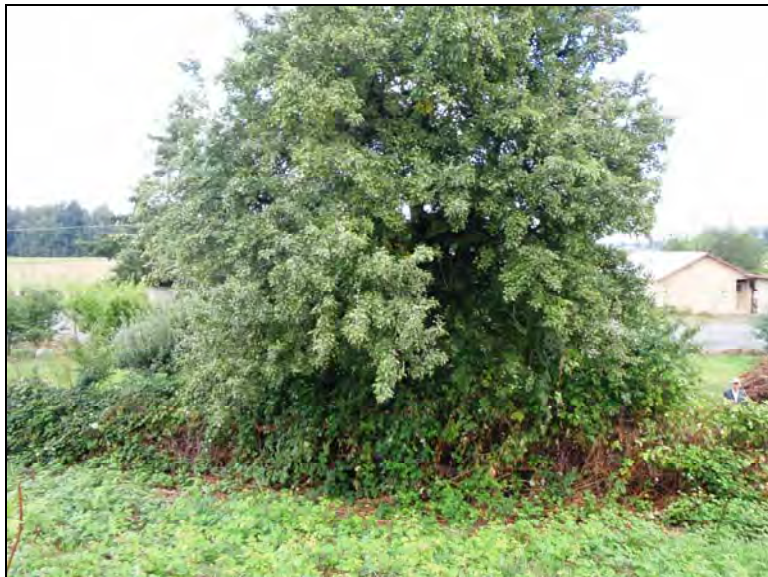
Inspect ID: SAUA_2011_a_0117 **Title:** USACE_CENWP_SAUA_2011_a_0117_1.jpg
Caption: View of 15-18" diameter trees at the landward toe of the levee. Station 70+50

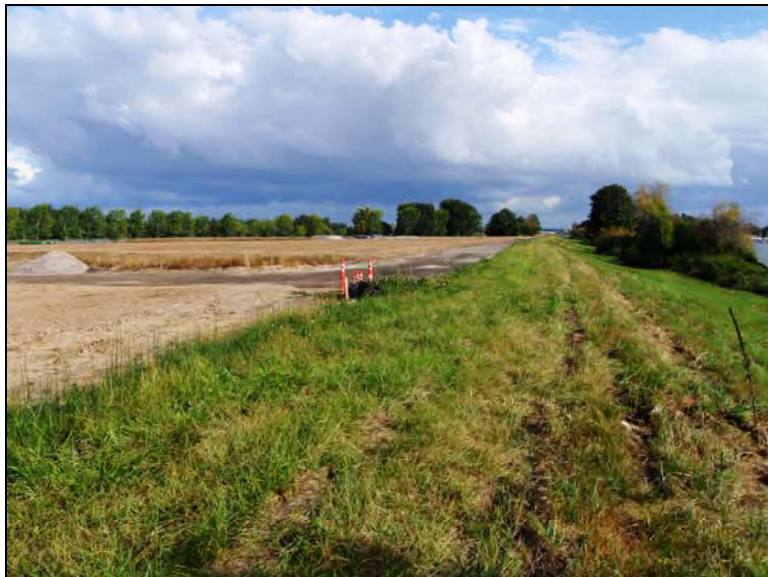
Inspect ID: SAUA_2011_a_0135 **Title:** USACE_CENWP_SAU_2011_a_0135_1.jpg
Caption: View of land side levee fill. Station 109+00 to 125+00

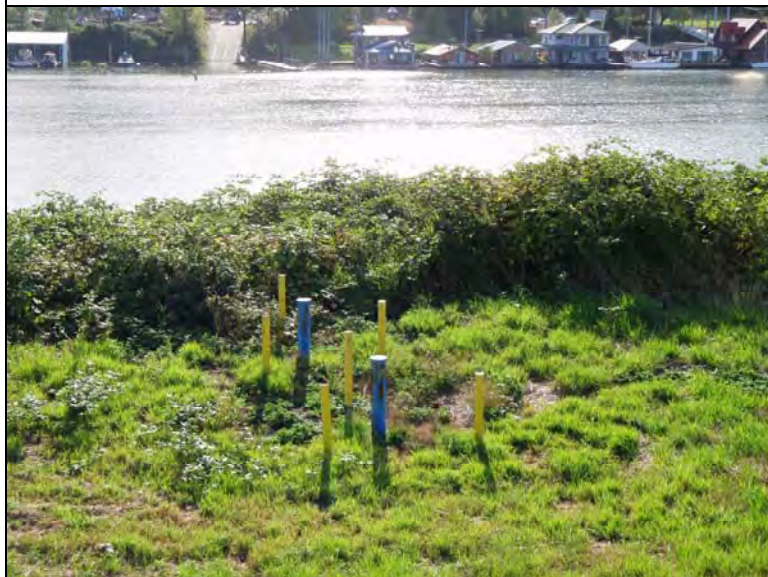
Inspect ID: SAUA_2011_a_0138 **Title:** USACE_CENWP_SAU_2011_a_0138_1.jpg
Caption: View of monitoring well and bollards located 5 to 15 feet from riverward levee toe.

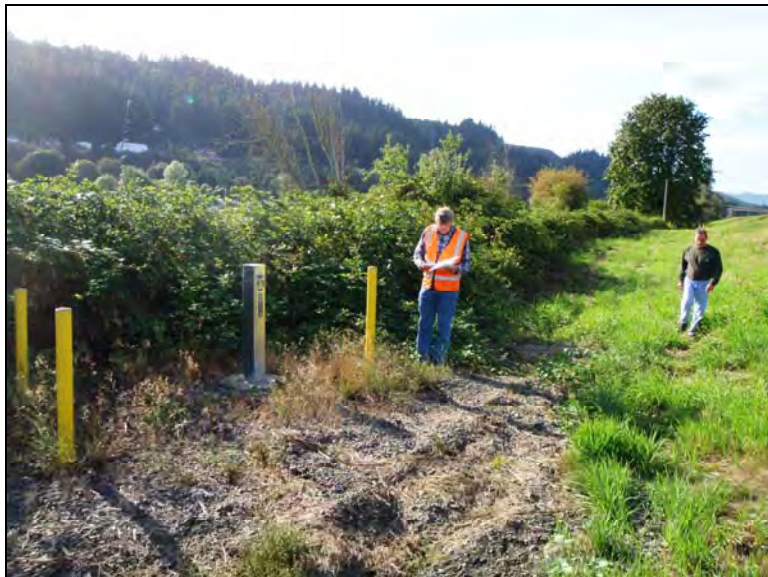
Inspect ID: SAUA_2011_a_0136 **Title:** USACE_CENWP_SAU_2011_a_0136_1.jpg
Caption: View of monitoring well and bollards 5-10 feet from riverward levee toe.

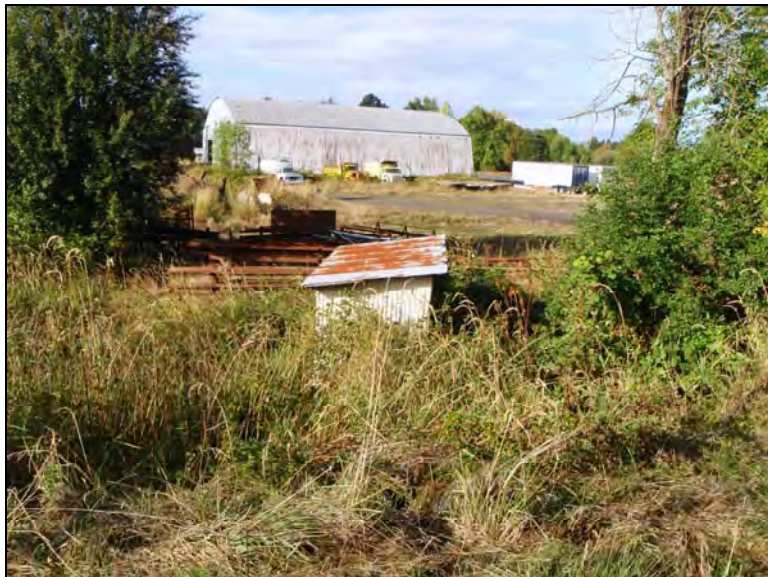
Inspect ID: SAUA_2011_a_0144 **Title:** USACE_CENWP_SAU_2011_a_0144_1.jpg
Caption: View of small corrugated metal storage shed at the landward levee toe. Station 140+00

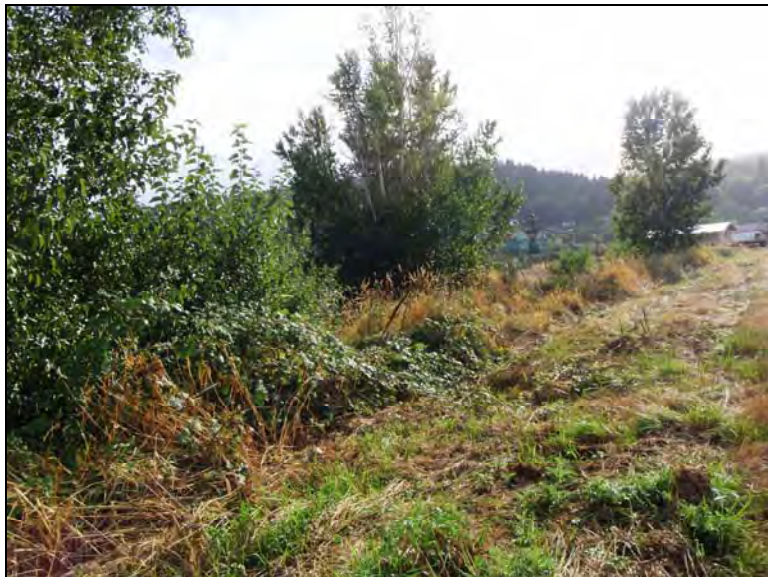
Inspect ID: SAUA_2011_a_0150 **Title:** USACE_CENWP_SAU_2011_a_0150_1.jpg
Caption: View of vegetation on the levee embankment. Station 145+00 to 156+00

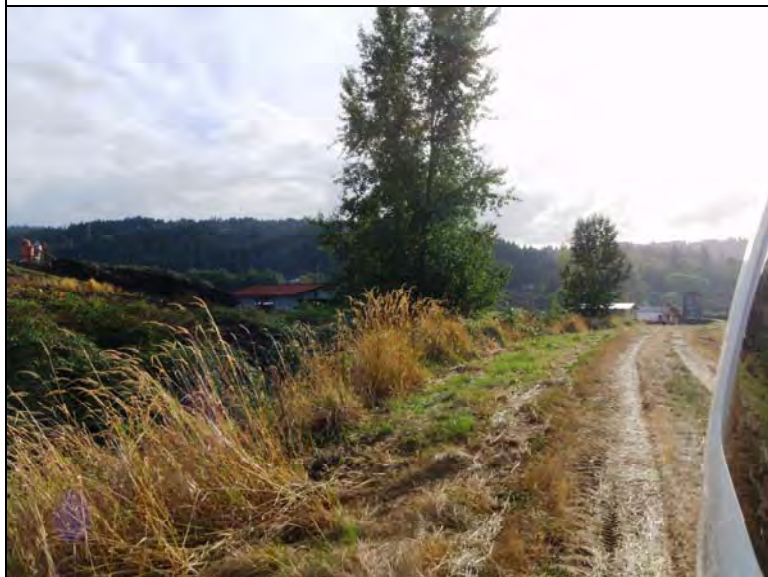
Inspect ID: SAUA_2011_a_0151 **Title:** USACE_CENWP_SAU_2011_a_0151_1.jpg
Caption: View of a tree on the riverward side of the levee.

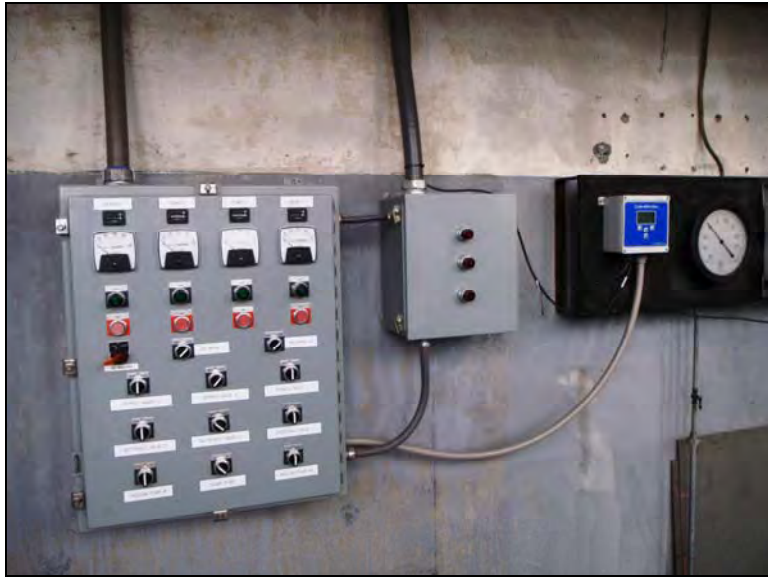
Inspect ID: SAUA_2011_a_0019 **Title:** USACE_CENWP_SAU_2011_a_0019_1.jpg
Caption: View of the automatic shutoff and primer pump control panel. Station 727+00

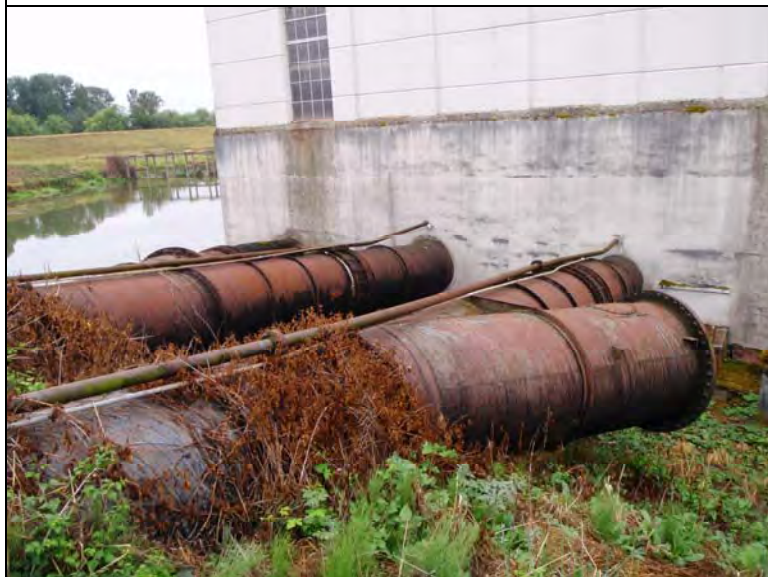
Inspect ID: SAUA_2011_a_0016 **Title:** USACE_CENWP_SAU_2011_a_0016_1.jpg
Caption: View of the pump station discharge pipes. Station727+00

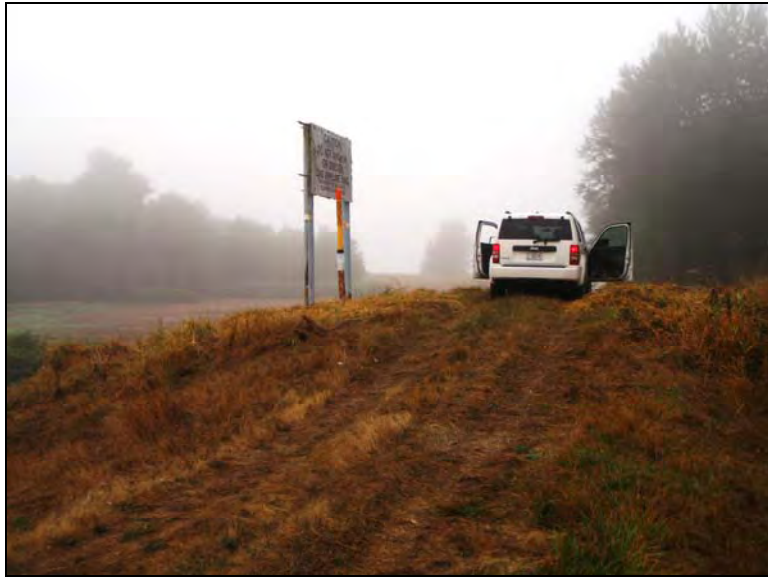
Inspect ID: SAUB_2011_a_0002 **Title:** USACE_CENWP_SAUB_2011_a_0002_1.jpg
Caption: View of natural gas pipeline crossing of the levee in apparent overbuild. Station 154+50

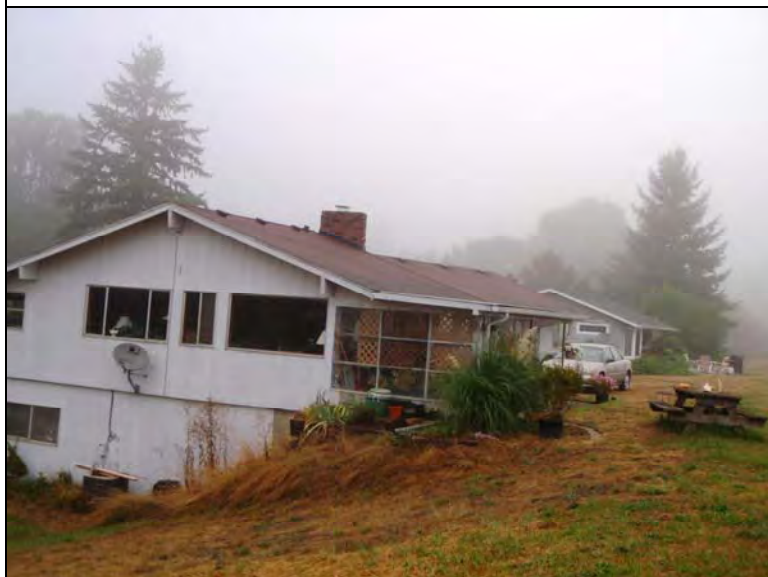
Inspect ID: SAUB_2011_a_0005 **Title:** USACE_CENWP_SAUB_2011_a_0005_1.jpg
Caption: View of two houses on the landward side of the levee. Station 165+00 to 167+50

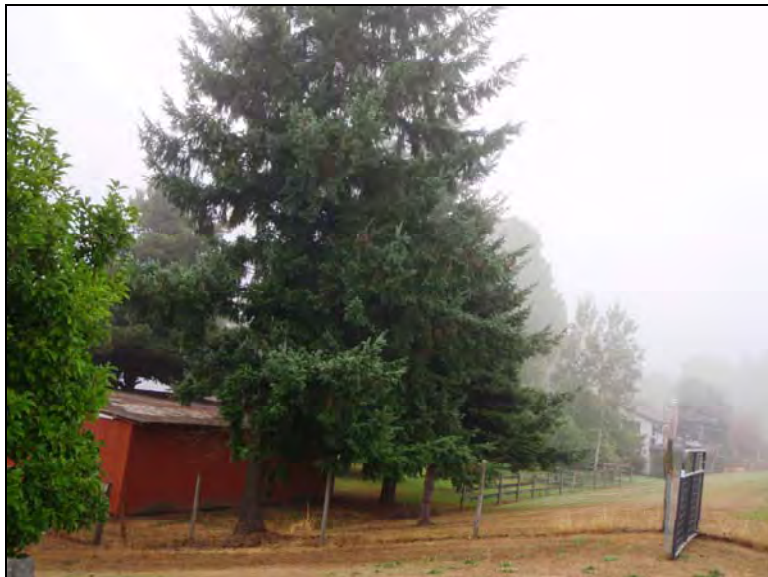
Inspect ID: SAUB_2011_a_0008 **Title:** USACE_CENWP_SAUB_2011_a_0008_1.jpg
Caption: View of three fir trees on the landward levee slope and toe 12 to 24 inches in diameter. Station 167+50

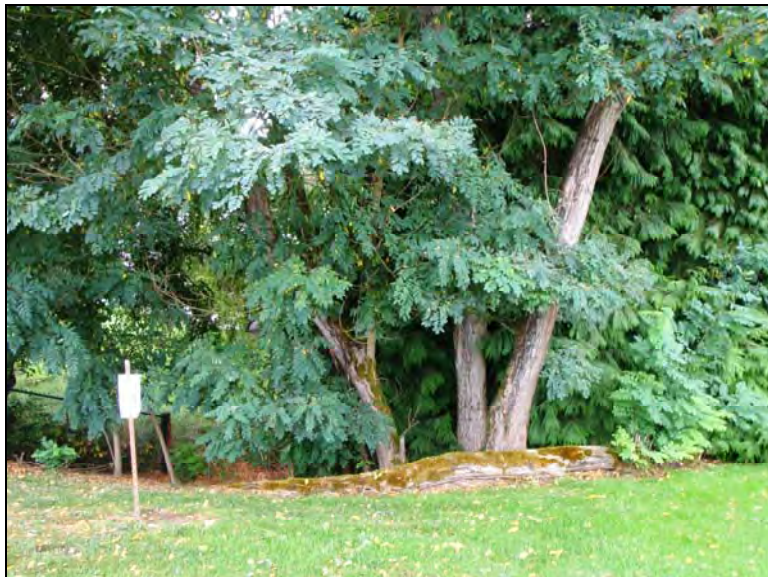
Inspect ID: SAUB_2011_a_0016 **Title:** USACE_CENWP_SAUB_2011_a_0016_1.jpg
Caption: View of trees on the landward levee slope. Station 173+50

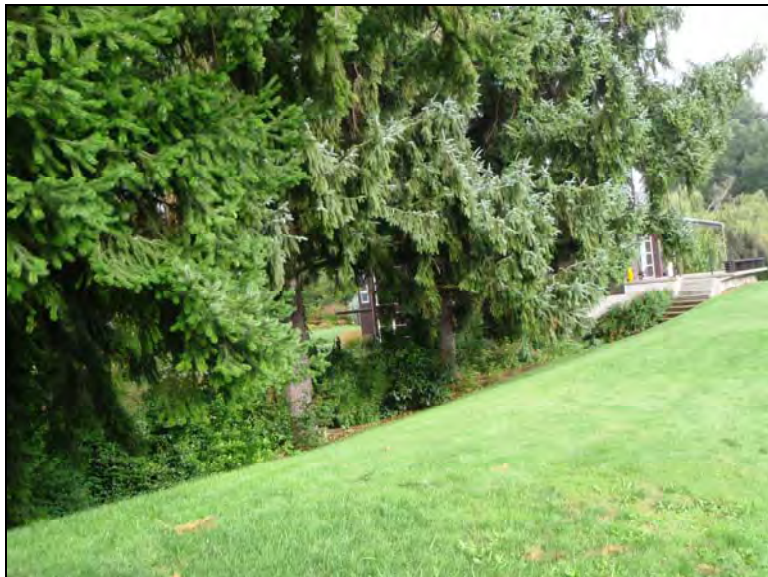
Inspect ID: SAUB_2011_a_0020 **Title:** USACE_CENWP_SAUB_2011_a_0020_1.jpg
Caption: View of two large 3- foot diameter trees on the landward levee toe. Station 175+00

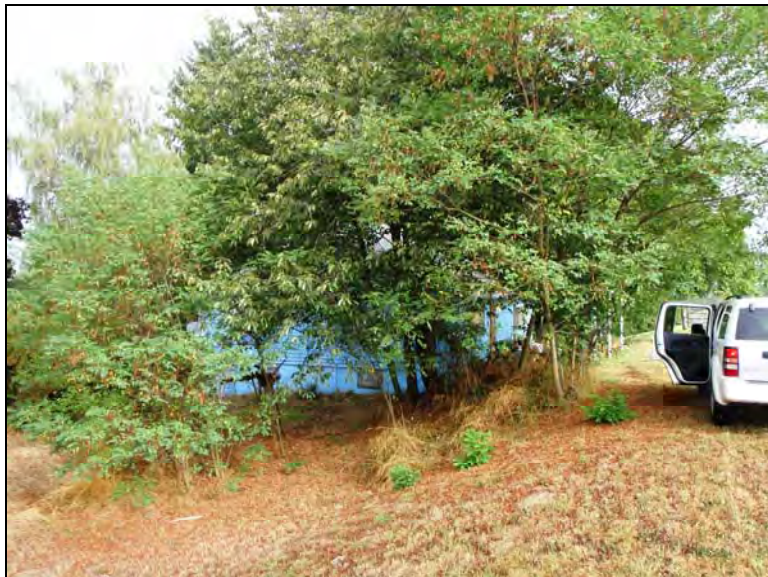
Inspect ID: SAUB_2011_a_0026 **Title:** USACE_CENWP_SAUB_2011_a_0026_1.jpg
Caption: View of a 10" diameter deciduous tree and brush at the landward levee toe and slope. Station 180+00

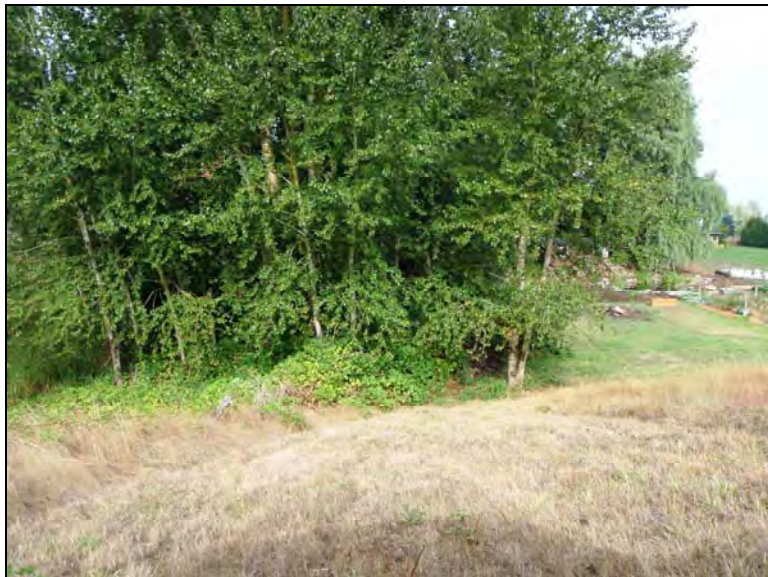
Inspect ID: SAUB_2011_a_0034 **Title:** USACE_CENWP_SAUB_2011_a_0034_1.jpg
Caption: View of trees at the landward levee toe. Station 192+50

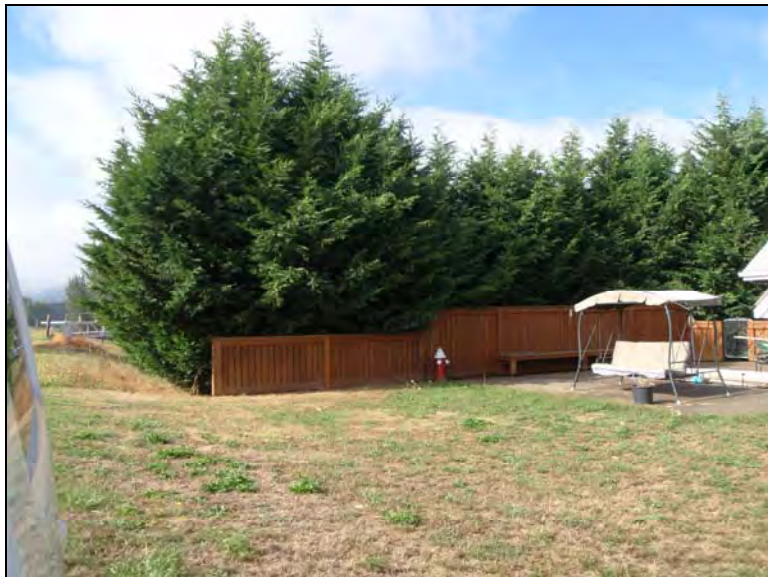
Inspect ID: SAUB_2011_a_0039 **Title:** USACE_CENWP_SAUB_2011_a_0039_1.jpg
Caption: View of large Arborvitae on the landward slope of the levee at Station 199+50.

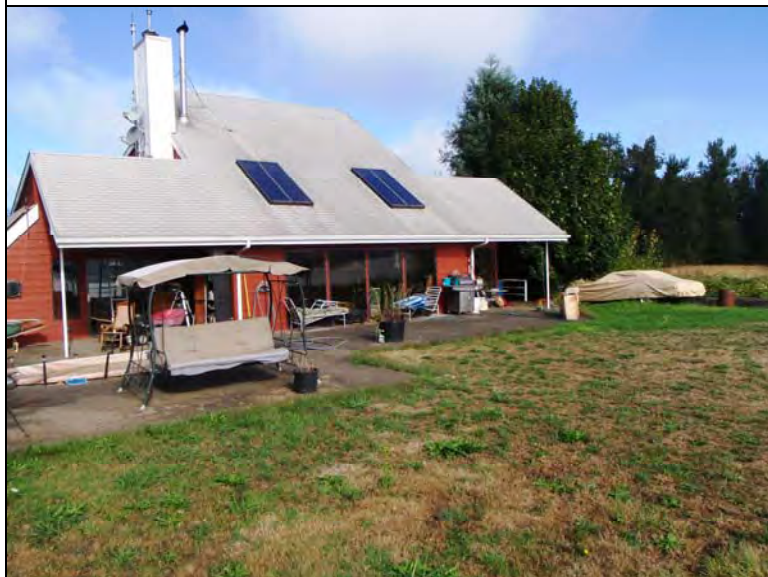
Inspect ID: SAUB_2011_a_0041 **Title:** USACE_CENWP_SAUB_2011_a_0041_1.jpg
Caption: View of house and overbuild on the landward levee slope. House appears to be shown on drawing CLW-99-42/4. There are fences, gates, access road, and a concrete fence along the access road associated with the property. Station 199+50

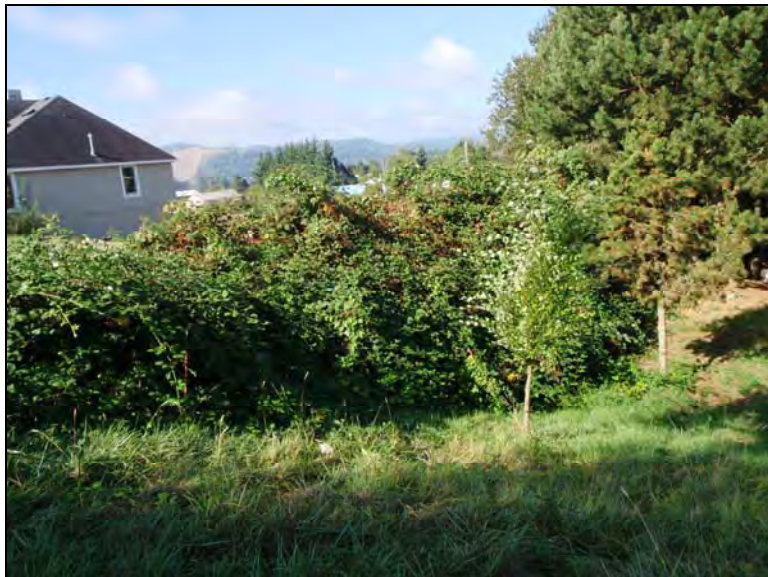
Inspect ID: SAUB_2011_a_0044 **Title:** USACE_CENWP_SAUB_2011_a_0044_1.jpg
Caption: View of brush and one small (4" diameter) evergreen tree on the landward levee slope at Station 203+50.

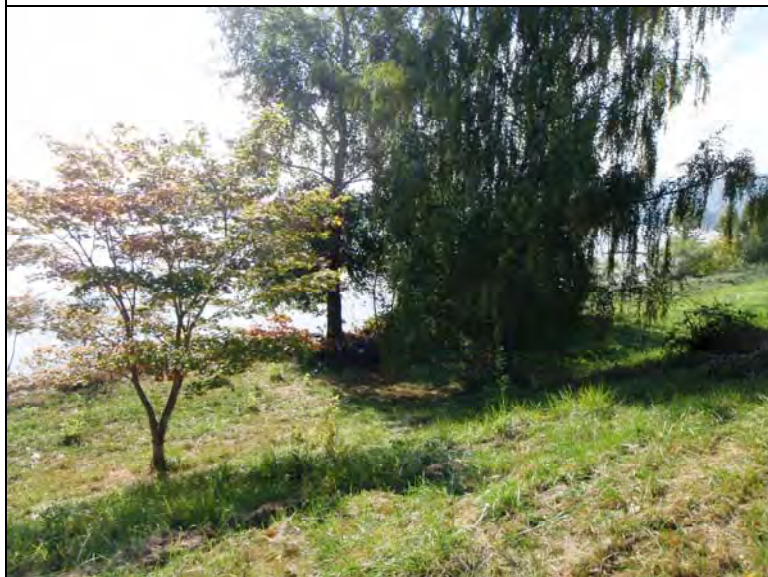
Inspect ID: SAUB_2011_a_0045 **Title:** USACE_CENWP_SAUB_2011_a_0045_1.jpg
Caption: View of birch and maple trees within 15 feet of the riverward levee toe. There are also blackberries along a fence and gate at this location. Station 203+50

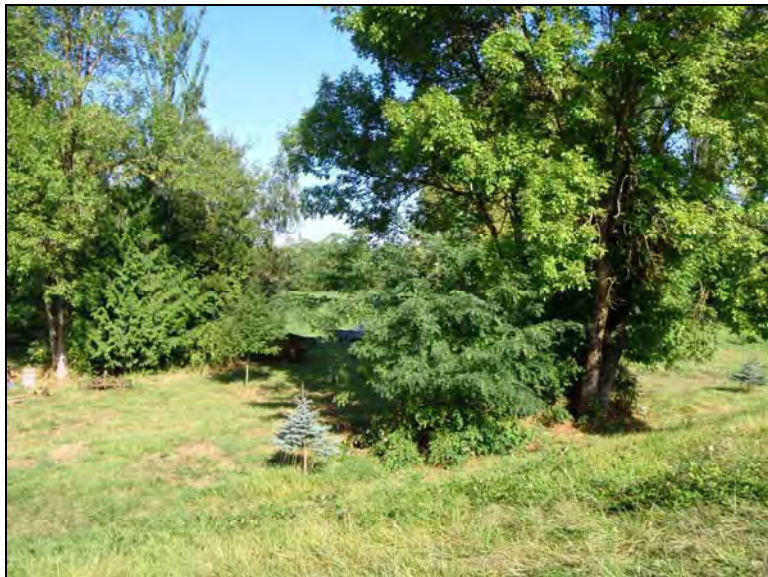
Inspect ID: SAUB_2011_a_0046 **Title:** USACE_CENWP_SAUB_2011_a_0046_1.jpg
Caption: View of a large (48 to 54" diameter) tree and young planted spruce trees at the landward toe of the levee. Station 207+00

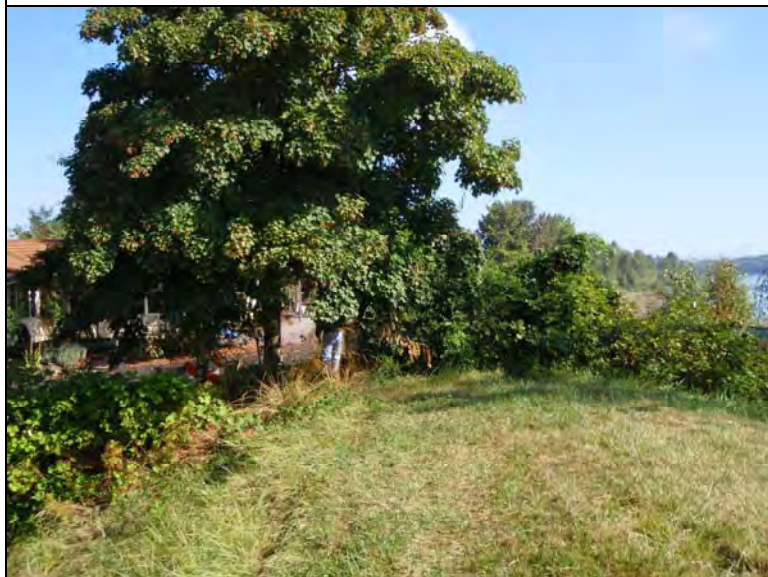
Inspect ID: SAUB_2011_a_0047 **Title:** USACE_CENWP_SAUB_2011_a_0047_1.jpg
Caption: View of one large deciduous tree on the landward shoulder of the levee and of bushes blocking gate and crown and extending down landward and riverward fence line. Station 210+00

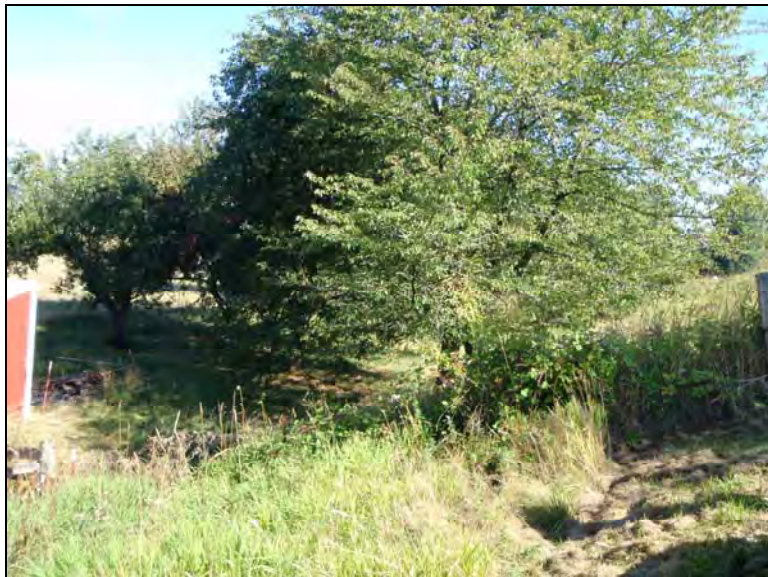
Inspect ID: SAUB_2011_a_0064 **Title:** USACE_CENWP_SAUB_2011_a_0064_1.jpg
Caption: View of two deciduous trees (16-18" diameter) at the landward levee toe. Station 224+00

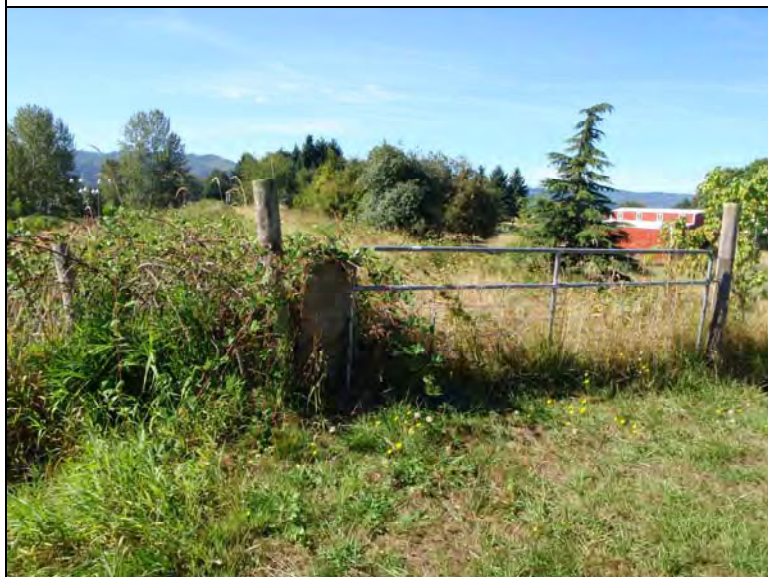
Inspect ID: SAUB_2011_a_0067 **Title:** USACE_CENWP_SAUB_2011_a_0067_1.jpg
Caption: View of gate (on crest) and levee crossing fence that is impassible due to vegetation. Station 231+50

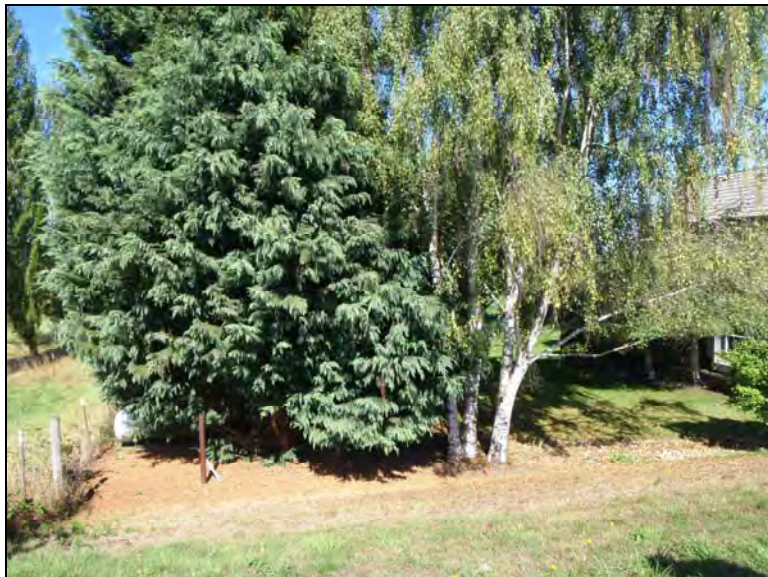
Inspect ID: SAUB_2011_a_0068 **Title:** USACE_CENWP_SAUB_2011_a_0068_1.jpg
Caption: View of three aspens and an arborvite tree at the landward levee toe. Station 231+50

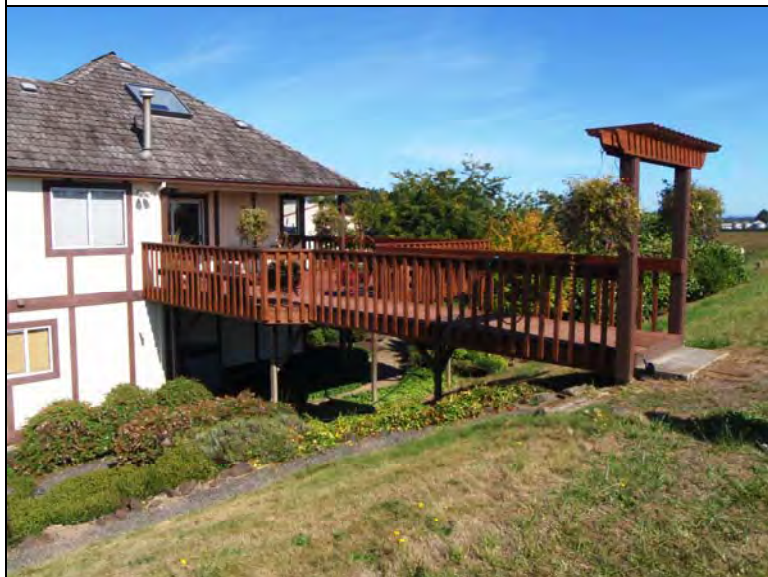
Inspect ID: SAUB_2011_a_0069 **Title:** USACE_CENWP_SAUB_2011_a_0069_1.jpg
Caption: View of house (Beall) and landscaping on the landward side of the levee. The house is permitted.

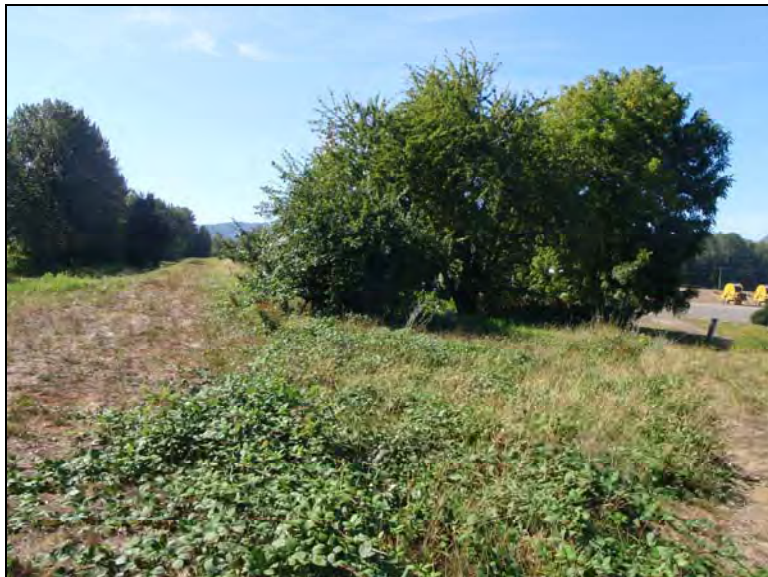
Inspect ID: SAUB_2011_a_0077 **Title:** USACE_CENWP_SAUB_2011_a_0077_1.jpg
Caption: View of a tree (8-12" diameter) and brush on the landward side of the levee within 15 feet of the toe. Station 259+00.

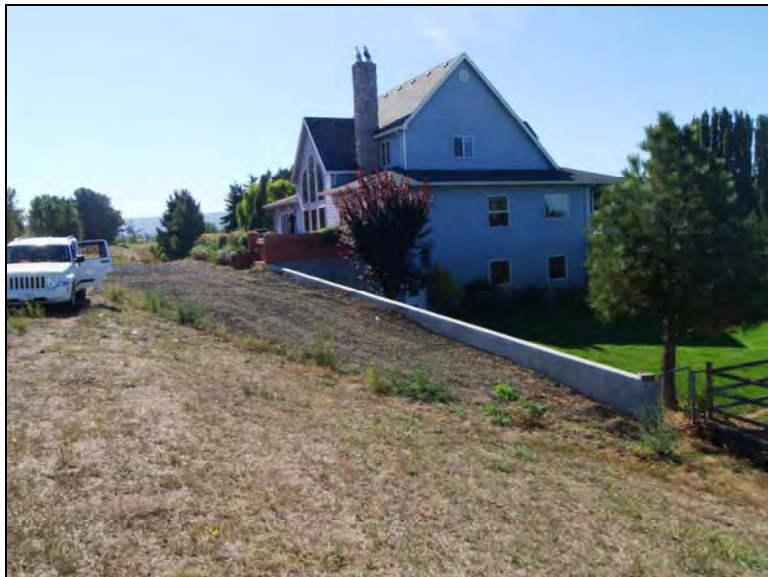
Inspect ID: SAUB_2011_a_0085 **Title:** USACE_CENWP_SAUB_2011_a_0085_1.jpg
Caption: View of permitted landside fill that was completed in 2011. Station 288+50

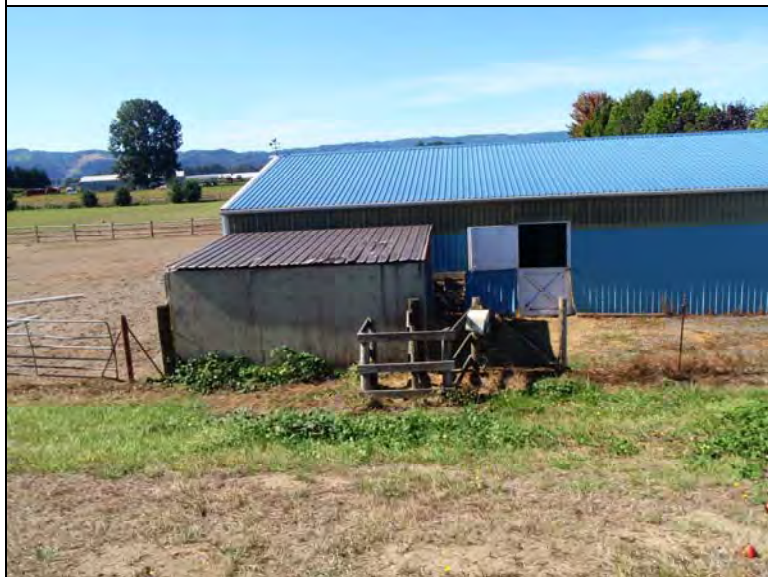
Inspect ID: SAUB_2011_a_0087 **Title:** USACE_CENWP_SAUB_2011_a_0087_1.jpg
Caption: View of small concrete storage shed at the landward toe of the levee. Station 290+00

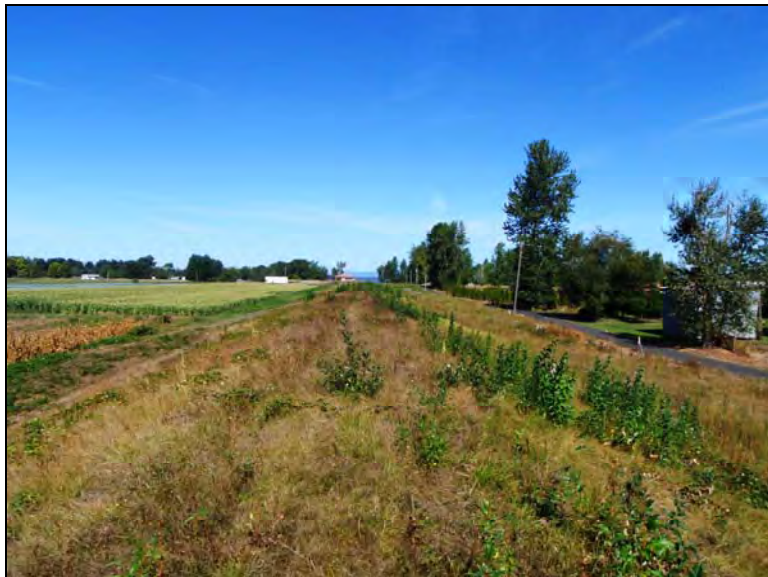
Inspect ID: SAUB_2011_a_0090 **Title:** USACE_CENWP_Saub_2011_a_0090_1.jpg
Caption: View of a reach of levee where significant efforts were made in 2010/2011 to clear cottonwood trees along both the riverward and landward levee toes. Emergent cottonwood growths can be seen in the photo.
