DEPARTMENT OF THE ARMY
CORPS OF ENGINEERS, PORTLAND DISTRICT
PO BOX 2946
PORTLAND OR 97208-2946

SUBJECT: Routine Inspection Results, Sauvie Island Flood Damage Reduction System, U.S. Army Corps of Engineers (USACE) Assigned System Rating.

Flood Damage Reduction Segment / System Inspection Report

1. Levee segment / system and district: (name of the segment / system and levee district) Multnomah Channel Segment, Sauvie Island Flood Damage Reduction Project, Sauvie Island Drainage Improvement Company

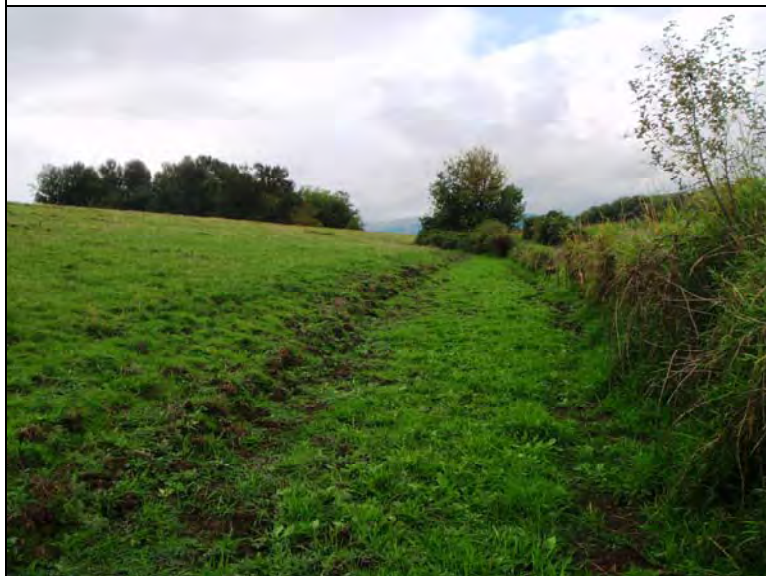
Inspect ID: SAUC_2011_a_0011 **Title:** USACE_CENWP_SAUC_2011_a_0011_1.jpg
Caption: View of cattle damage along the riverward toe of the levee that has caused an 18-24" vertical cut. Station 477+00

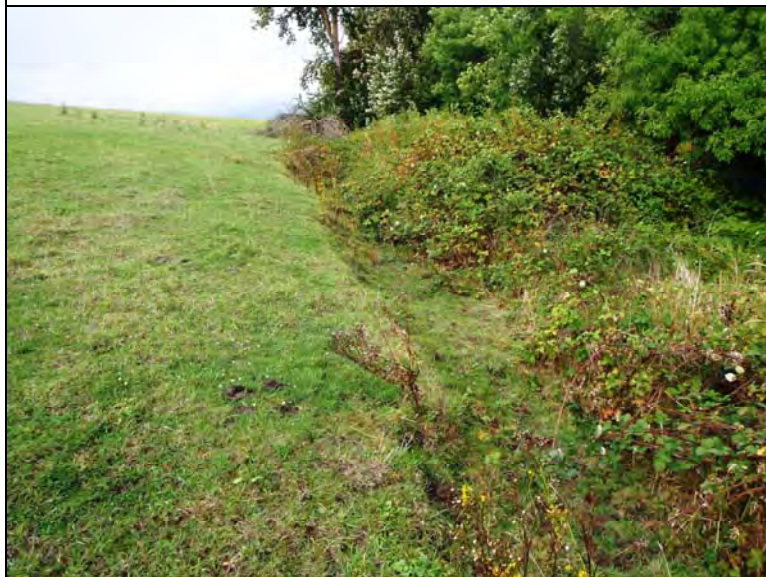
Inspect ID: SAUC_2011_a_0036 **Title:** USACE_CENWP_SAUC_2011_a_0036_1.jpg
Caption: View of cattle caused cut in the riverward slope of the levee. Station 540+00 to 562+00

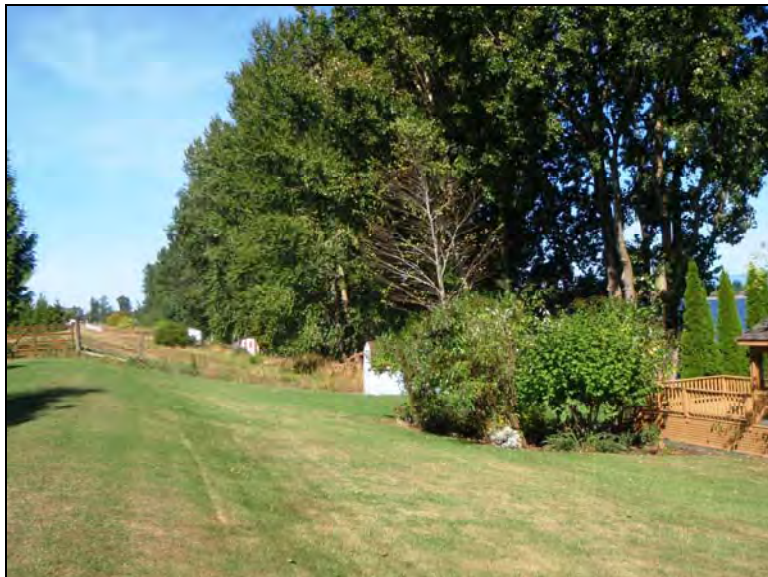
Inspect ID: SAUD_2011_a_0009 **Title:** USACE_CENWP_SAUD_2011_a_0009_1.jpg
Caption: View of large trees within 15 feet of the riverward toe of the levee at Station 327+00 to 335+00.

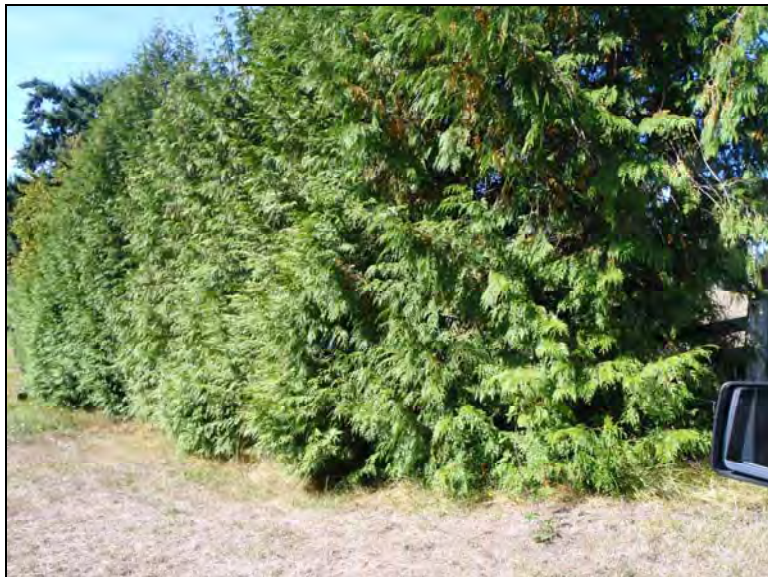
Inspect ID: SAUD_2011_a_0019 **Title:** USACE_CENWP_SAUD_2011_a_0019_1.jpg
Caption: View of large arborvitae/cyprus trees on the landward levee slope and toe at Station 335+00.

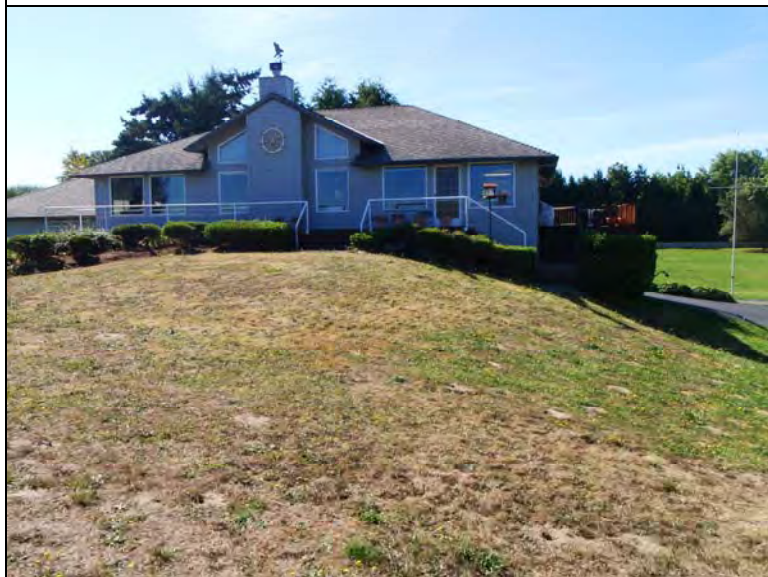
Inspect ID: SAUD_2011_a_0021 **Title:** USACE_CENWP_SAUD_2011_a_0021_1.jpg
Caption: View of house on landward side of the levee located within 15 feet of the levee toe. Station 338+00.

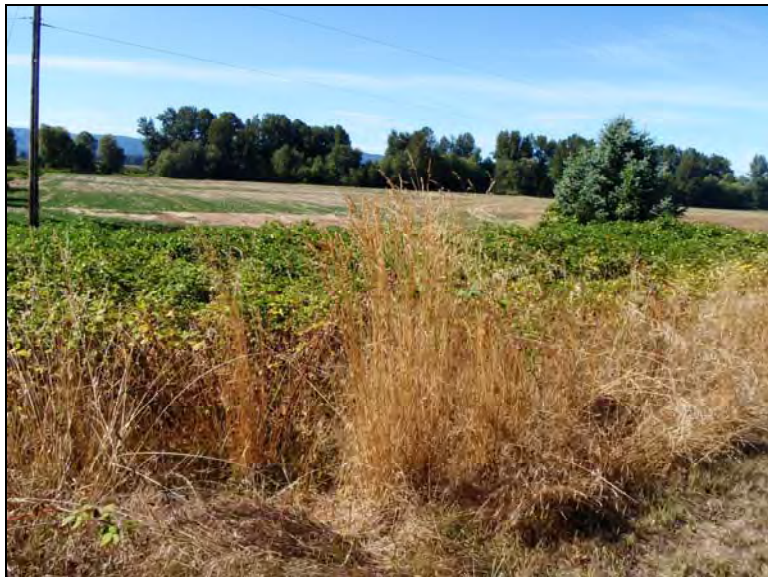
Inspect ID: SAUD_2011_a_0025 **Title:** USACE_CENWP_SAUD_2011_a_0025_1.jpg
Caption: View of dense berry vines and brush with occasional trees on the landward side of the levee.

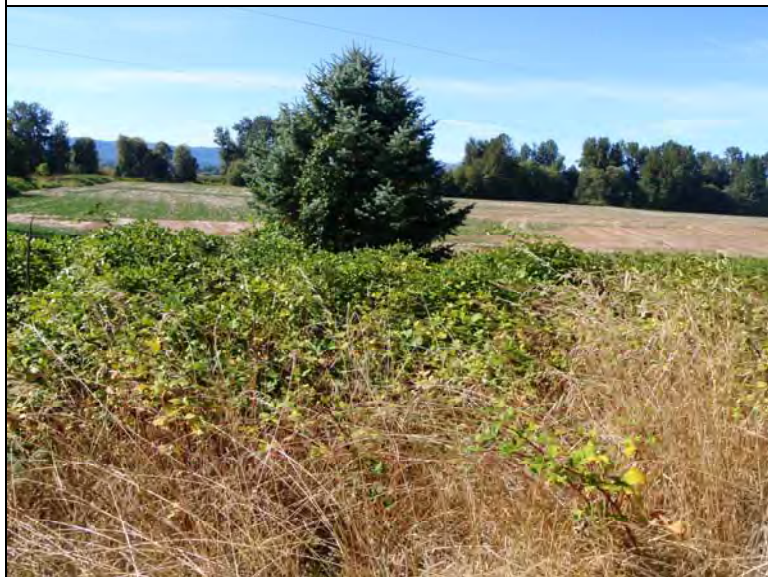
Inspect ID: SAUD_2011_a_0026 **Title:** USACE_CENWP_SAUD_2011_a_0026_1.jpg
Caption: View of a blue spruce tree on the land side of the levee. There are also four trees on the riverside of the levee at this location. Station 340+00.

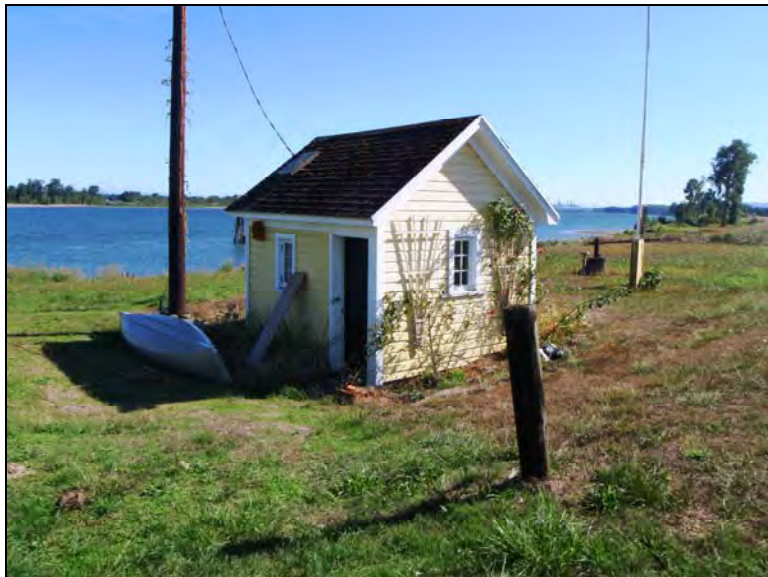
Inspect ID: SAUD_2011_a_0043 **Title:** USACE_CENWP_SAUD_2011_a_0043_1.jpg
Caption: View of small pumphouse at the riverward toe of the levee at Station 378+00. The pumphouse is indicated on drawing CLW-99-42/6.

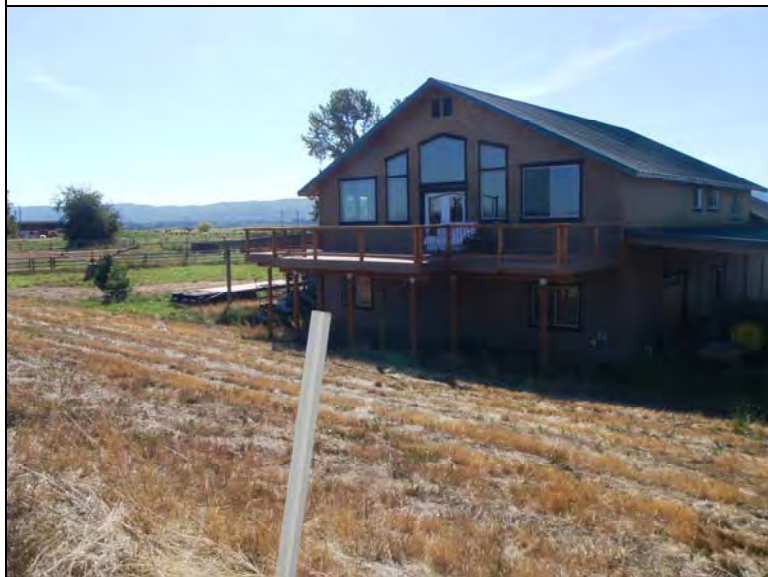
Inspect ID: SAUD_2011_a_0046 **Title:** USACE_CENWP_SAUD_2011_a_0046_1.jpg
Caption: View of house barn on the landward side of the levee at Station 387+00.

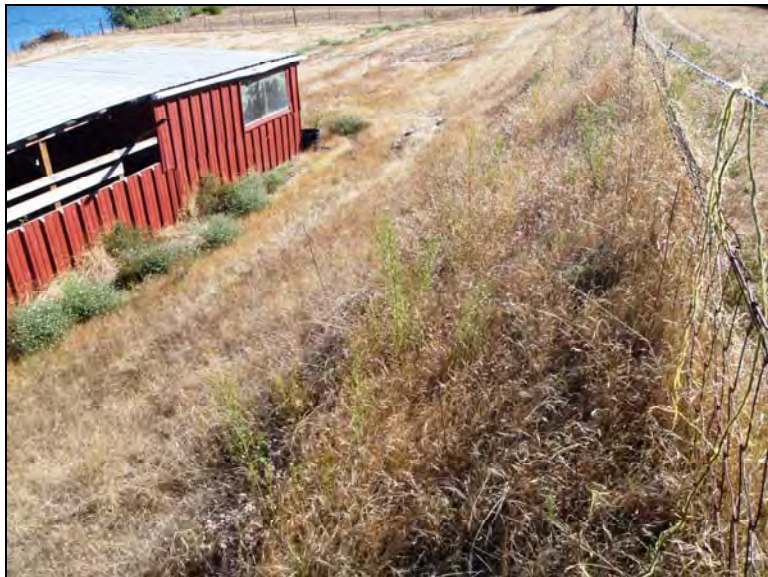
Inspect ID: SAUD_2011_a_0056 **Title:** USACE_CENWP_SAUD_2011_a_0056_1.jpg
Caption: View of approximately 180 linear feet of over-steepened riverward levee slope at Station 395+00. The affected slope is up to 45 degrees in some areas and appears to be caused by farm animals

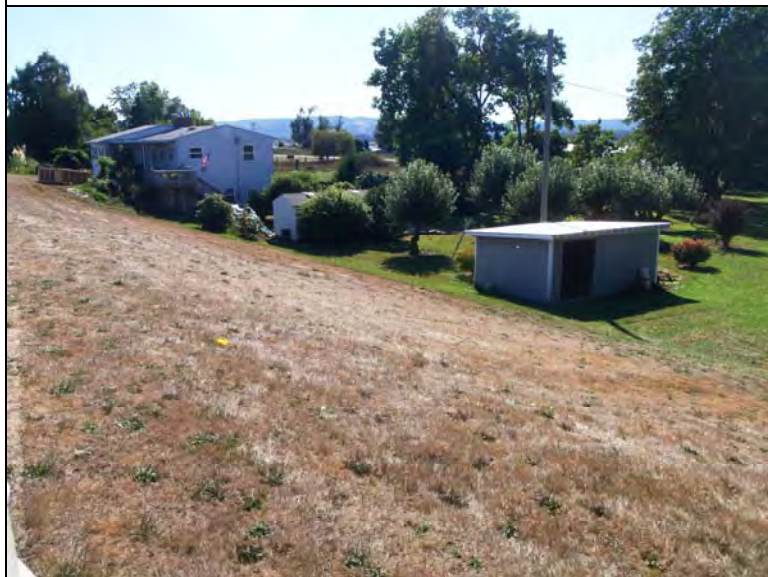
Inspect ID: SAUD_2011_a_0065 **Title:** USACE_CENWP_SAUD_2011_a_0065_1.jpg
Caption: View of house and fill on land side levee slope and two storage sheds on the landward levee toe. Station 400+00. The house may be shown on drawing CLW-99-42/7.

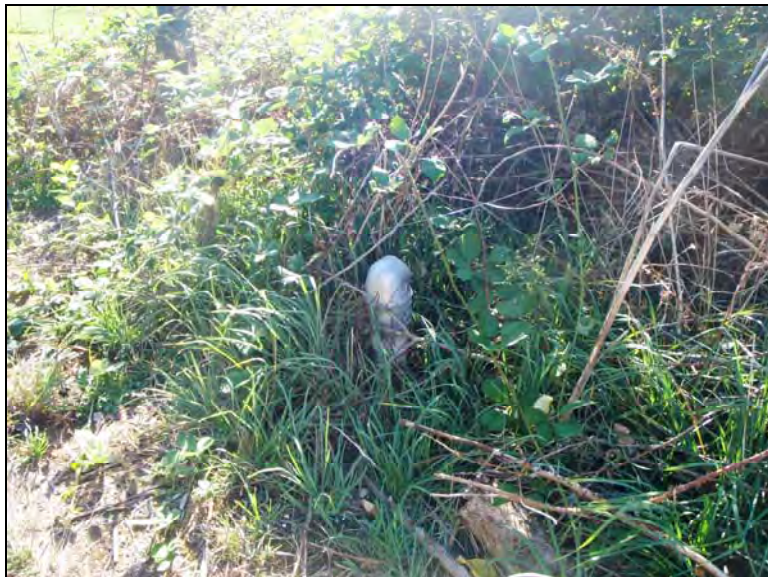
Inspect ID: SAUD_2011_a_0095 **Title:** USACE_CENWP_SAUD_2011_a_0095_1.jpg
Caption: View of air breaker to irrigation pipe crossing of the levee at Station 424+50.

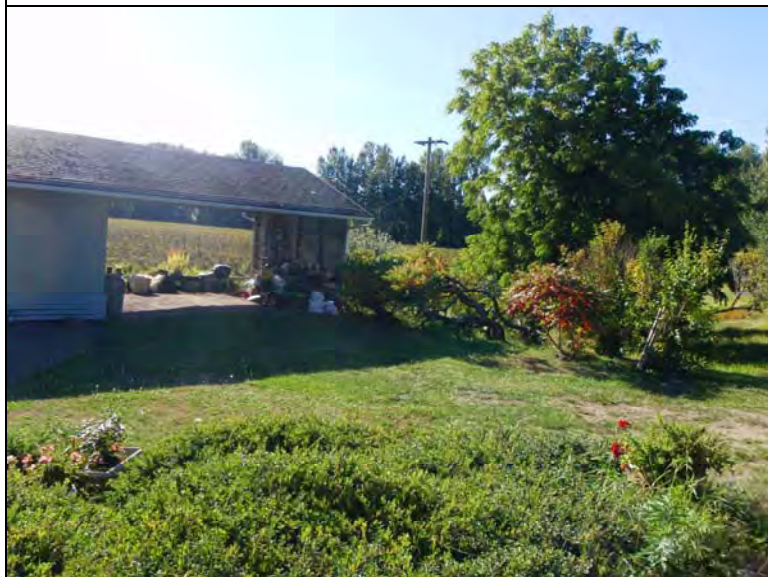
Inspect ID: SAUD_2011_a_0099 **Title:** USACE_CENWP_SAUD_2011_a_0099_1.jpg
Caption: View of landward house and fill with landscaping that is shown on drawing CLW-99-42/7. Station 446+50

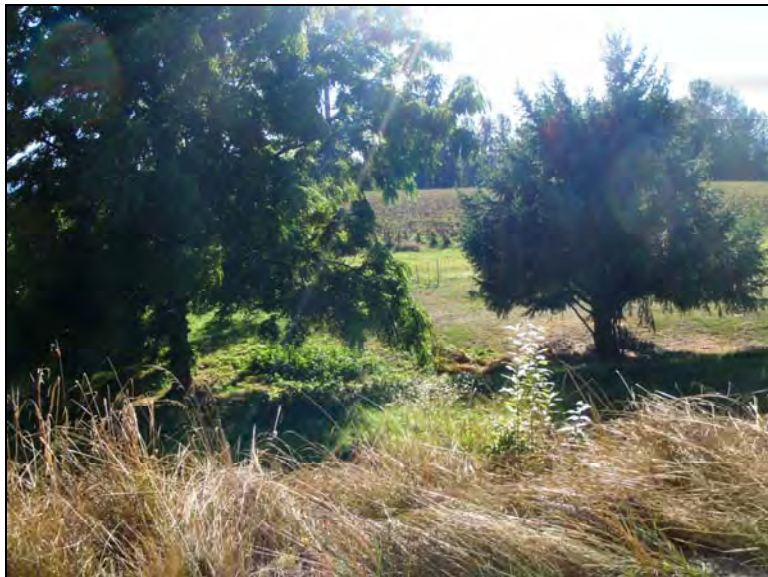
Inspect ID: SAUD_2011_a_0101 **Title:** USACE_CENWP_SAUD_2011_a_0101_1.jpg
Caption: View of one 18" diameter deciduous tree and one 18" diameter fir tree on landward levee toe at Station 447+00.

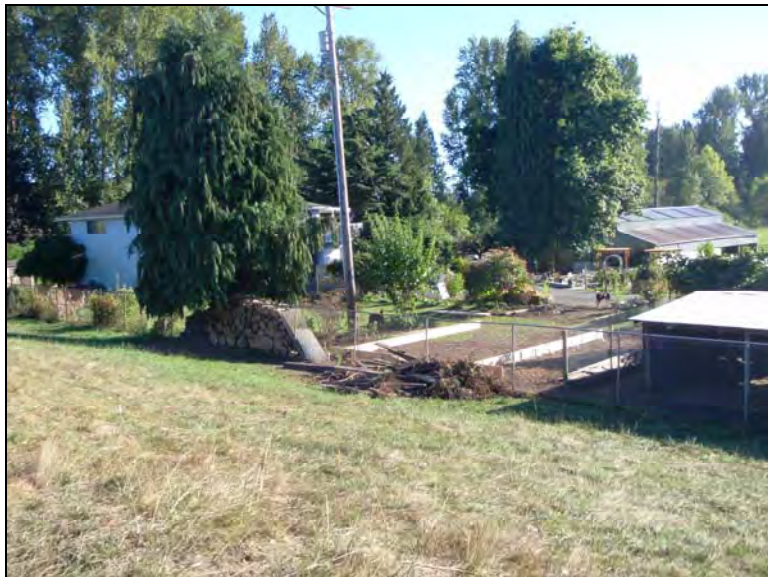
Inspect ID: SAUD_2011_a_0109 **Title:** USACE_CENWP_SAUD_2011_a_0109_1.jpg
Caption: View of a large evergreen tree that is within 15 feet of the landward toe of the levee. Small trees and two other evergreen trees noted at the site during the 2010 periodic inspection have been removed. Station 455+00.

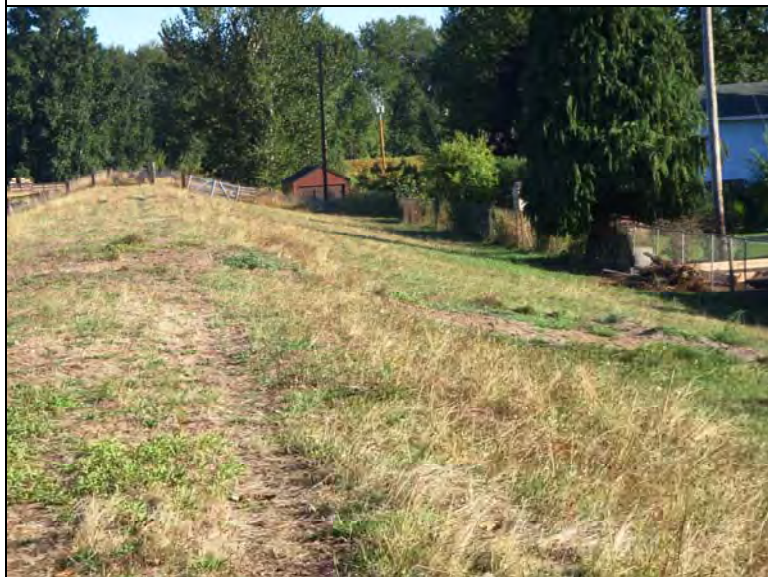
Inspect ID: SAUD_2011_a_0110 **Title:** USACE_CENWP_SAUD_2011_a_0110_1.jpg
Caption: View of 12' long 15" deep cattle dusting hole on crest and land side of the levee at Station 457+00.
