DEPARTMENT OF THE ARMY
CORPS OF ENGINEERS, PORTLAND DISTRICT
PO BOX 2946
PORTLAND OR 97208-2946

SUBJECT: Routine Inspection Results, Sauvie Island Flood Damage Reduction System, U.S. Army Corps of Engineers (USACE) Assigned System Rating.

Flood Damage Reduction Segment / System Inspection Report

1. Levee segment / system and district: (name of the segment / system and levee district) Multnomah Channel Segment, Sauvie Island Flood Damage Reduction Project, Sauvie Island Drainage Improvement Company

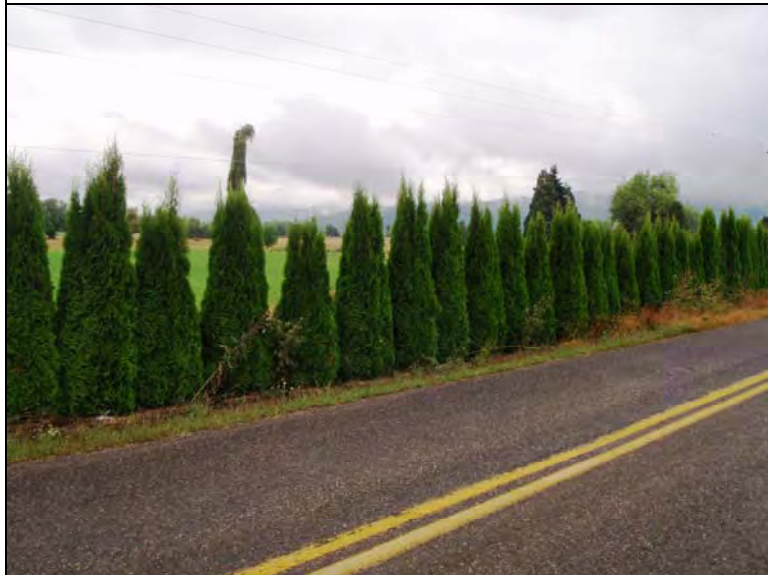
Inspect ID: SAUA_2011_a_0028 **Title:** USACE_CENWP_SAU_2011_a_0028_1.jpg
Caption: View of the row of Arborvita on the land side of the levee crown. Station 727+50

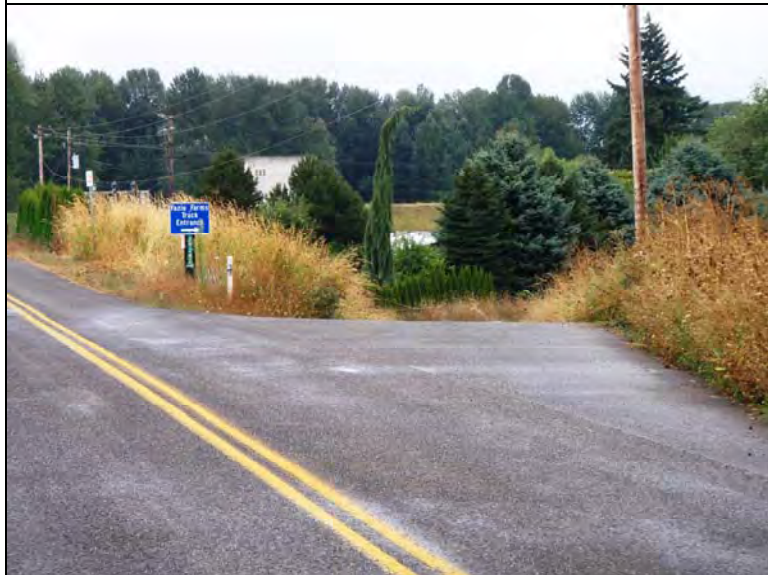
Inspect ID: SAUA_2011_a_0030 **Title:** USACE_CENWP_SAU_2011_a_0030_1.jpg
Caption: View of the land side access road. Station 728+50

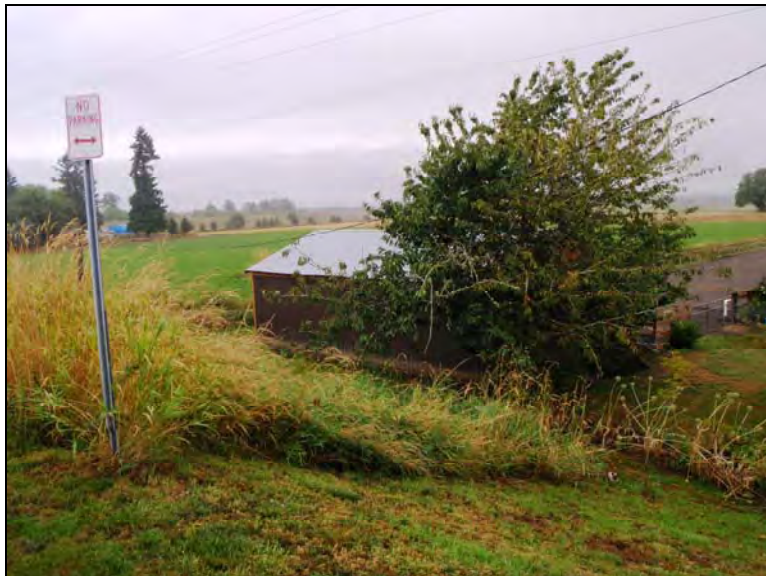
Inspect ID: SAUA_2011_a_0033 **Title:** USACE_CENWP_SAU_2011_a_0033_1.jpg
Caption: View of cherry tree 10 feet from the landward levee toe. Station 729+50

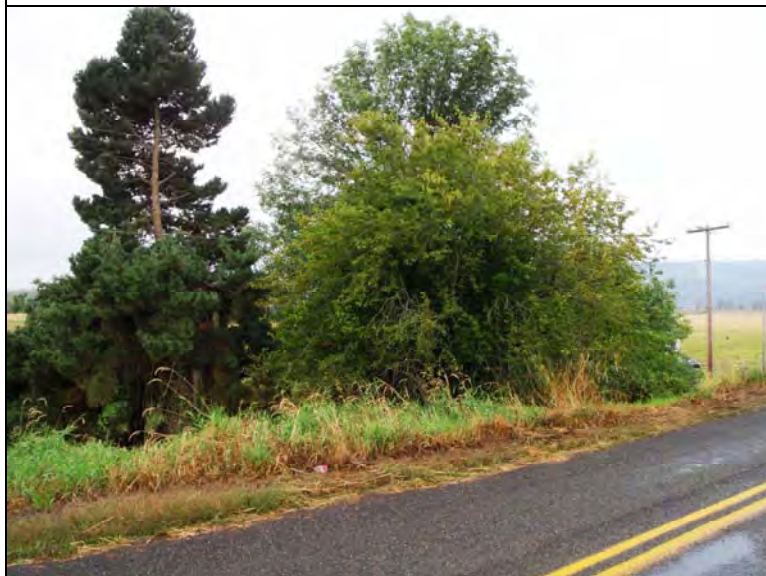
Inspect ID: SAUA_2011_a_0035 **Title:** USACE_CENWP_SAU_2011_a_0035_1.jpg
Caption: View of pine tree at landside levee toe under powerlines and three clusters of trees (apple) on landside levee slope and toe. Station 729+50

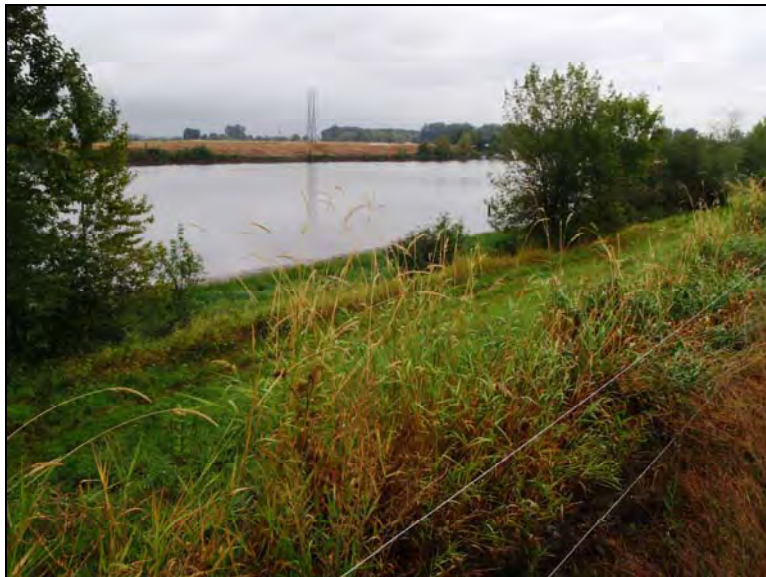
Inspect ID: SAUA_2011_a_0036 **Title:** USACE_CENWP_SAU_2011_a_0036_1.jpg
Caption: View of the riverward levee berm showing trees and stumps to be greater than 15 feet from the riverward levee toe. Station 730+00

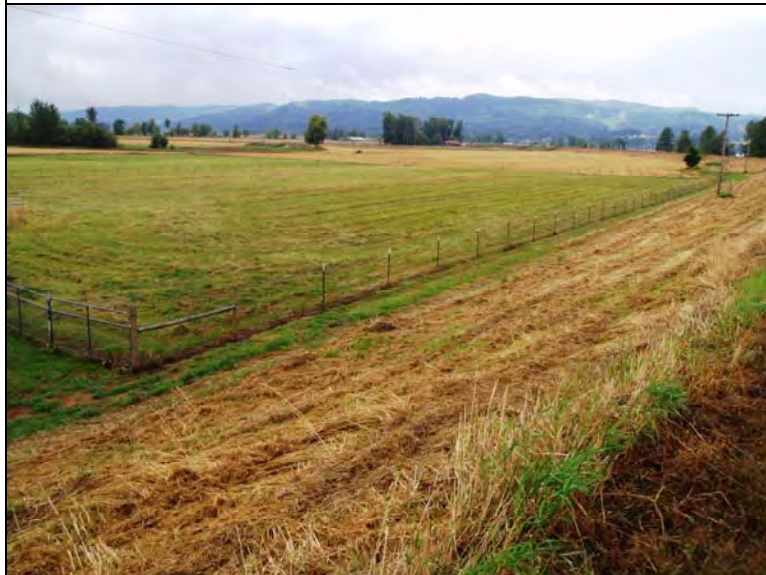
Inspect ID: SAUA_2011_a_0037 **Title:** USACE_CENWP_SAU_2011_a_0037_1.jpg
Caption: View of fence located landward of the landward levee toe. The fence is 15 feet or more from the toe of the levee except for the downstream corner. Fence is acceptable so long as vegetation at the downstream corner is maintained. Station 730+00 to 735+00

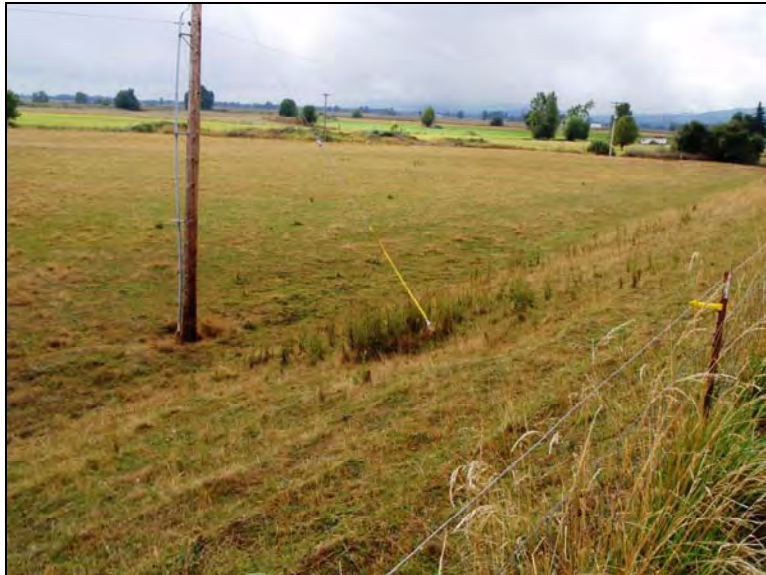
Inspect ID: SAUA_2011_a_0044 **Title:** USACE_CENWP_SAU_2011_a_0044_1.jpg
Caption: View of 10 - 12 foot diameter depression, 12 to 15 inches deep on landward levee slope from sheep rubbing levee embankment in the area around a guy-wire anchor and power pole. Station 766+00

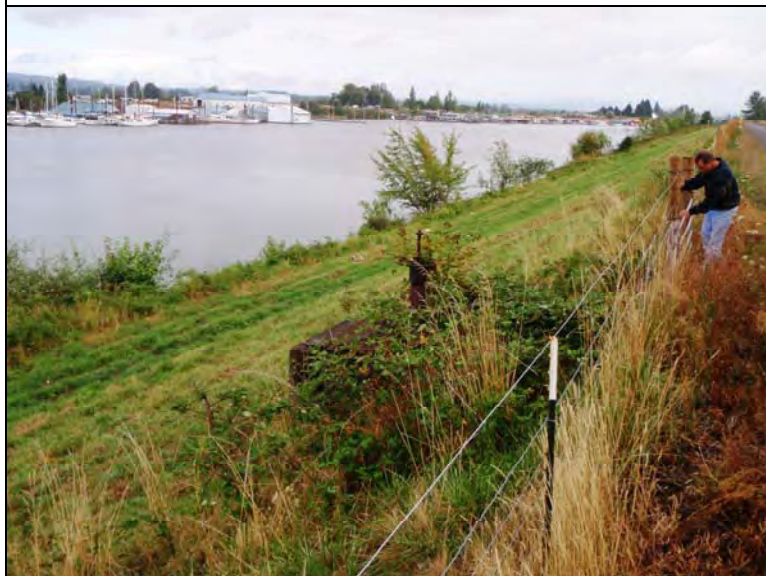
Inspect ID: SAUA_2011_a_0046 **Title:** USACE_CENWP_SAU_2011_a_0046_1.jpg
Caption: View of the riverside of an inlet structure having 24" CMP plugged with concrete on river side with two 5" irrigation pipes passing through. Station 771+00

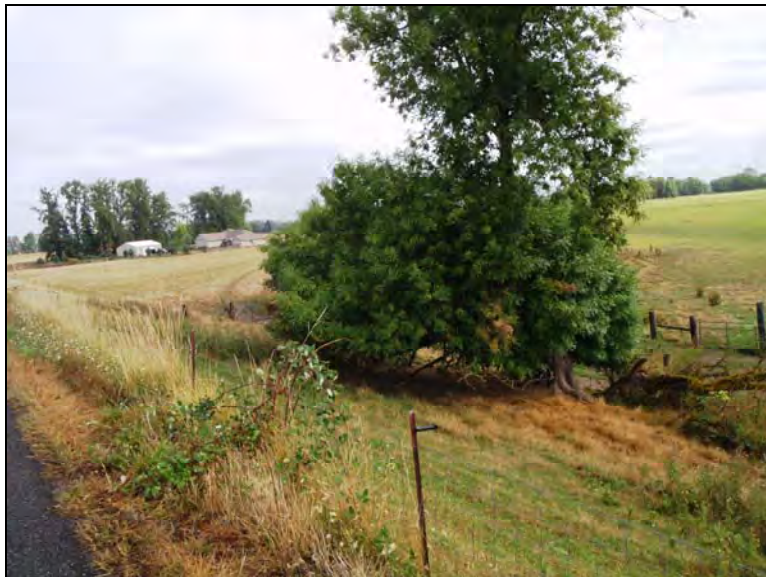
Inspect ID: SAUA_2011_a_0049 **Title:** USACE_CENWP_SAU_2011_a_0049_1.jpg
Caption: View of a 36" to 42" diameter deciduous tree on the landward levee slope.
Station 772+00

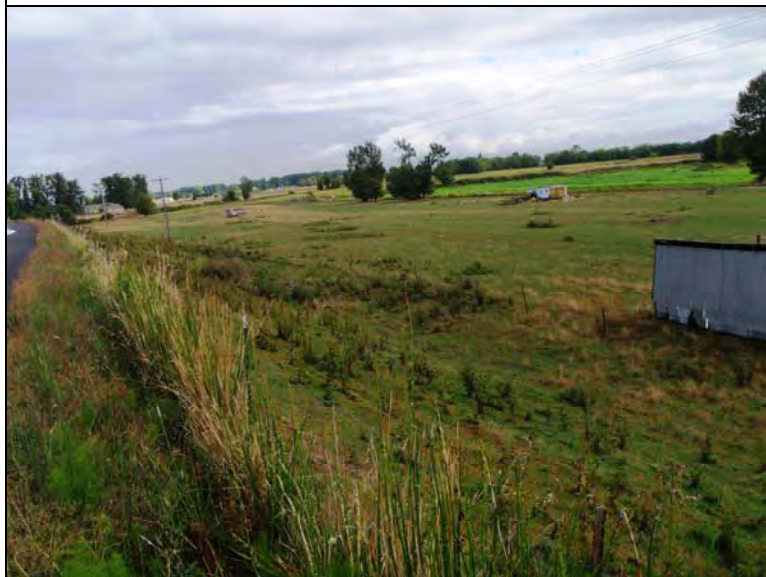
Inspect ID: SAUA_2011_a_0051 **Title:** USACE_CENWP_SAU_2011_a_0051_1.jpg
Caption: View of landward levee slope where blackberry vines have been removed.
Station 781+00

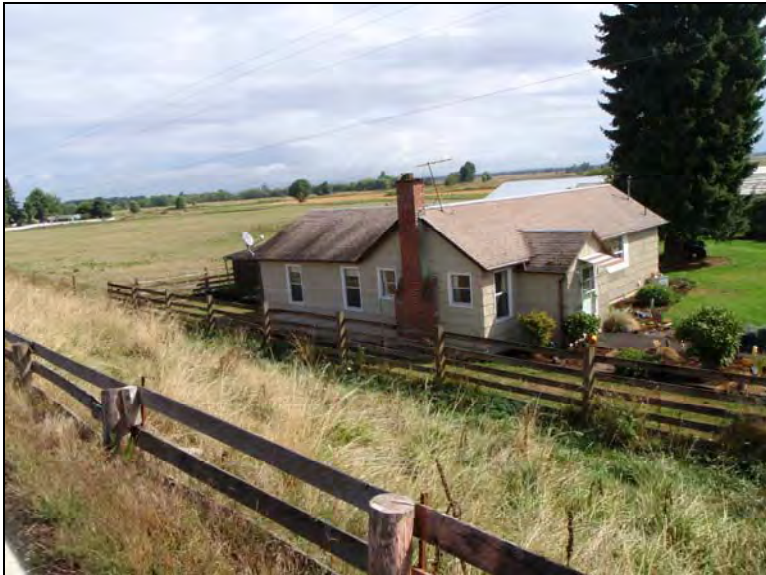
Inspect ID: SAUA_2011_a_0056 **Title:** USACE_CENWP_SAU_2011_a_0056_1.jpg
Caption: View of house on land side to the levee. Station 795+00

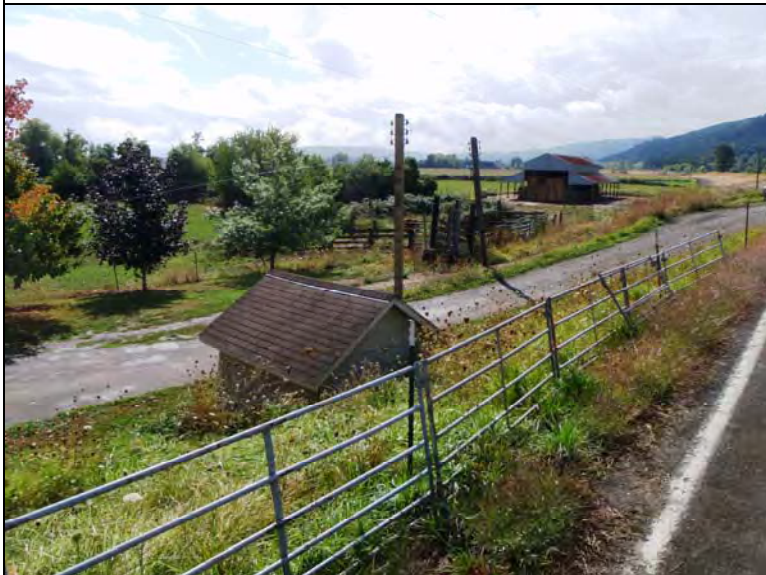
Inspect ID: SAUA_2011_a_0058 **Title:** USACE_CENWP_SAU_2011_a_0058_1.jpg
Caption: View of small shed (may be well house) on landward levee slope near driveway to house (27238 Sauvie Island Road). Two small power poles are at the toe of the levee. Station 800+00

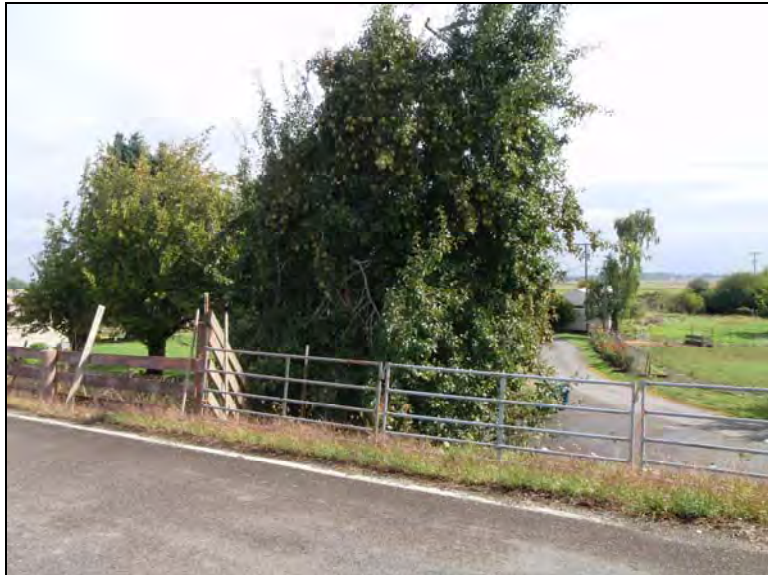
Inspect ID: SAUA_2011_a_0057 **Title:** USACE_CENWP_SAU_2011_a_0057_1.jpg
Caption: View of 24 to 30" diameter pear tree at land side levee toe and a view of a fence on the land side levee slope at this location. Station 800+00

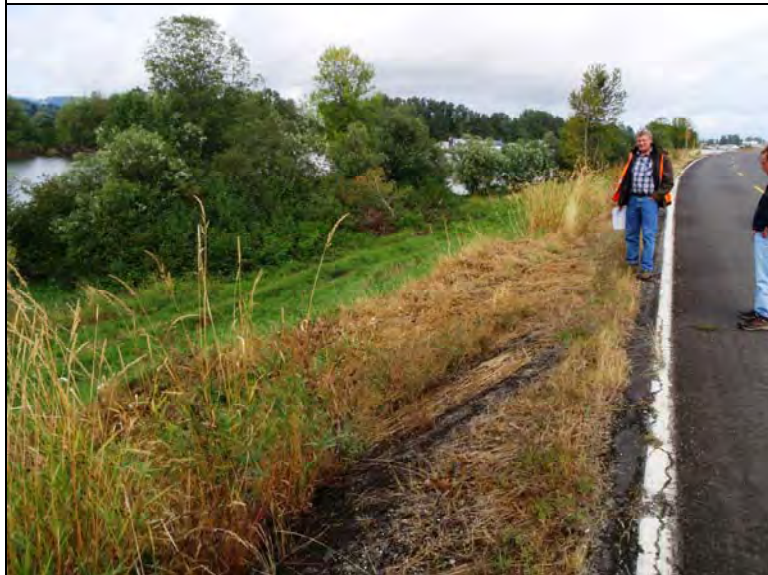
Inspect ID: SAUA_2011_a_0061 **Title:** USACE_CENWP_SAU_2011_a_0061_1.jpg
Caption: View of two sod covered access roads on the riverward levee slope. Station 817+00

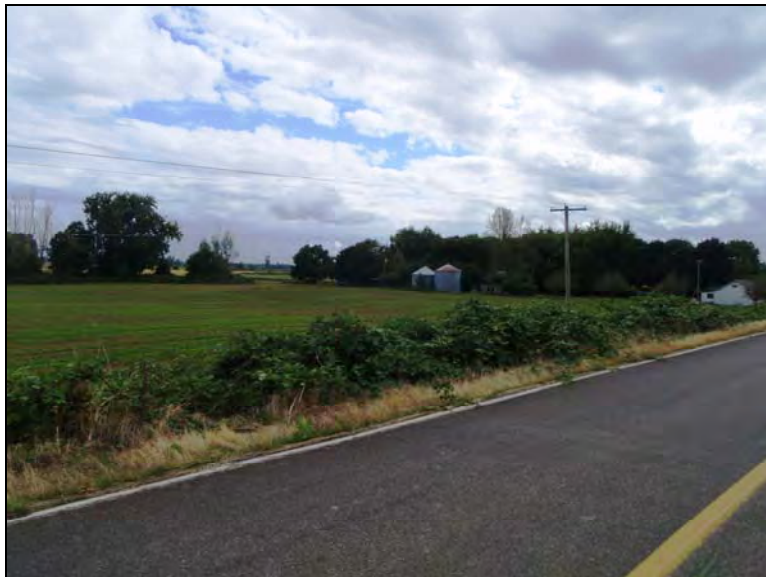
Inspect ID: SAUA_2011_a_0068 **Title:** USACE_CENWP_SAU_2011_a_0068_1.jpg
Caption: View of heavy brush on land side levee toe and slope. Station 836+00 to 845+00

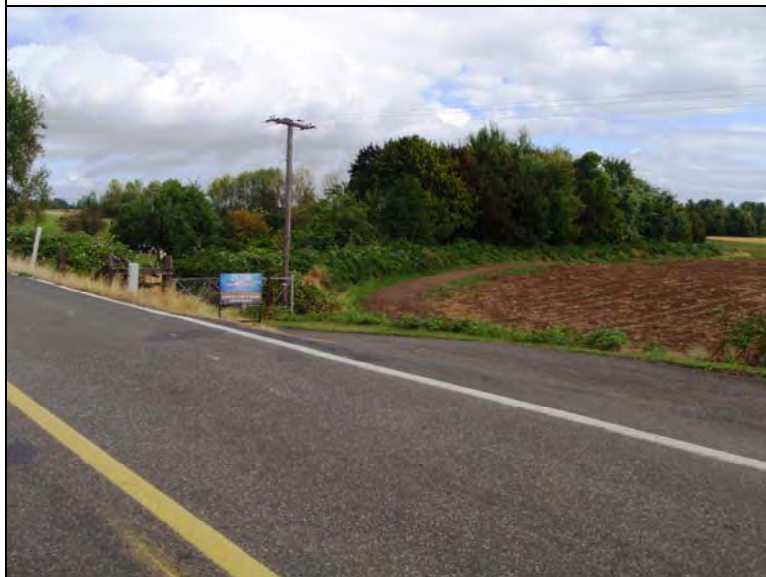
Inspect ID: SAUA_2011_a_0070 **Title:** USACE_CENWP_SAU_2011_a_0070_1.jpg
Caption: View of paved access road on landward side of the levee. Station 845+00

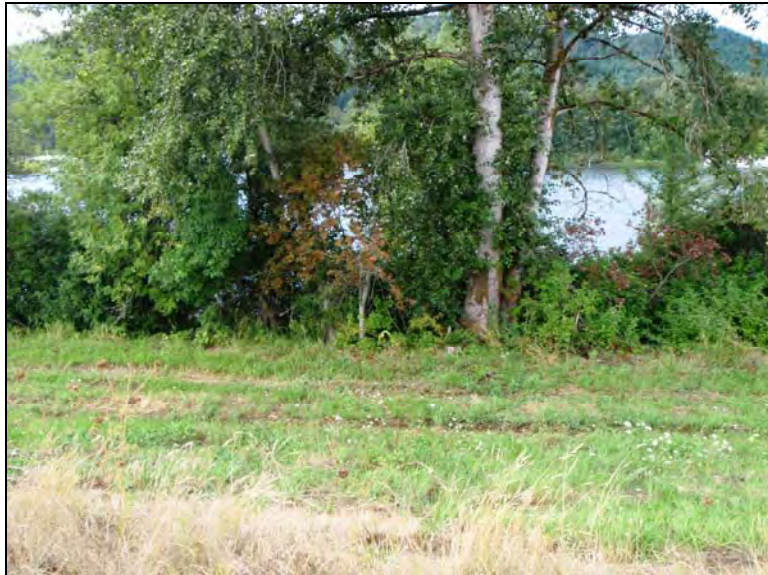
Inspect ID: SAUA_2011_a_0072 **Title:** USACE_CENWP_SAU_2011_a_0072_1.jpg
Caption: View of the riverward levee berm than shows stumps and trees 15 feet or greater from the levee toe. Station 848+00

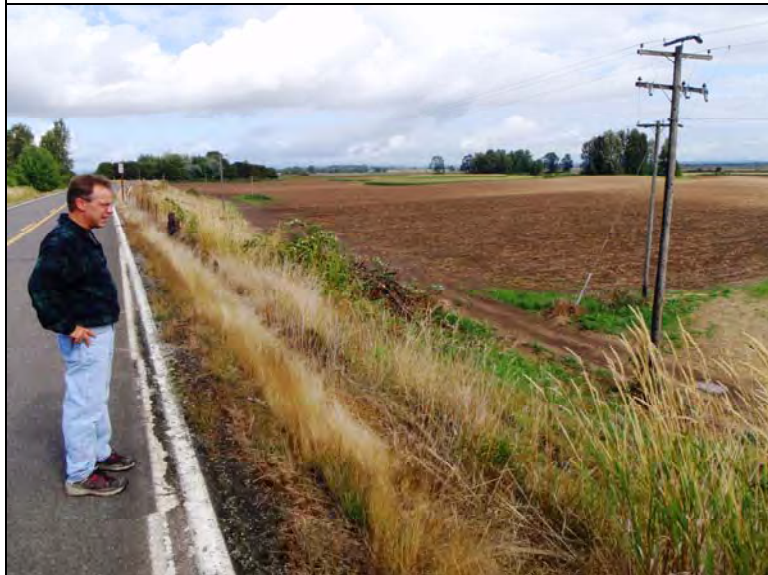
Inspect ID: SAUA_2011_a_0073 **Title:** USACE_CENWP_SAU_2011_a_0073_1.jpg
Caption: View of cut trees and brush on the landward levee slope. Station 860+00

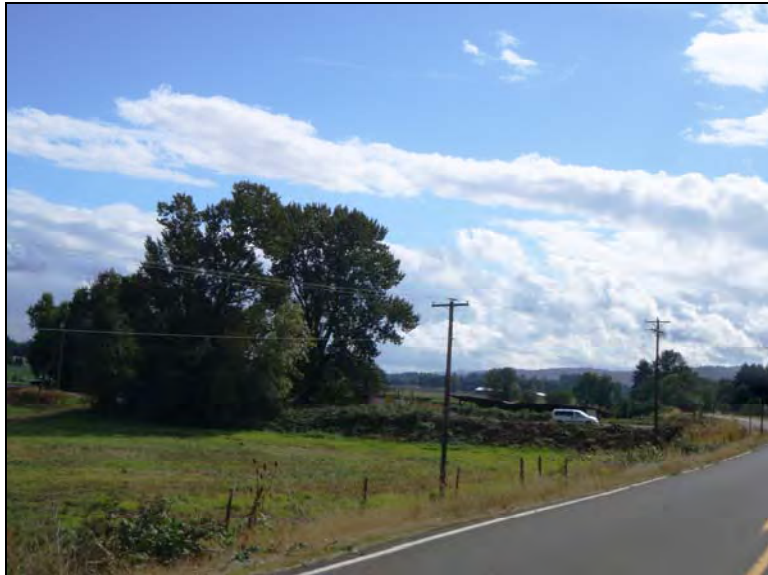
Inspect ID: SAUA_2011_a_0081 **Title:** USACE_CENWP_SAU_2011_a_0081_1.jpg
Caption: View of fence with brush along the landward shoulder of the levee. Station 902+00 to 923+00

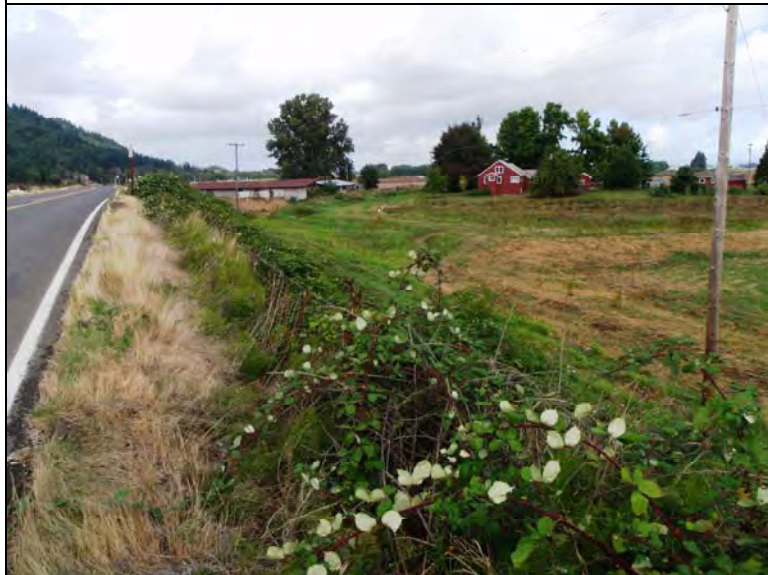
Inspect ID: SAUA_2011_a_0086 **Title:** USACE_CENWP_SAU_2011_a_0086_1.jpg
Caption: View of brush on the landside levee slope. Station 923+00

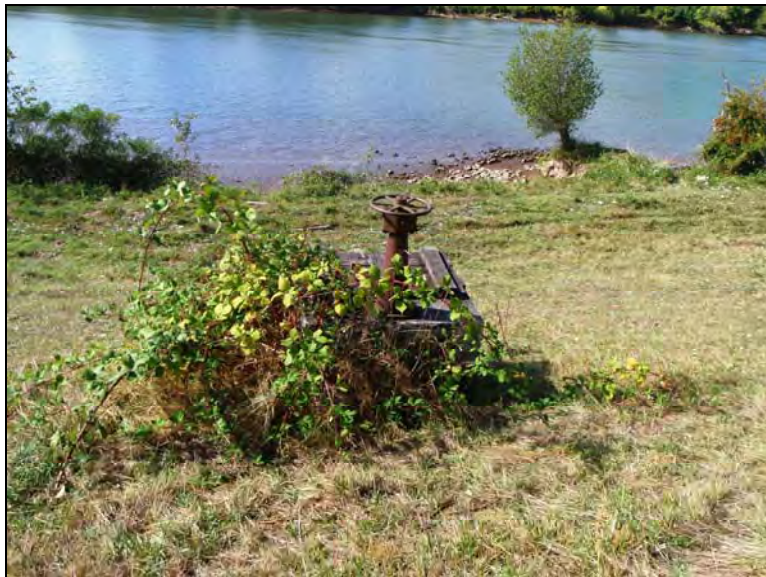
Inspect ID: SAUA_2011_a_0093 **Title:** USACE_CENWP_SAU_2011_a_0093_1.jpg
Caption: View of the riverward side of the fresh water inlet. Station 937+00

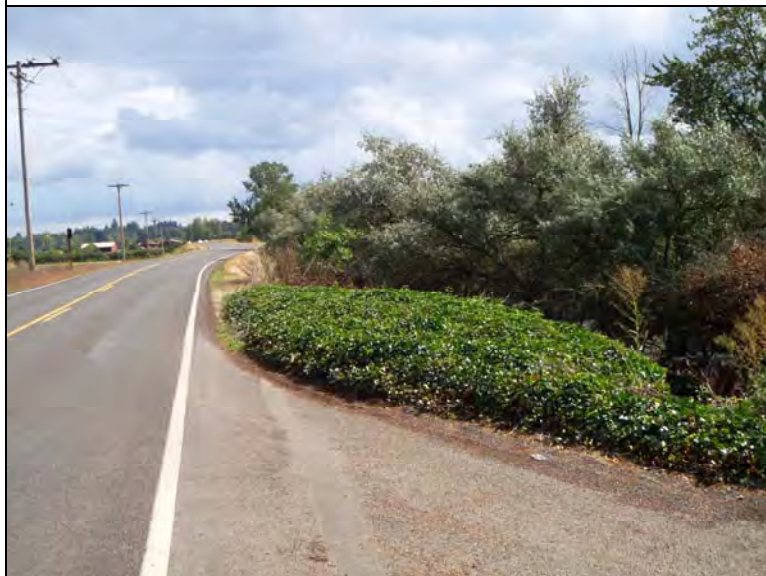
Rated Item	Rating	Rating Guidelines	Location/Remarks/Recommendations
			<p>SAUA_2011_a_0095: Small trees and vegetation on river side of levee. Approximate upstream 1/2 of parking lot is in district.: Comply with vegetation maintenance plan (U)</p> <p>SAUA_2011_a_0096: Small tree on riverward levee slope.: Comply with vegetation maintenance plan (U)</p> <p>SAUA_2011_a_0104: Trees at landward toe of the levee.: Comply with vegetation maintenance plan (U)</p> <p>SAUA_2011_a_0116: Patch of blackberries on riverward slope was mowed and will be sprayed.: Comply with vegetation maintenance plan (A)</p> <p>SAUA_2011_a_0117: Trees (15-18" diam.) at landward levee toe: Comply with vegetation maintenance plan (U)</p> <p>SAUA_2011_a_0119: Trees and brush along toe of levee. Drawings CLW-99-42/3 and CLW-99-42/22 shows the ROW line to be above the toe of the levee.: NA (A)</p> <p>SAUA_2011_a_0121: Blackberries have been mowed and will be sprayed. Reccomend removing old gate opening that hinders mowing.: No action required. (A)</p> <p>SAUA_2011_a_0122: Bush and trees (up to 4 ft diam) at land side toe of levee. Drawings CLW-99-42/22 and CLW-99-42/3 show the ROW line to be above the toe of the levee.: NA (A)</p> <p>SAUA_2011_a_0130: Blackberry bushes (approx 150 feet in length) and tree along toe of land side levee. Mowed in 2011, needs spray to prevent regrowth.: Comply with vegetation maintenance plan (M)</p> <p>SAUA_2011_a_0134: Trees cut to within 3" of rock revetment. Not removing stumps due to rock. District will spray but can not mow due to rock.: Comply with vegetation maintenance plan. Increase spray effort or clear manually. (U)</p> <p>SAUA_2011_a_0139: Brush and trees at land side toe. Scattered, 8-16" diam tree groups. To be removed in 2012 as part of mitigation project: NA (U)</p> <p>SAUA_2011_a_0149: Brush and tree groups at land side toe of levee, 18-24" diam. trees. To be removed in 2012 as part of mitigation project.: Comply with vegetation maintenance plan (U)</p> <p>SAUA_2011_a_0150: Significant vegetation to be removd as part of mitigation project.: Comply with vegetation management plan. (U)</p> <p>SAUA_2011_a_0151: Tree (12" diam.) on river side of levee.: Comply with vegetation maintenance plan. (U)</p>

Inspect ID: SAUA_2011_a_0095 **Title:** USACE_CENWP_SAU_2011_a_0095_1.jpg
Caption: View of small trees and vegetation on the river side of the levee. Station -1+00 to 2+50

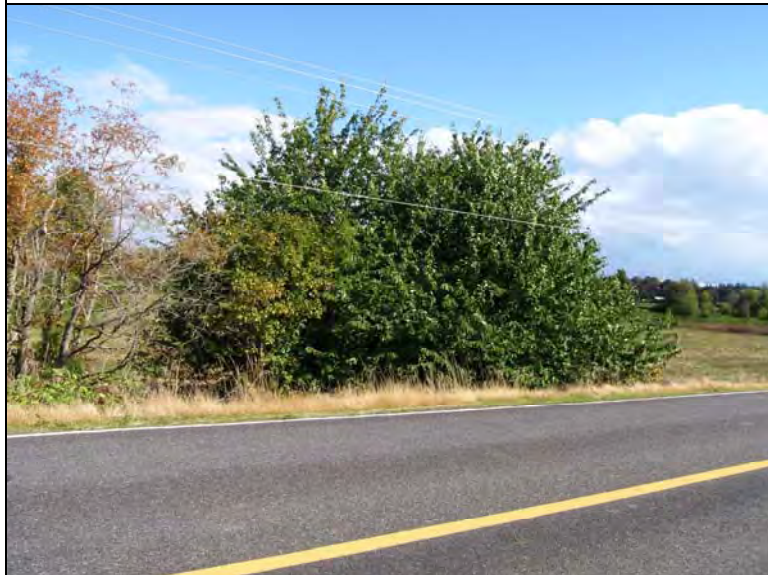
Inspect ID: SAUA_2011_a_0104 **Title:** USACE_CENWP_SAU_2011_a_0104_1.jpg
Caption: View of trees along the landward levee toe. Station 30+00 to 42+00

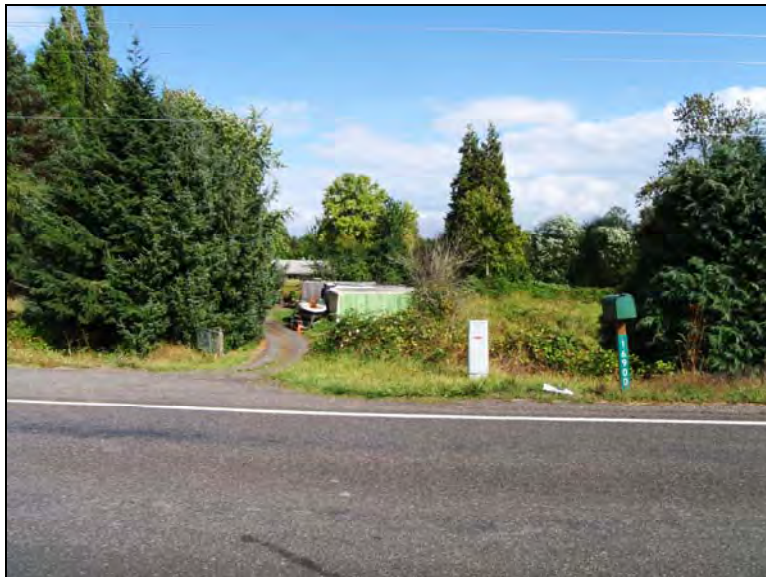
Inspect ID: SAUA_2011_a_0106 **Title:** USACE_CENWP_SAU_2011_a_0106_1.jpg
Caption: View of paved and gravel access road in overbuild section on land side of levee. Access road is shown on drawing CLW-99-42/2. Station 38+00

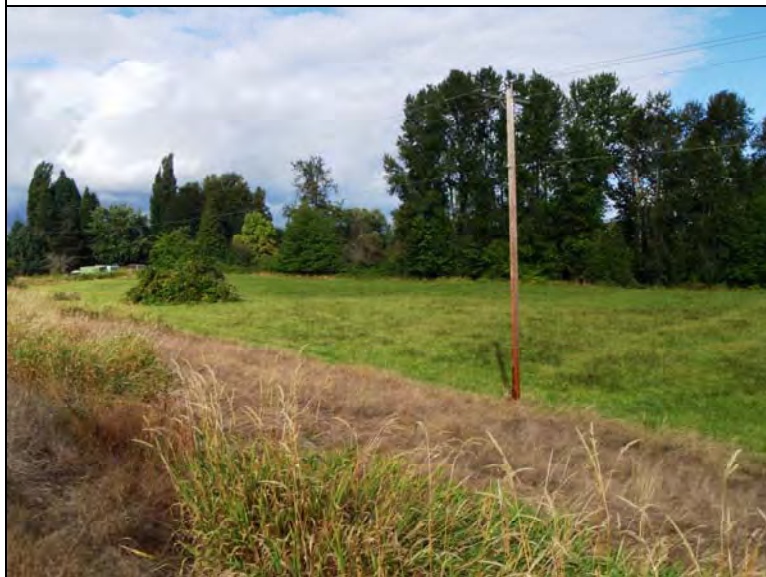
Inspect ID: SAUA_2011_a_0107 **Title:** USACE_CENWP_SAU_2011_a_0107_1.jpg
Caption: View of power poles within 15 feet of landward levee toe from Station 0+00 to 42+00.

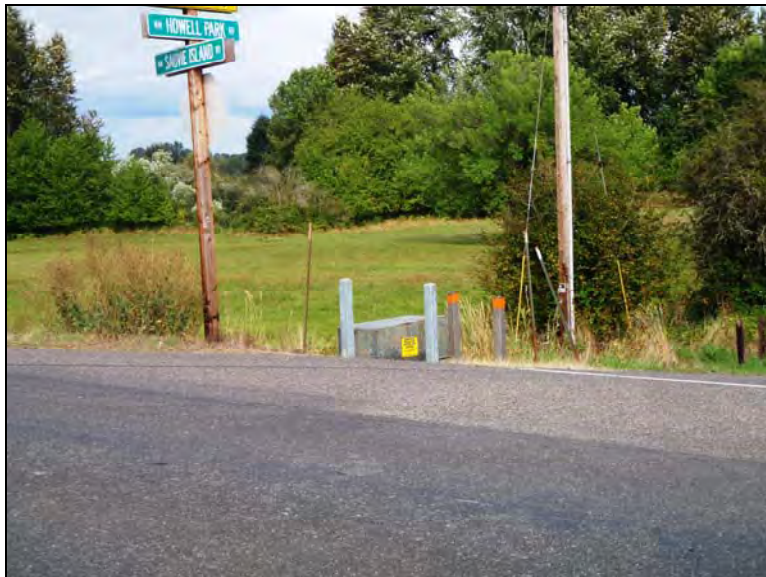
Inspect ID: SAUA_2011_a_0108 **Title:** USACE_CENWP_SAU_2011_a_0108_1.jpg
Caption: Natural gas line crossing levee to valve pressure meter. Station 46+50

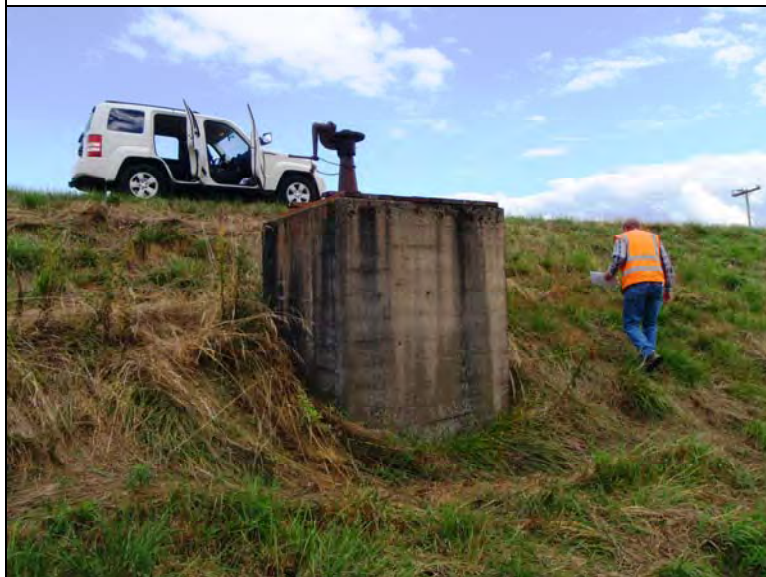
Inspect ID: SAUA_2011_a_0113 **Title:** USACE_CENWP_SAU_2011_a_0113_1.jpg
Caption: View of fresh water intake. Station 63+50

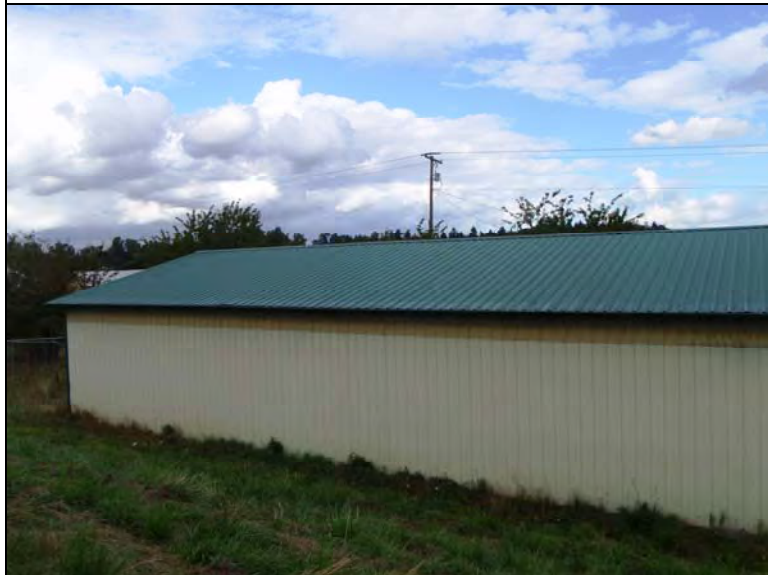
Inspect ID: SAUA_2011_a_0118 **Title:** USACE_CENWP_SAUA_2011_a_0118_1.jpg
Caption: View of residential garage structure at landward toe of the levee. Station 74+00

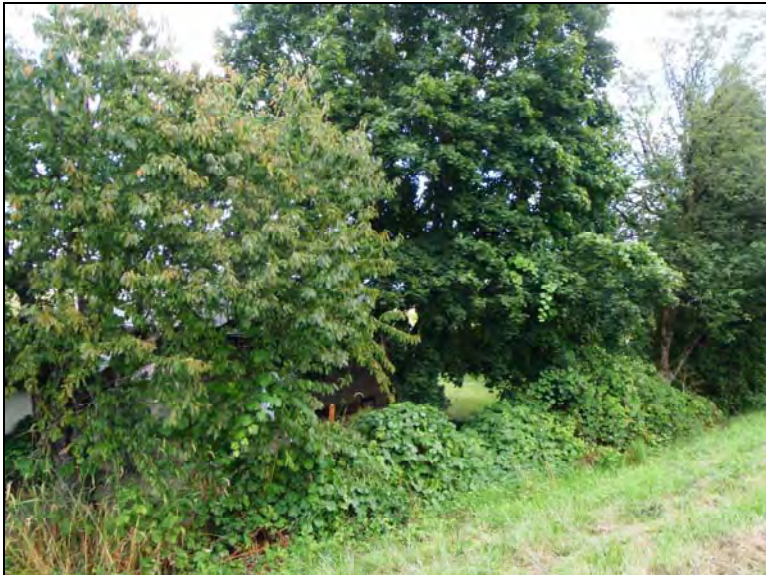
Inspect ID: SAUA_2011_a_0119 **Title:** USACE_CENWP_SAU_2011_a_0119_1.jpg
Caption: View of trees and brush along the landward toe of the levee. Station 74+00 to 80+00

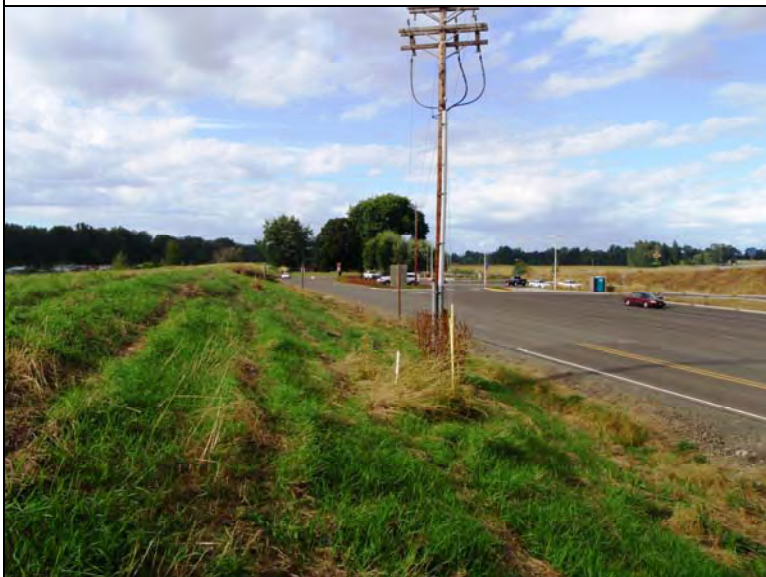
Inspect ID: SAUA_2011_a_0127 **Title:** USACE_CENWP_SAU_2011_a_0127_1.jpg
Caption: View of power pole at landward toe of the levee with guy wire into levee embankment. Station 94+50

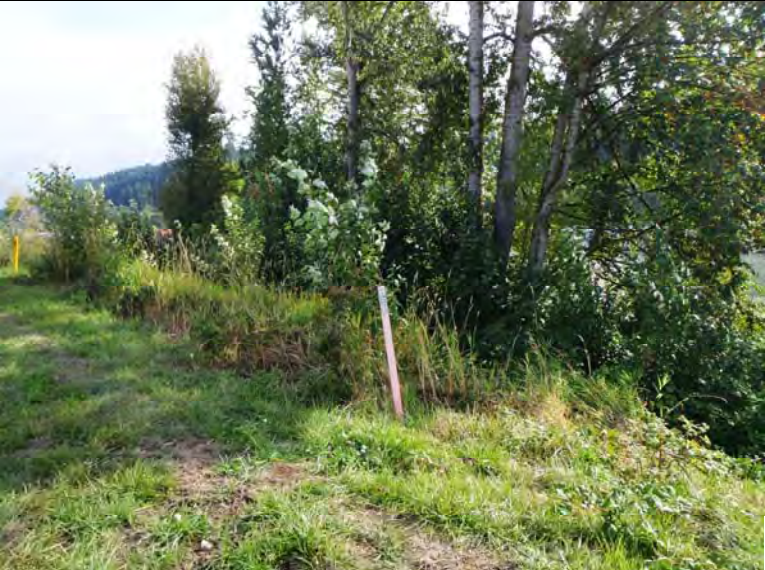
<p>Inspect ID: SAUA_2011_a_0134 Title: USACE_CENWP_SAU_2011_a_0134_2.jpg Caption: View of riverside of the levee where trees were cut within 3 " of stone surface with stumps remaining. Station 108+00</p>

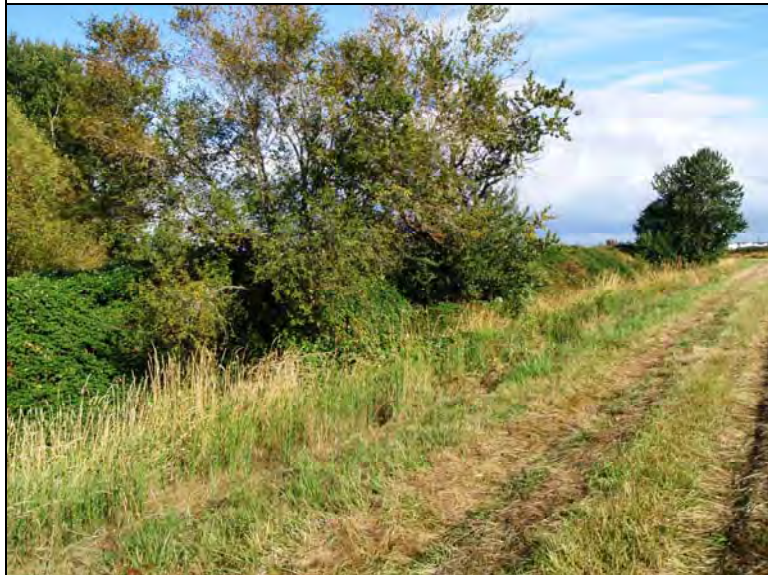
Inspect ID: SAUA_2011_a_0139 **Title:** USACE_CENWP_SAU_2011_a_0139_1.jpg
Caption: View of brush and trees landward of the landward levee toe. Scattered, 8-16" diameter tree groups. Station 125+00 to 144+00

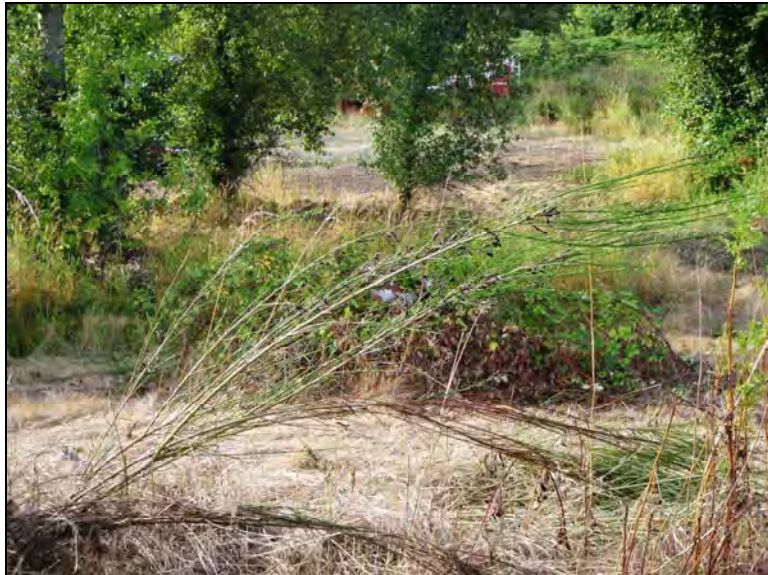
Rated Item	Rating	Rating Guidelines		Location/Remarks/Recommendations
				levee section is overbuilt. Road is acceptable as indicated on CLW-99-42/3.: Review and permit per current guidelines (M) SAUA_2011_a_0152: Appears to be an abandoned well head/valve near toe of land side slope.: Review and permit per current guidelines (M) SAUA_2011_a_0153: Access road from river side to land side of levee. Appears to be shown on CLW-99-42/4.: No action required. (A) SAUA_2011_a_0155: Fence from crest to land side toe of levee, with gate laying on ground. No fence on river side.: Remove or review and permit per current guidelines. (M)

Inspect ID: SAUA_2011_a_0152 **Title:** USACE_CENWP_SAU_2011_a_0152_1.jpg
Caption: View of abandoned well head/valve near the landward levee toe. Station 149+00

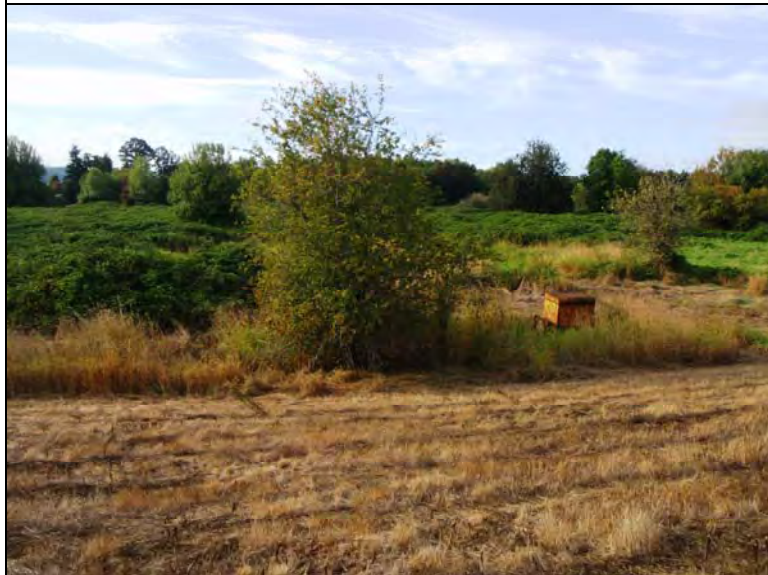
Rated Item	Rating	Rating Guidelines	Location/Remarks/Recommendations
			SAUA_2011_a_0154: 16" diam. tree at land side toe of levee. To be removed during 2012 as part of mitigation project.: Comply with vegetation maintenance plan (U)

Inspect ID: SAUA_2011_a_0154 **Title:** USACE_CENWP_SAU_2011_a_0154_1.jpg
Caption: View of a 16" diameter tree at the landward toe of the levee. Station 153+00

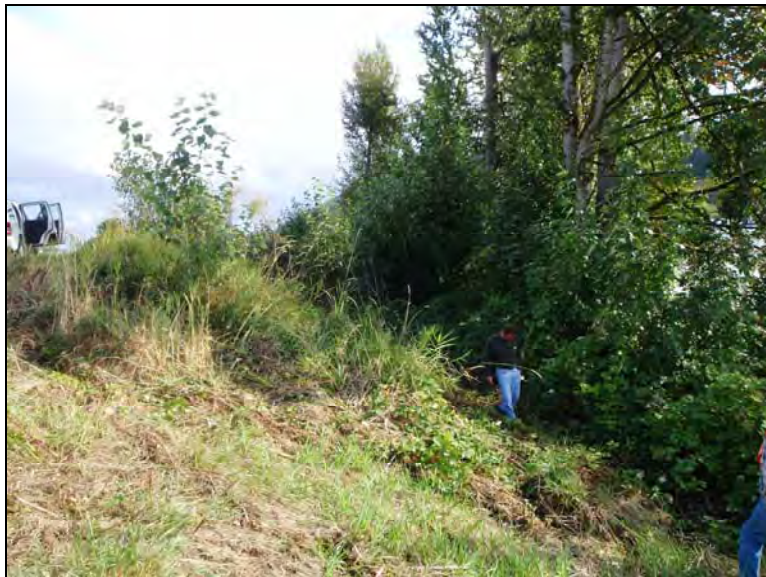
Inspect ID: SAUA_2011_a_0134 **Title:** USACE_CENWP_SAU_2011_a_0134_1.jpg
Caption: View of area where trees were cut to within 3" of stone surface but stumps not removed. Station 108+00

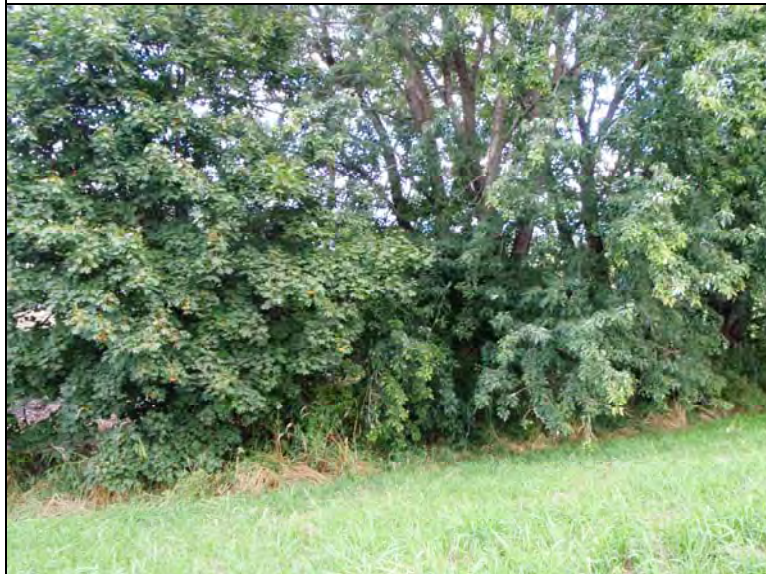
Inspect ID: SAUA_2011_a_0122 **Title:** USACE_CENWP_SAU_2011_a_0122_1.jpg
Caption: View of brush and trees (up to 4 ft diameter) at the landward toe of the levee. Station 85+00

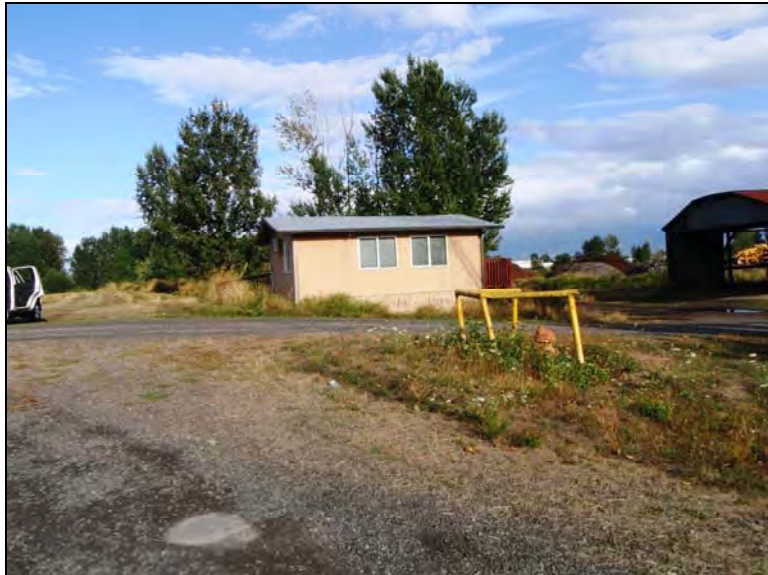
Inspect ID: SAUA_2011_a_0146 **Title:** USACE_CENWP_SAU_2011_a_0146_1.jpg
Caption: View of fire hydrant and house on river side of the levee. Station 144+00

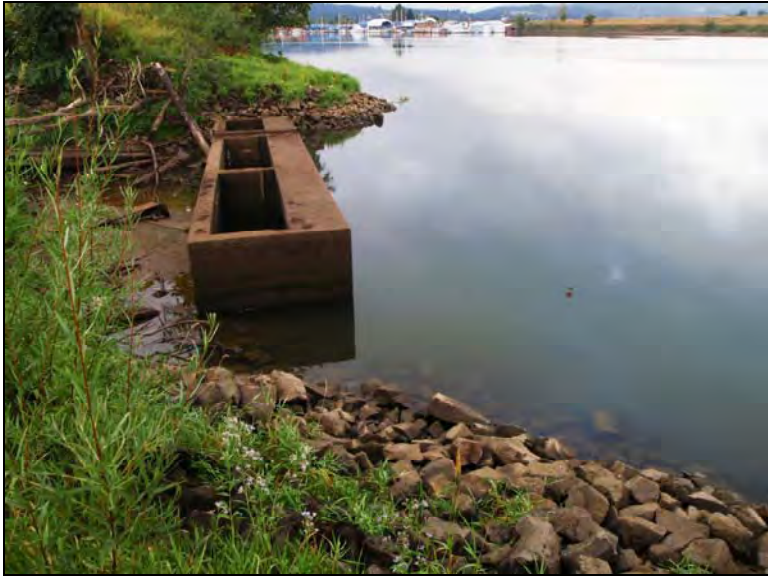
Inspect ID: SAUA_2011_a_0024 **Title:** USACE_CENWP_SAU_2011_a_0024_1.jpg
Caption: View of the pump station energy dissipator and displaced stone. Station 727+00

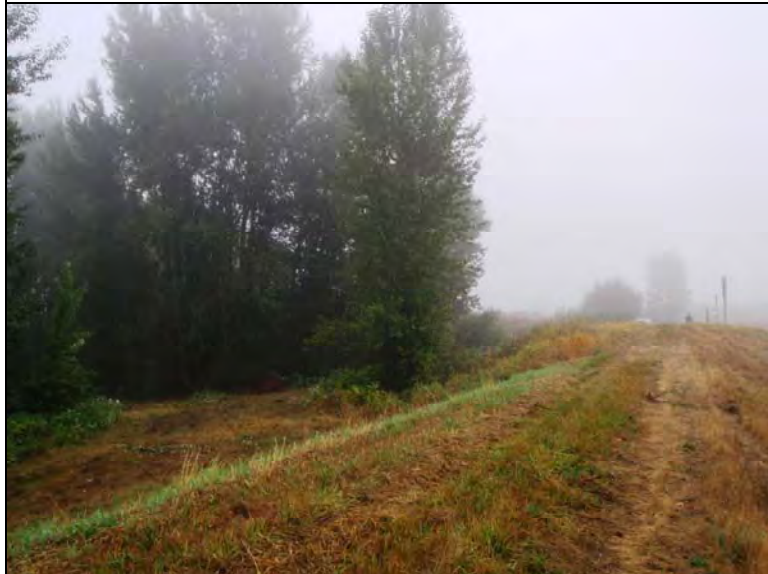
Inspect ID: SAUB_2011_a_0003 **Title:** USACE_CENWP_SAUB_2011_a_0003_1.jpg
Caption: View of tree at the riverward levee toe. Station 158+50

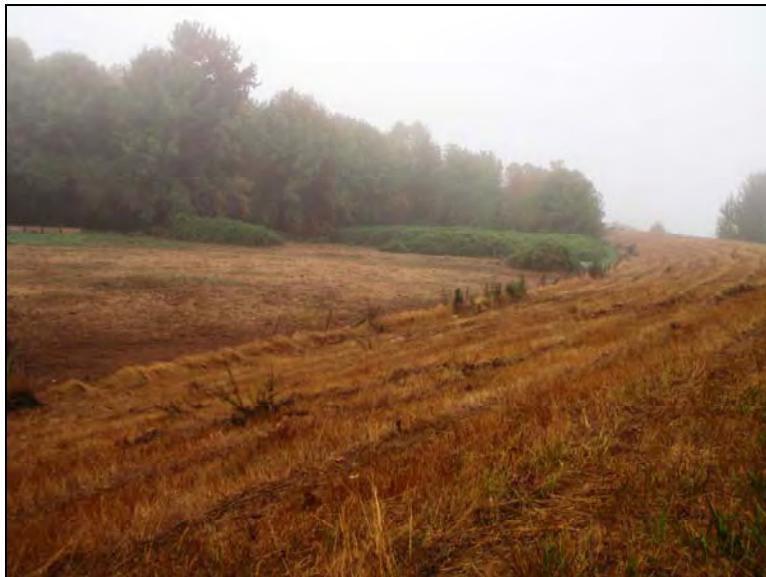
Inspect ID: SAUB_2011_a_0001 **Title:** USACE_CENWP_SAUB_2011_a_0001_1.jpg
Caption: View of fence located along the landward levee toe. There are berry vines and scattered brush along the fence line. Station 155+00 to 165+00

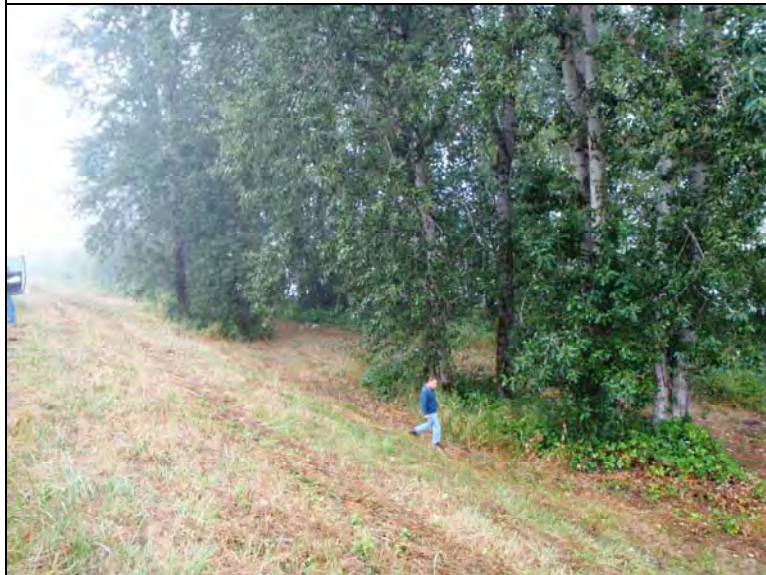
Inspect ID: SAUB_2011_a_0004 **Title:** USACE_CENWP_SAUB_2011_a_0004_1.jpg
Caption: View of cottonwood trees along the river side of the levee toe. Station 158+50 to 158+50

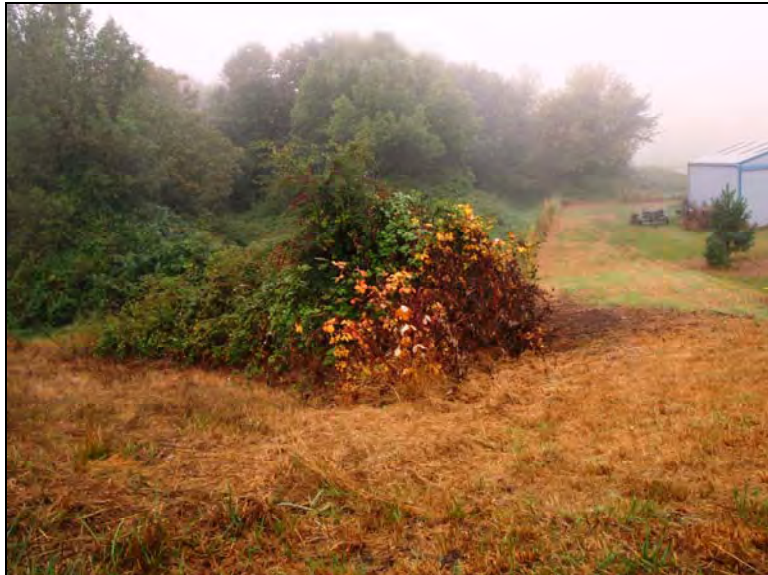
Inspect ID: SAUB_2011_a_0006 **Title:** USACE_CENWP_SAUB_2011_a_0006_1.jpg
Caption: View of brush on the landward slope of the levee and along the access road fill. Station 167+00

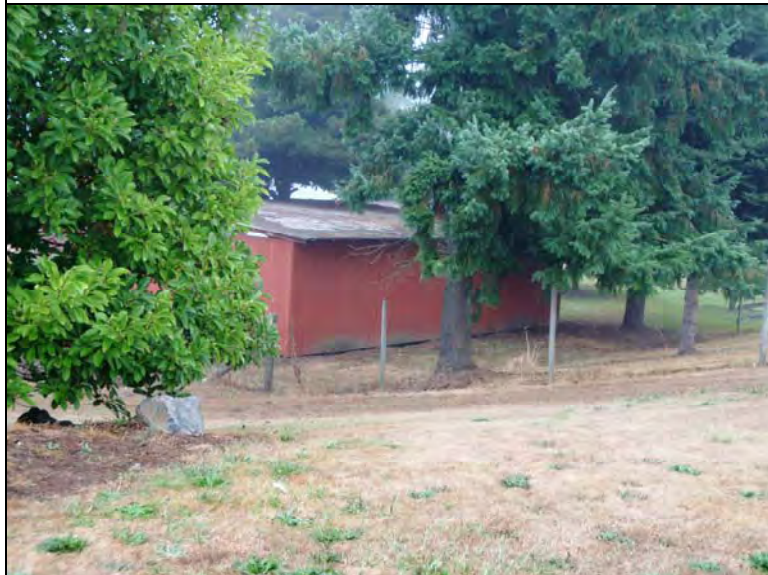
Inspect ID: SAUB_2011_a_0009 **Title:** USACE_CENWP_SAUB_2011_a_0009_1.jpg
Caption: View of small storage shed and garage approximately 12 feet from the landward toe of the levee. Station 167+50

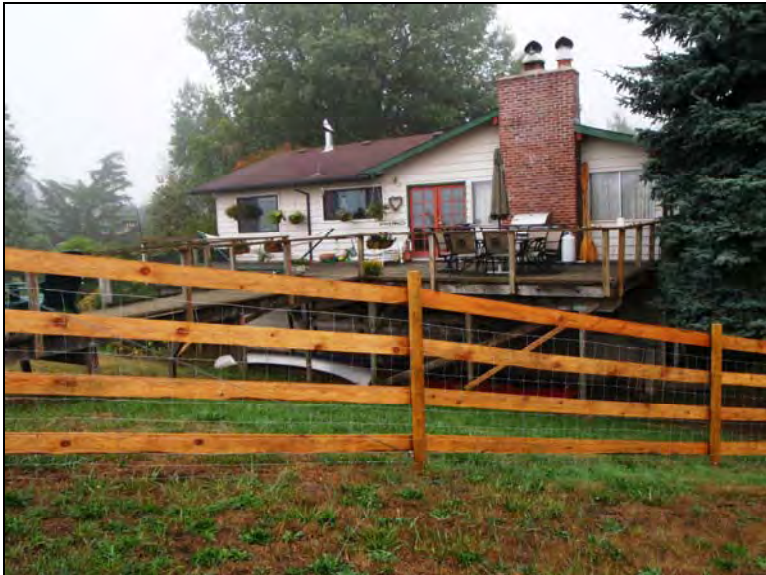
Inspect ID: SAUB_2011_a_0011 **Title:** USACE_CENWP_SAUB_2011_a_0011_1.jpg
Caption: View of house and deckwalkway on the landward side of the levee. Station 169+00
