DEPARTMENT OF THE ARMY
CORPS OF ENGINEERS, PORTLAND DISTRICT
PO BOX 2946
PORTLAND OR 97208-2946

SUBJECT: Routine Inspection Results, Sauvie Island Flood Damage Reduction System, U.S. Army Corps of Engineers (USACE) Assigned System Rating.

Flood Damage Reduction Segment / System Inspection Report

1. Levee segment / system and district: (name of the segment / system and levee district) Multnomah Channel Segment, Sauvie Island Flood Damage Reduction Project, Sauvie Island Drainage Improvement Company

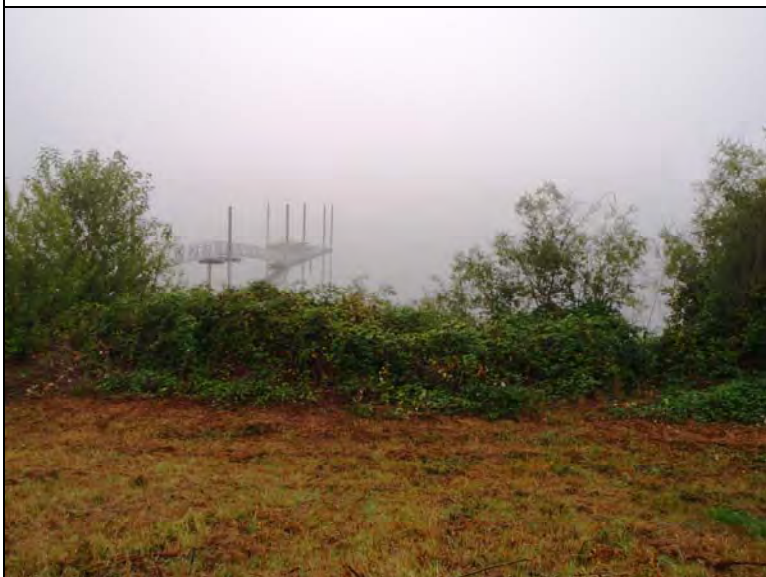
Inspect ID: SAUB_2011_a_0013 **Title:** USACE_CENWP_SAUB_2011_a_0013_1.jpg
Caption: View of mowed berry vines on the river side of the levee. Station 171+00

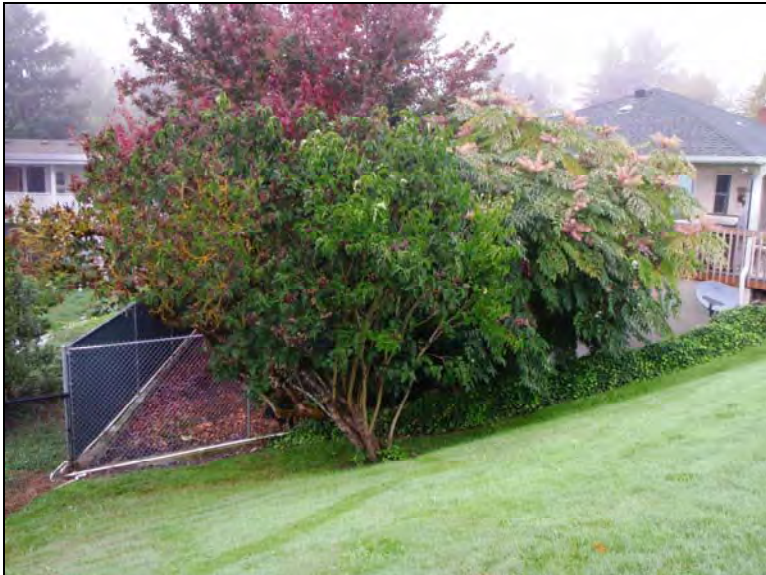
Inspect ID: SAUB_2011_a_0014 **Title:** USACE_CENWP_SAUB_2011_a_0014_1.jpg
Caption: View of house on landside of the levee. Chain link fence shown in the photo extends along the land side and river side slopes and the levee crest at both sides of the property. Station 171+50

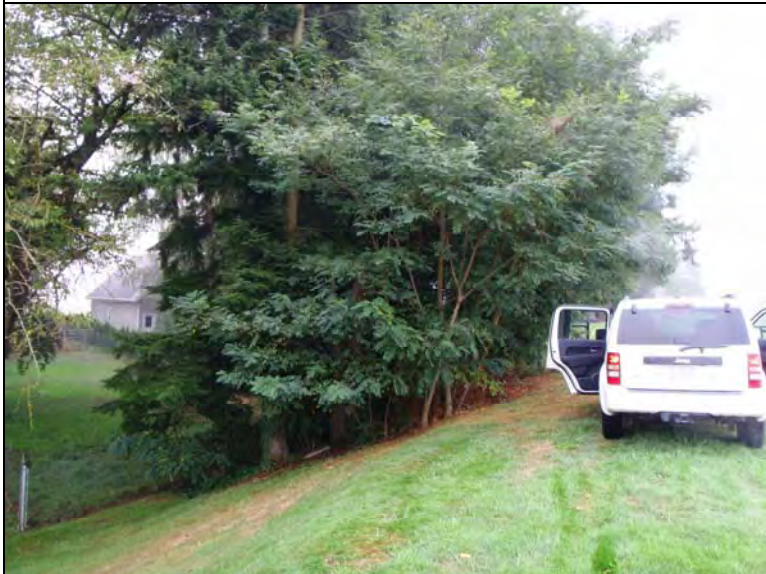
Inspect ID: SAUB_2011_a_0015 **Title:** USACE_CENWP_SAUB_2011_a_0015_1.jpg
Caption: View of a stand of 2 to 30" diameter trees on the landward levee slope. Station 173+50

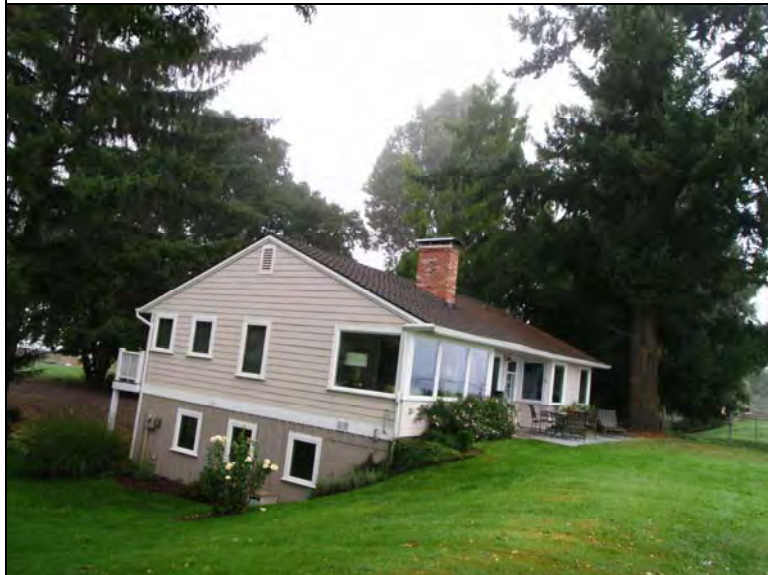
Inspect ID: SAUB_2011_a_0017 **Title:** USACE_CENWP_SAUB_2011_a_0017_1.jpg
Caption: View of house on landside of levee shown on drawing CLW-99-42/4. Station 174+50

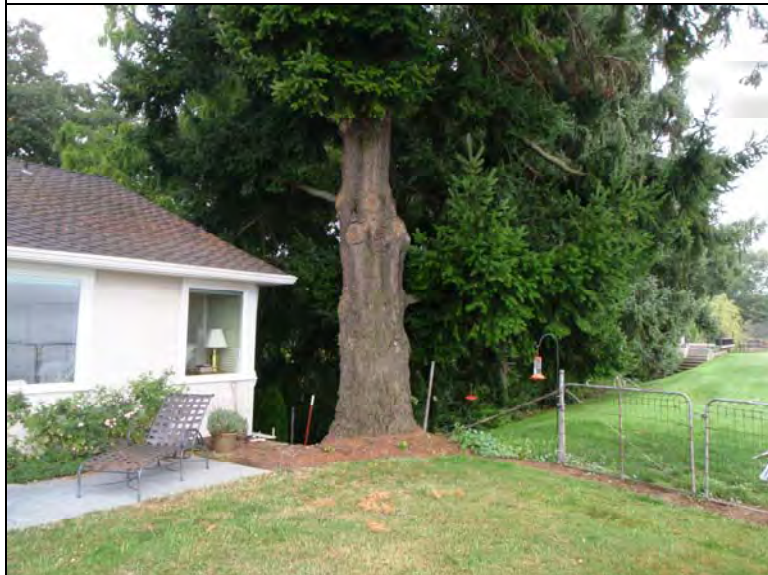
Inspect ID: SAUB_2011_a_0019 **Title:** USACE_CENWP_SAUB_2011_a_0019_1.jpg
Caption: View of 3-foot diameter douglas fir tree on the landward levee slope. Station 174+50

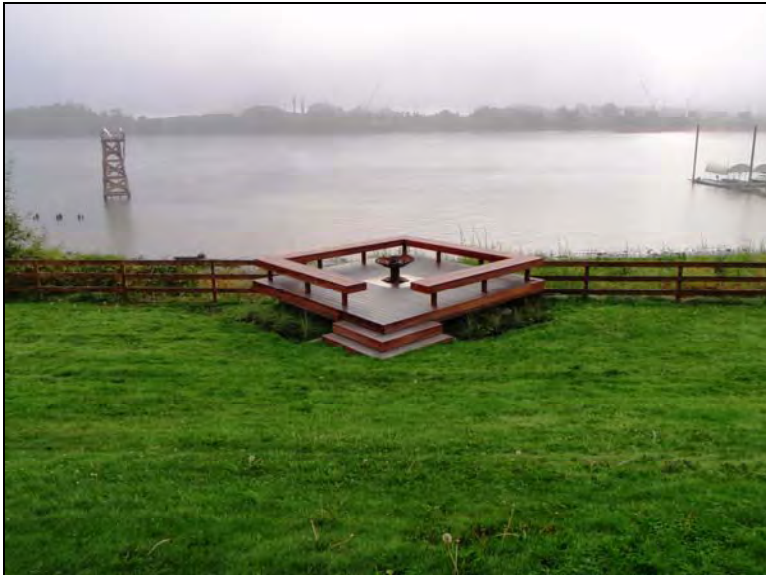
Inspect ID: SAUB_2011_a_0021 **Title:** USACE_CENWP_SAUB_2011_a_0021_1.jpg
Caption: View of newly constructed deck on the river side of the levee. Station 176+00

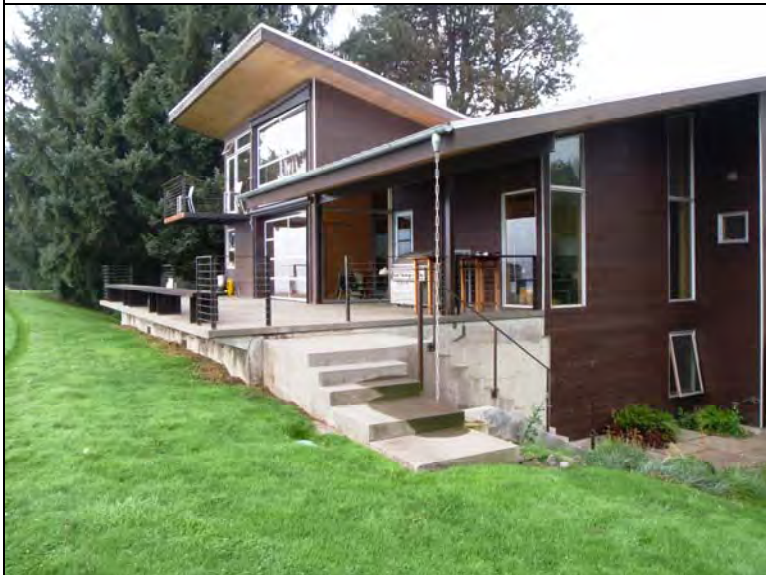
Inspect ID: SAUB_2011_a_0021 **Title:** USACE_CENWP_SAUB_2011_a_0021_2.jpg
Caption: View of house on land side of levee slope. Original house is shown on CLW-99-42/4. Station 176+00

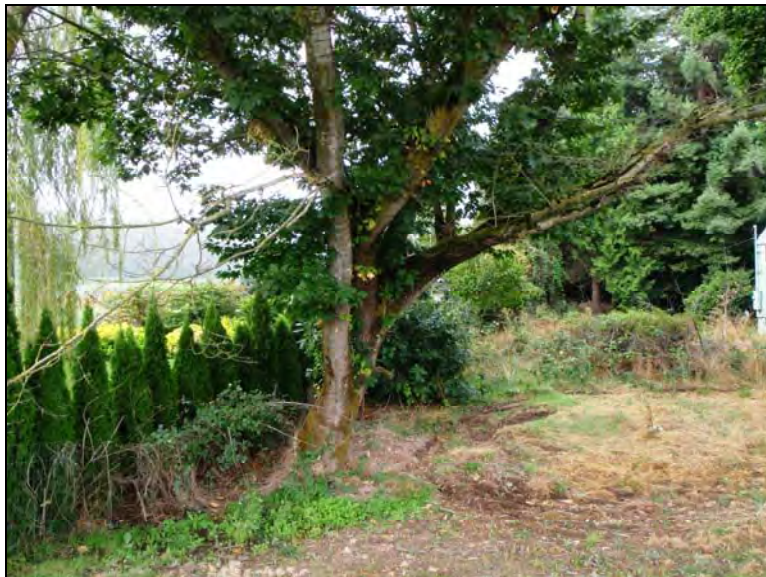
Inspect ID: SAUB_2011_a_0022 **Title:** USACE_CENWP_SAUB_2011_a_0022_1.jpg
Caption: View of 30" diameter deciduous tree located 5 feet from the landward levee toe. Station 177+00

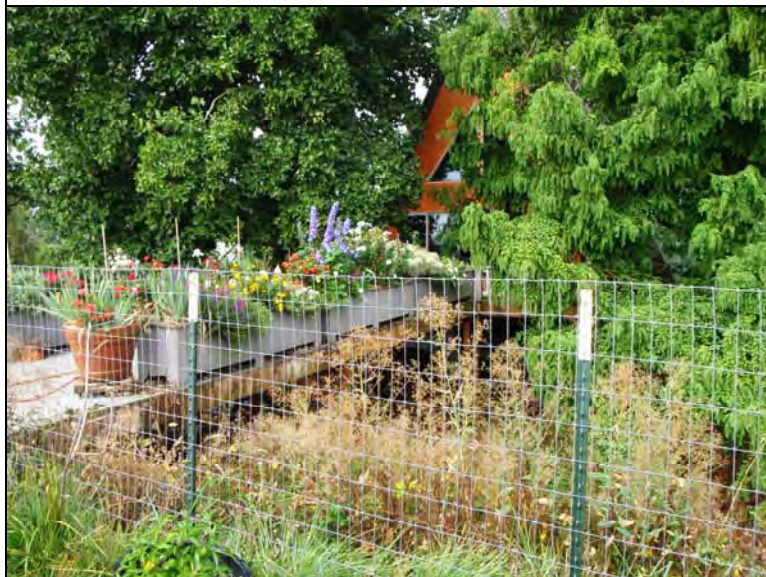
Inspect ID: SAUB_2011_a_0023 **Title:** USACE_CENWP_SAUB_2011_a_0023_1.jpg
Caption: View of walkway and fence on the land side of the levee. Station 177+50

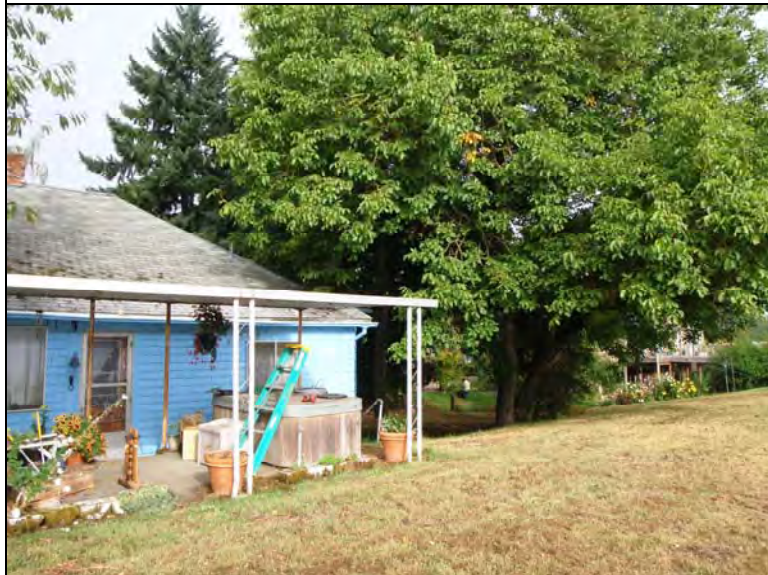
Inspect ID: SAUB_2011_a_0024 **Title:** USACE_CENWP_SAUB_2011_a_0024_1.jpg
Caption: View of house and walnut tree at Station 180+00. House is shown on drawing CLW-99-42/4. The walnut tree needs to be removed.

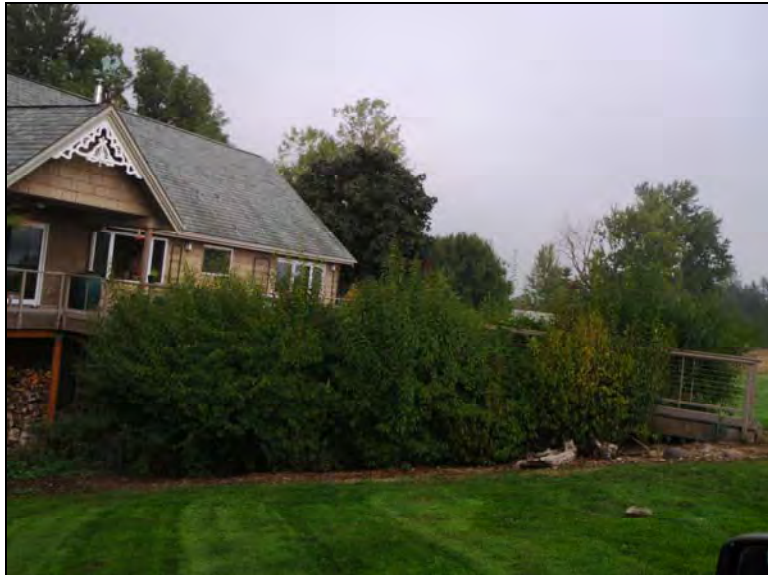
Inspect ID: SAUB_2011_a_0028 **Title:** USACE_CENWP_SAUB_2011_a_0028_1.jpg
Caption: View of bushes, ground cover, and walkway structure on the landward levee slope. Station 182+00

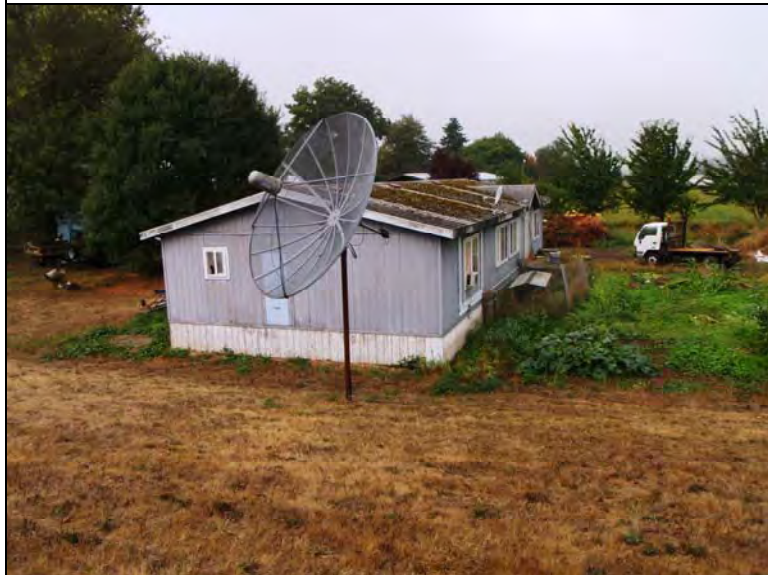
Inspect ID: SAUB_2011_a_0029 **Title:** USACE_CENWP_SAUB_2011_a_0029_1.jpg
Caption: View of a double-wide trailer house near the landward toe of the levee and a satellite dish on the landward levee slope at Station 183+00.

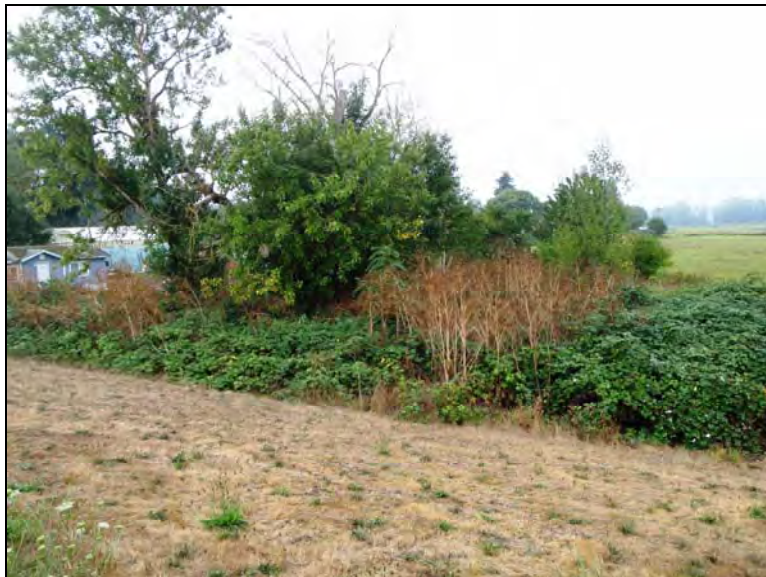
Inspect ID: SAUB_2011_a_0031 **Title:** USACE_CENWP_SAUB_2011_a_0031_1.jpg
Caption: View of brush, trees, and debris adjacent to the landward levee toe at Station 183+00 to 188+00.

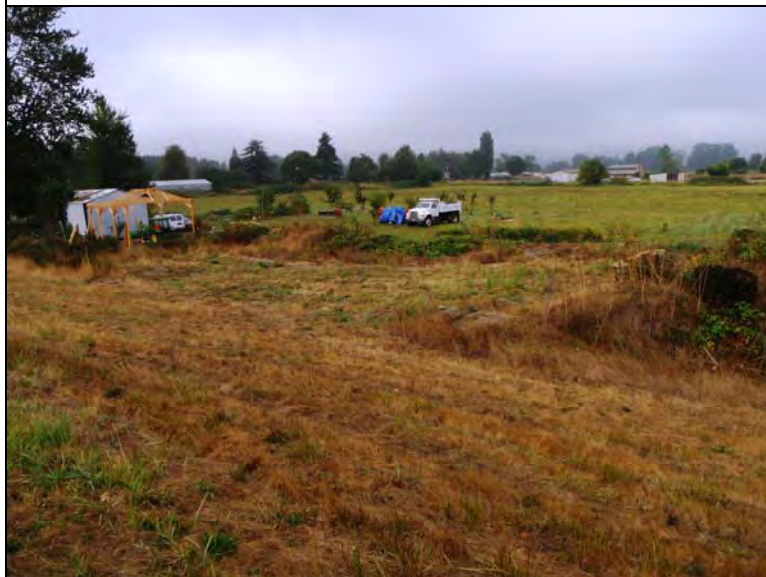
Inspect ID: SAUB_2011_a_0032 **Title:** USACE_CENWP_SAUB_2011_a_0032_1.jpg
Caption: View of random fill abutting the landward toe of the levee at Station 190+00. The fill is approximately 125 feet in length and about 8 feet deep.

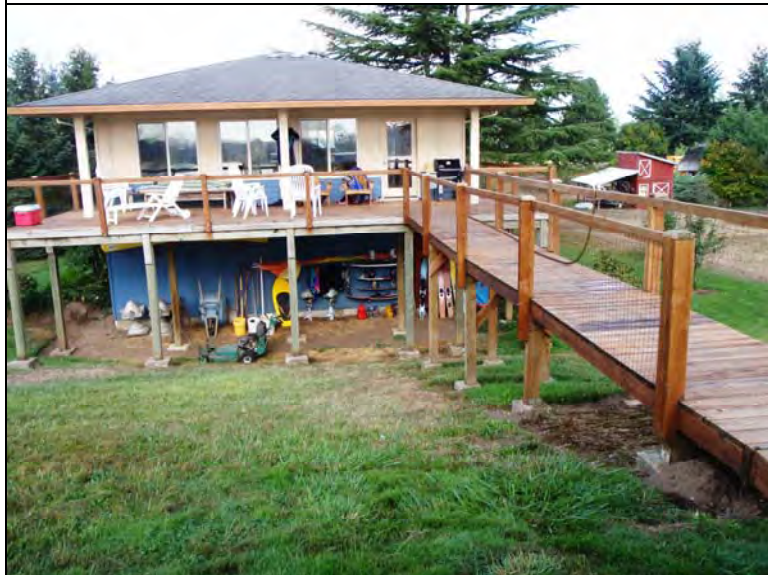
Inspect ID: SAUB_2011_a_0036 **Title:** USACE_CENWP_SAUB_2011_a_0036_1.jpg
Caption: View of house which appears to be shown on drawing CLW-99-42/4. There is a deck and walkway on the landward levee slope, fence on both sides of the property, and access road over the levee associated with the house. Station 196+50

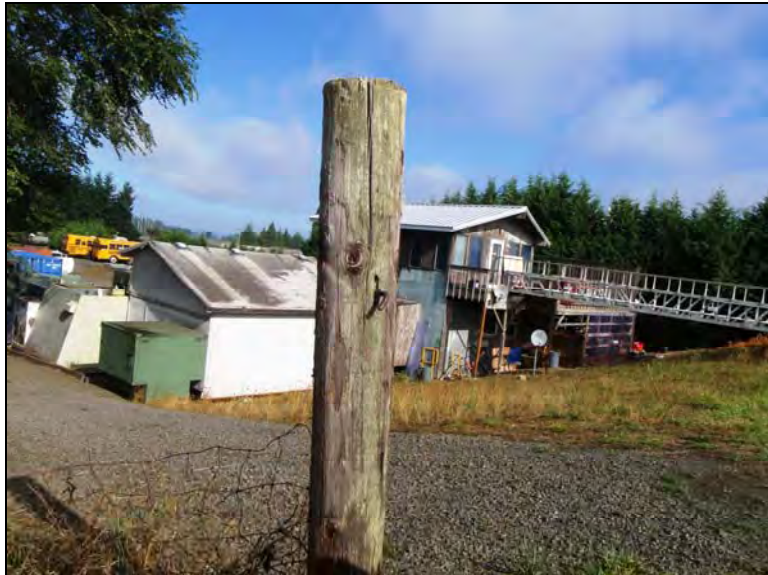
Inspect ID: SAUB_2011_a_0037 **Title:** USACE_CENWP_SAUB_2011_a_0037_1.jpg
Caption: View of trees and small sheds at the landward toe of the levee. Station 197+50

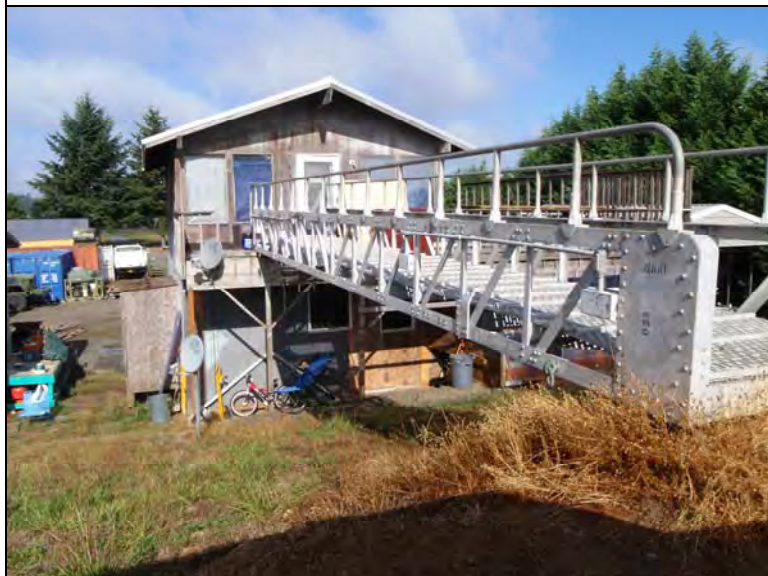
Inspect ID: SAUB_2011_a_0038 **Title:** USACE_CENWP_SAUB_2011_a_0038_1.jpg
Caption: View of house on landward toe of the levee at Station 199+00. House is shown on drawing CLW-99-42/4

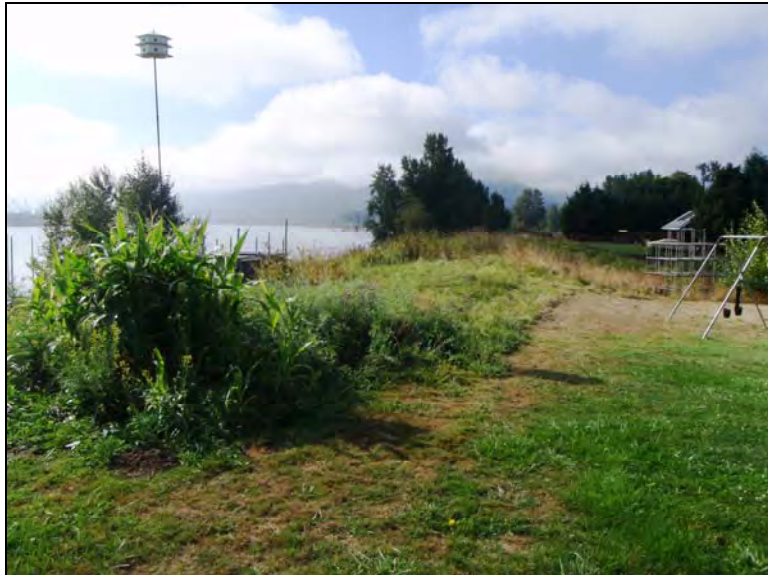
Inspect ID: SAUB_2011_a_0042 **Title:** USACE_CENWP_SAUB_2011_a_0042_1.jpg
Caption: View of brush, landscaping, and gardening activity on the levee slopes and crest at Station 200+10 to 202+30.

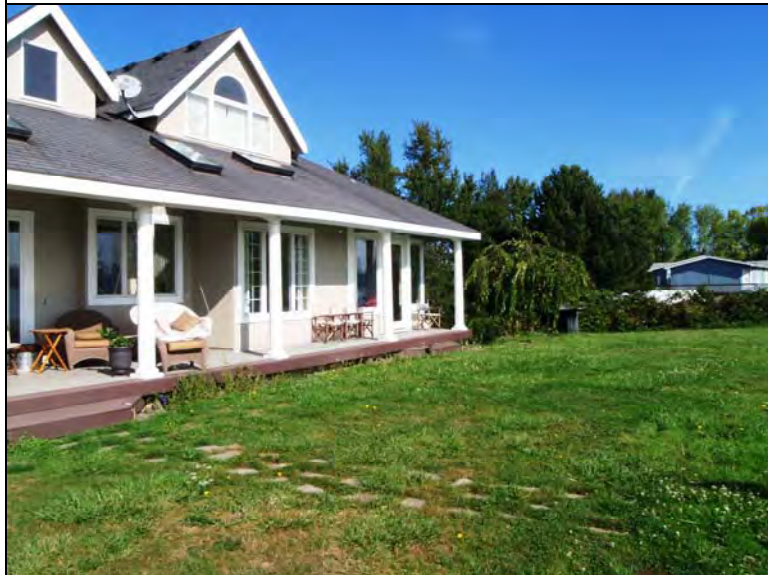
Inspect ID: SAUB_2011_a_0043 **Title:** USACE_CENWP_SAUB_2011_a_0043_1.jpg
Caption: View of house on the landward side of the levee at Station 202+30. The house is not shown on the drawings. It appears that toe drains were installed at this location.

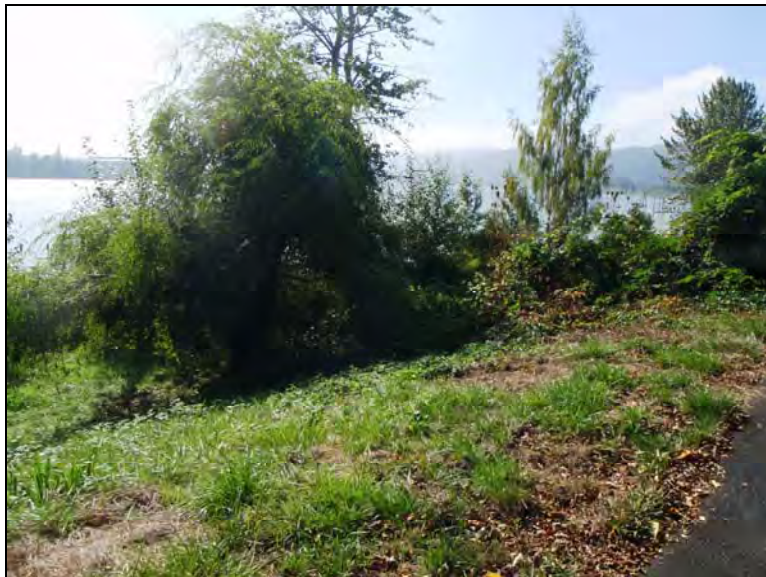
Inspect ID: SAUB_2011_a_0050 **Title:** USACE_CENWP_SAUB_2011_a_0050_1.jpg
Caption: View of a large tree (24" diameter) at the riverward toe of the levee. Station 210+00

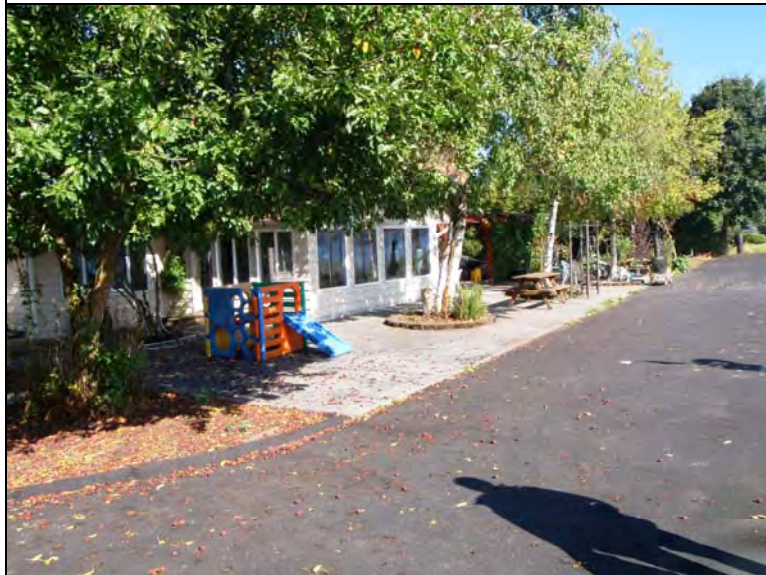
Inspect ID: SAUB_2011_a_0049 **Title:** USACE_CENWP_SAUB_2011_a_0049_1.jpg
Caption: View of house on landward levee slope at Station 210+00. There are fences, gates, trees, and brush associated with the house. The gate at the upstream end of the property is impassable.

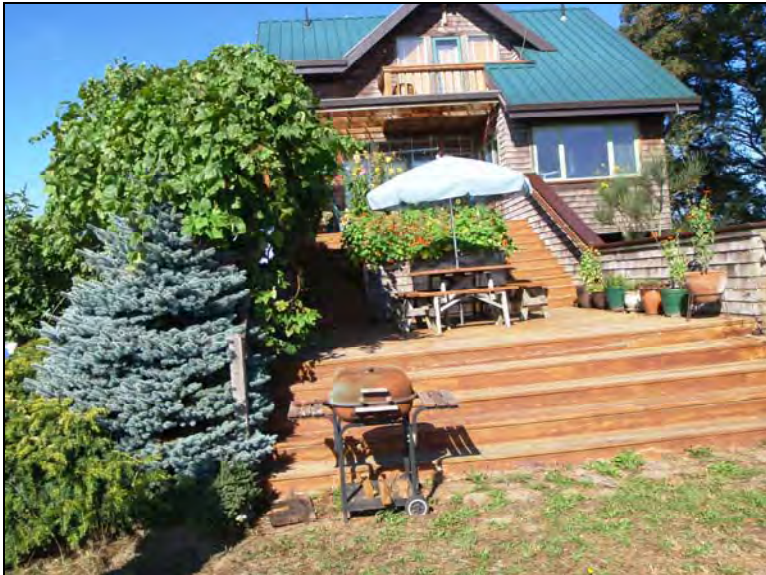
Inspect ID: SAUB_2011_a_0051 **Title:** USACE_CENWP_SAUB_2011_a_0051_1.jpg
Caption: View of house, deck, and landscaping on the landward side of the levee. House is not shown on the drawings.

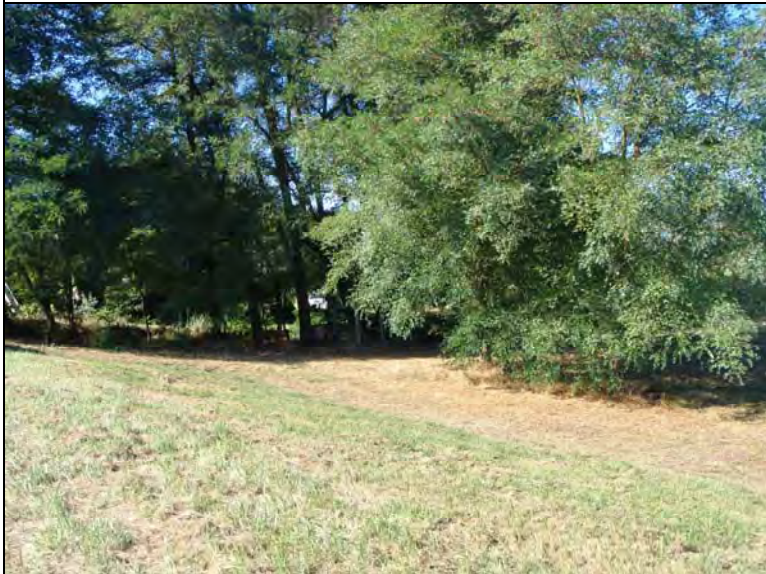
Inspect ID: SAUB_2011_a_0052 **Title:** USACE_CENWP_SAUB_2011_a_0052_1.jpg
Caption: View of six to ten trees (8-16" diameter) on the landward side of the levee at Station 212+00.

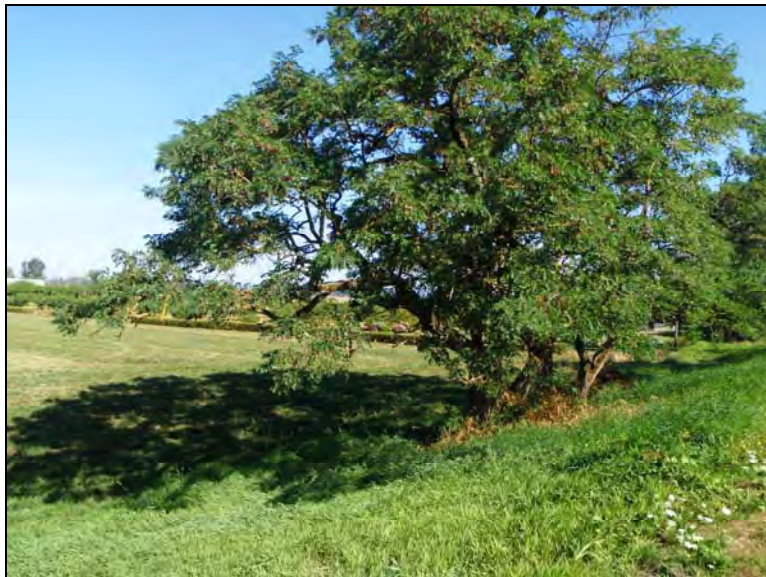
Inspect ID: SAUB_2011_a_0054 **Title:** USACE_CENWP_SAUB_2011_a_0054_1.jpg
Caption: View of trees (10-24" in diameter) at the landward toe of the levee. Station 215+50

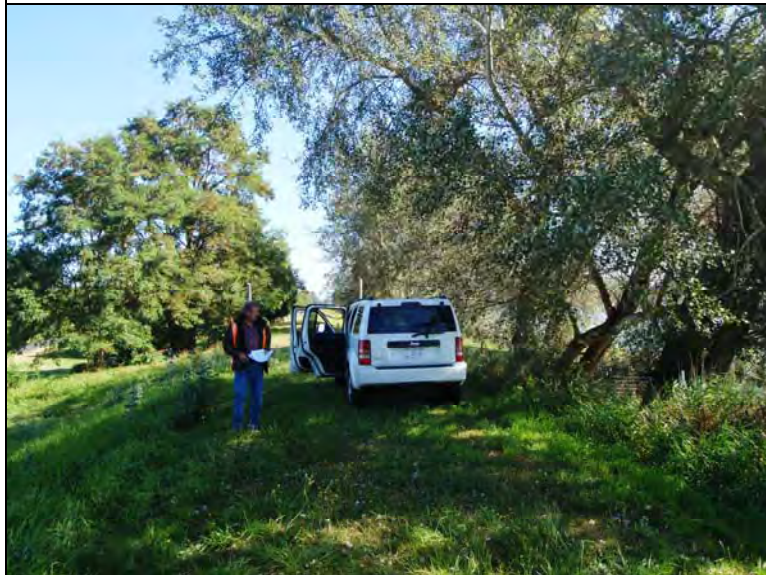
Inspect ID: SAUB_2011_a_0056 **Title:** USACE_CENWP_SAUB_2011_a_0056_1.jpg
Caption: View of large trees on the landward and riverward levee slopes at Station 217+50 to 223+50.

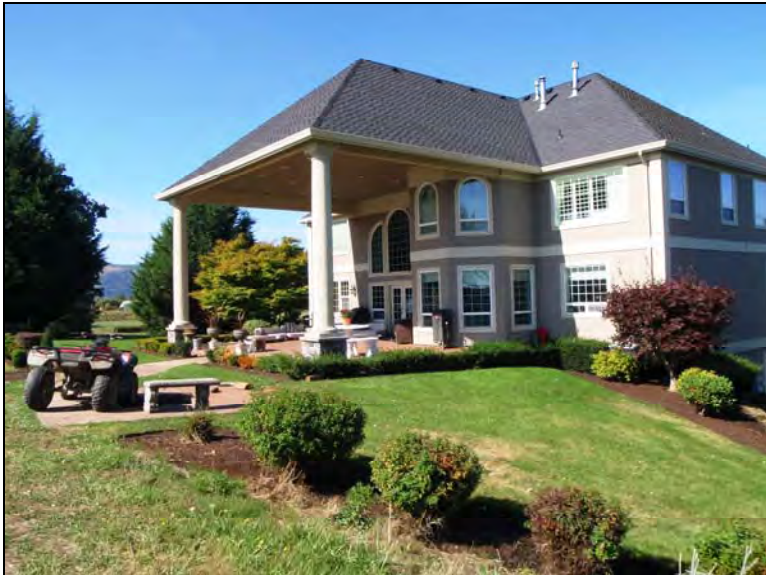
Inspect ID: SAUB_2011_a_0059 **Title:** USACE_CENWP_SAUB_2011_a_0059_1.jpg
Caption: View of house, overbuild fill, and landscaping on the landward side of the levee at Station 223+00. There is no house indicated on the drawings.

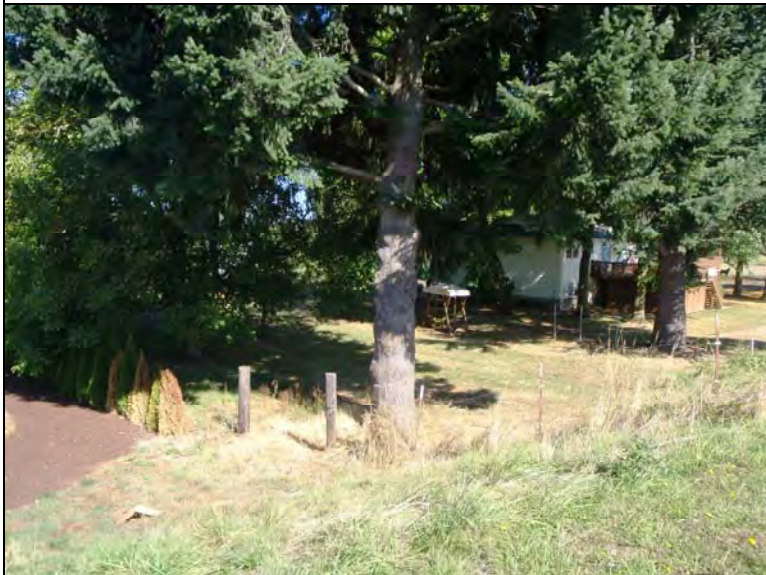
Inspect ID: SAUB_2011_a_0060 **Title:** USACE_CENWP_SAUB_2011_a_0060_1.jpg
Caption: View of large fir tree on the landward toe of the levee and gate and fence crossing of the levee. Station 223+50

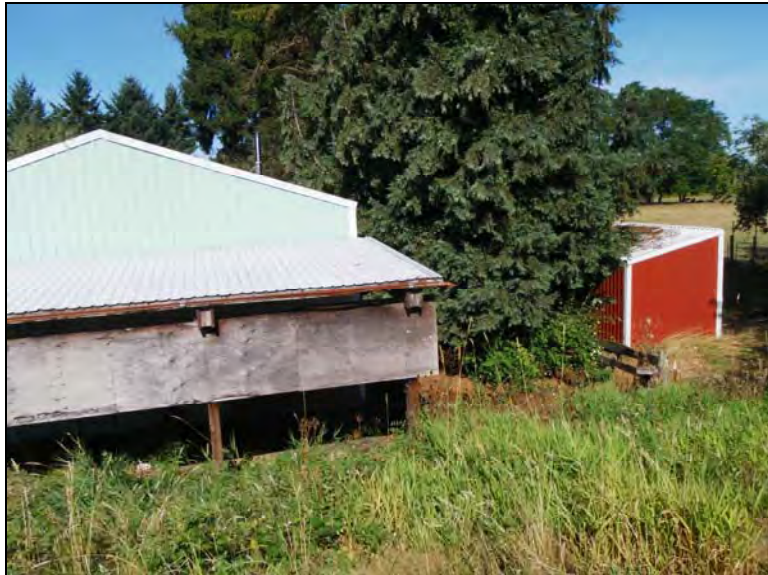
Inspect ID: SAUB_2011_a_0061 **Title:** USACE_CENWP_SAUB_2011_a_0061_1.jpg
Caption: View of a storage shed and garage structure at the landward levee toe. Station 224+00

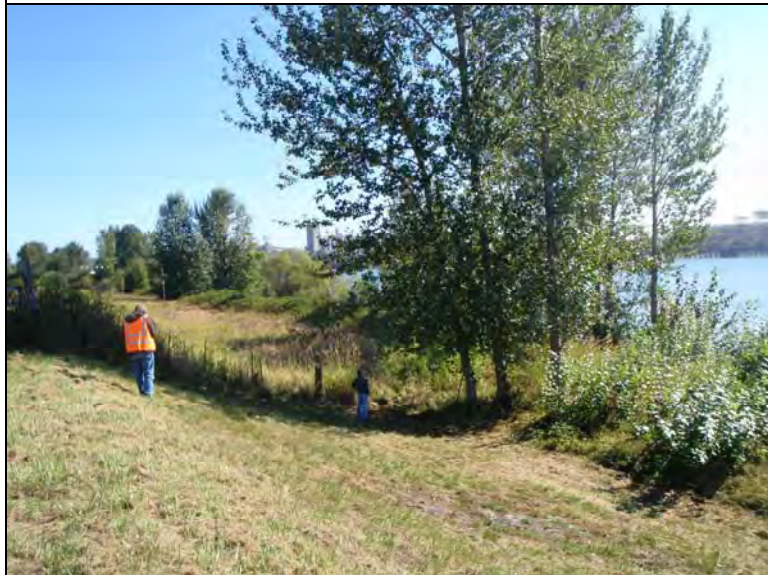
Inspect ID: SAUB_2011_a_0062 **Title:** USACE_CENWP_SAUB_2011_a_0062_1.jpg
Caption: View of cottonwood trees on the river side of the levee at Station 224+00.

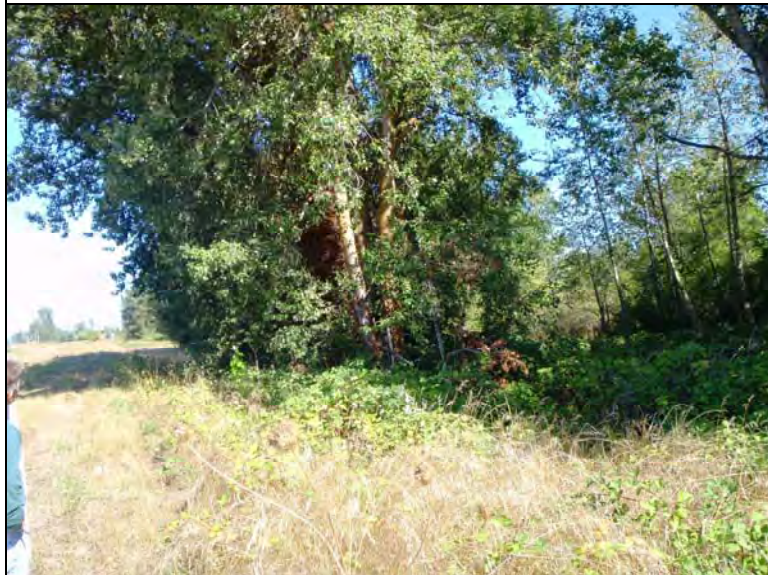
Inspect ID: SAUB_2011_a_0080 **Title:** USACE_CENWP_SAUB_2011_a_0080_1.jpg
Caption: View of large trees located within 15 feet of the riverward levee toe at Station 275+00.

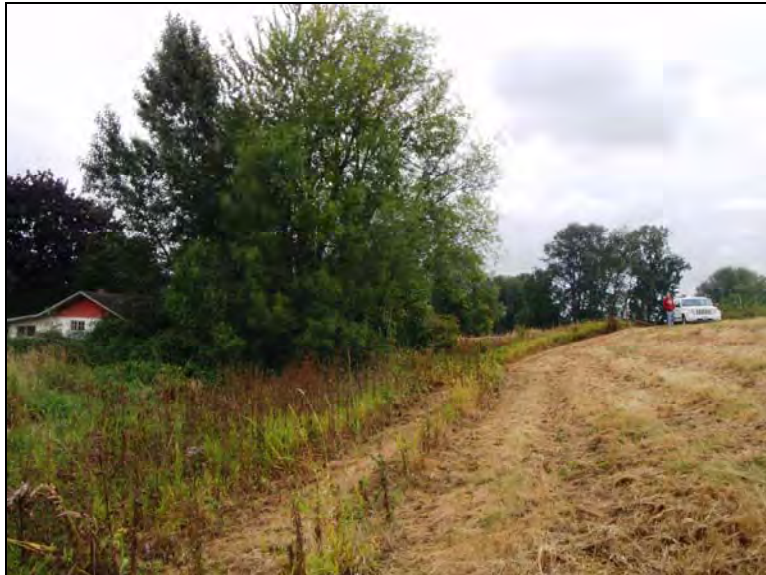
Inspect ID: SAUC_2011_a_0003 **Title:** USACE_CENWP_SAUC_2011_a_0003_1.jpg
Caption: View of two large trees within 15 feet of the riverward levee toe at Station 461+00.

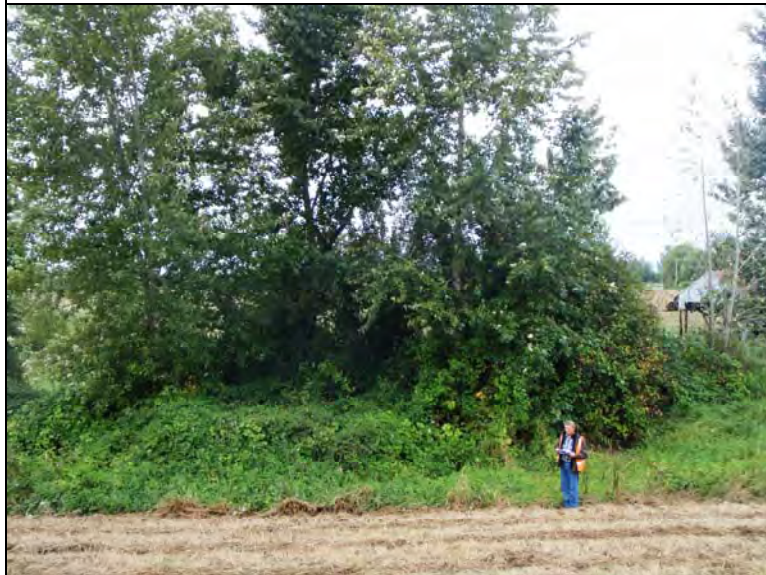
Inspect ID: SAUC_2011_a_0006 **Title:** USACE_CENWP_SAUC_2011_a_0006_1.jpg
Caption: View of the riverward side of the levee at Station 462+00. The trees are 15 feet or greater from the riverward toe of the levee. However, there is a thick growth of berry vines along the riverward toe that impairs visual inspection and impedes access.

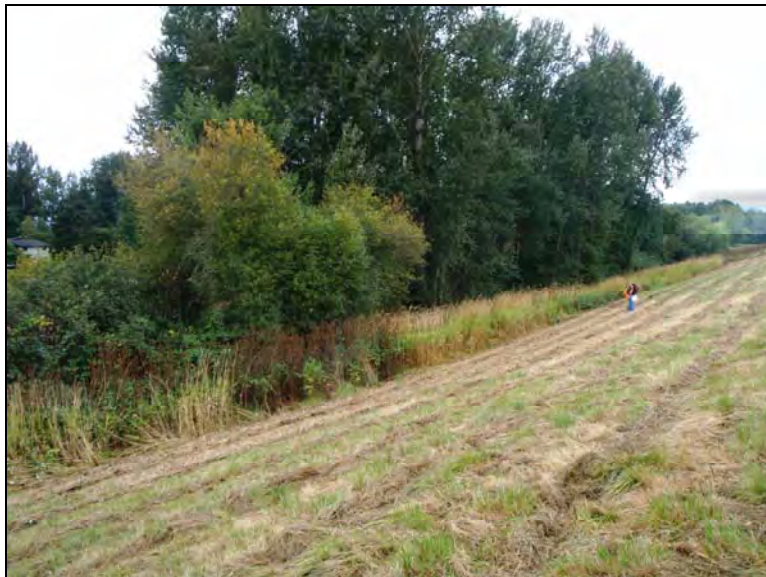
Inspect ID: SAUC_2011_a_0005 **Title:** USACE_CENWP_SAUC_2011_a_0005_1.jpg
Caption: View of multiple tree groups at land side of levee toe. The majority of length of trees were cleared (2011). Station 462+00 to 474+00

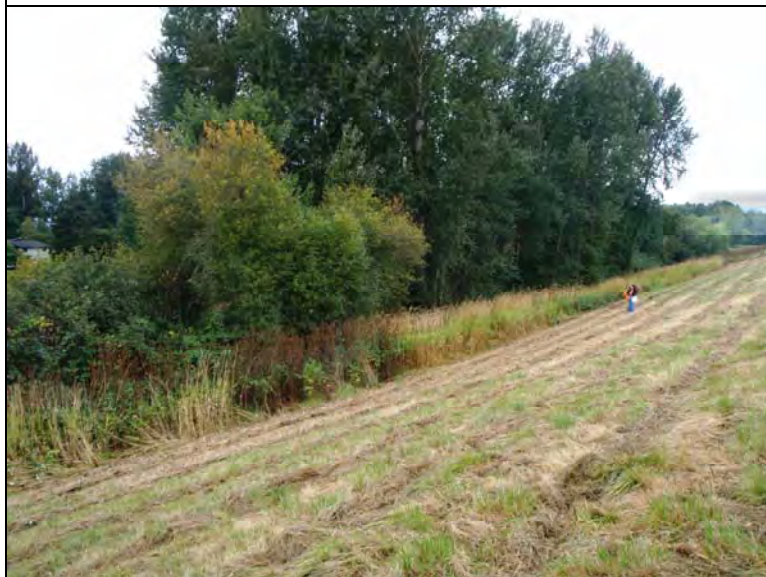
Inspect ID: SAUC_2011_a_0007 **Title:** USACE_CENWP_SAUC_2011_a_0007_1.jpg
Caption: View of approximately 100 linear feet of brush and hawthorne trees at the landward toe of the levee. Station 464+60

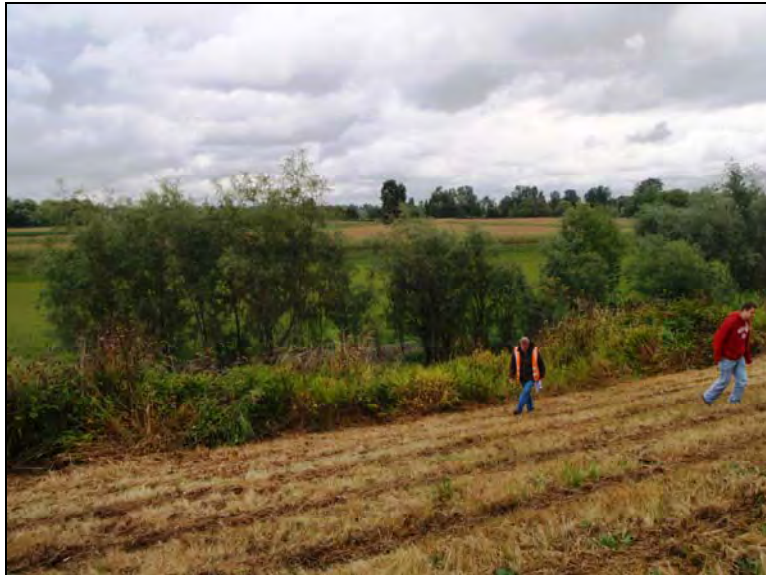
Inspect ID: SAUC_2011_a_0009 **Title:** USACE_CENWP_SAUC_2011_a_0009_1.jpg
Caption: View of woody debris intermingled with small willow trees at the riverward toe of the levee. Station 468+00

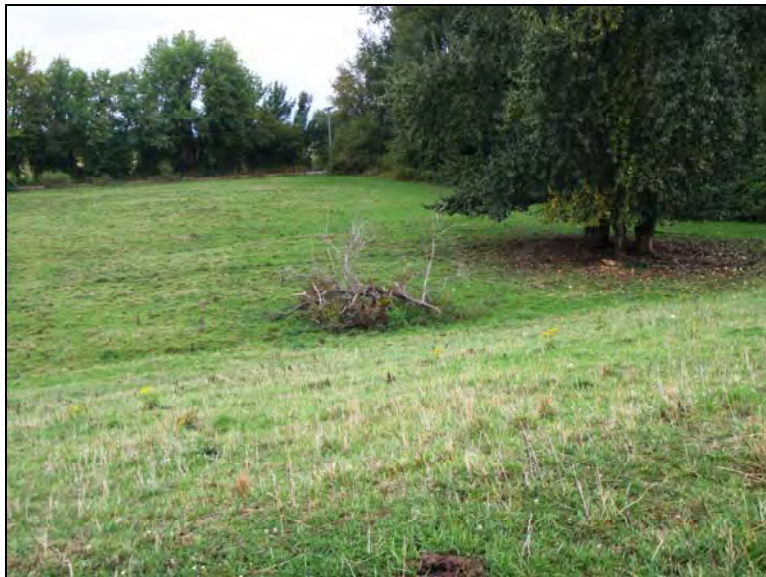
Inspect ID: SAUC_2011_a_0013 **Title:** USACE_CENWP_SAUC_2011_a_0013_2.jpg
Caption: View of dead tree on the landward levee toe at Station 483+00.

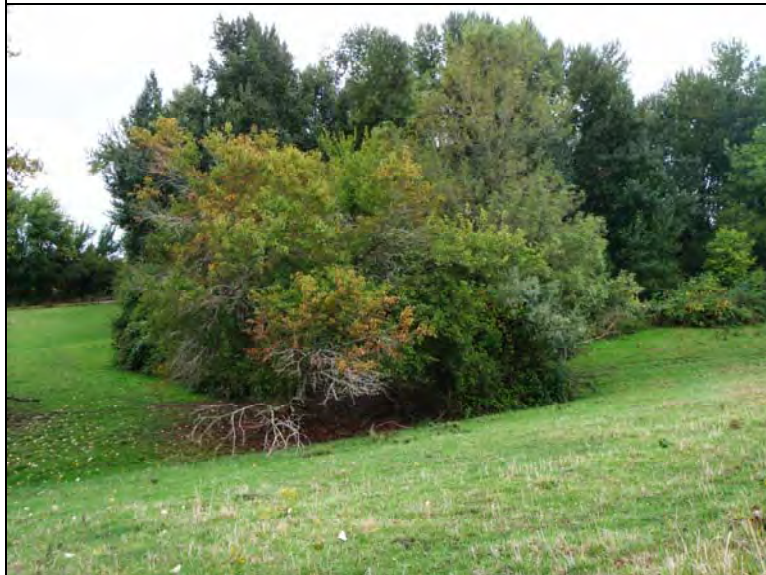
Inspect ID: SAUC_2011_a_0014 **Title:** USACE_CENWP_SAUC_2011_a_0014_1.jpg
Caption: View of six to eight medium (8-12" diameter) trees on the landward levee toe. Station 483+00

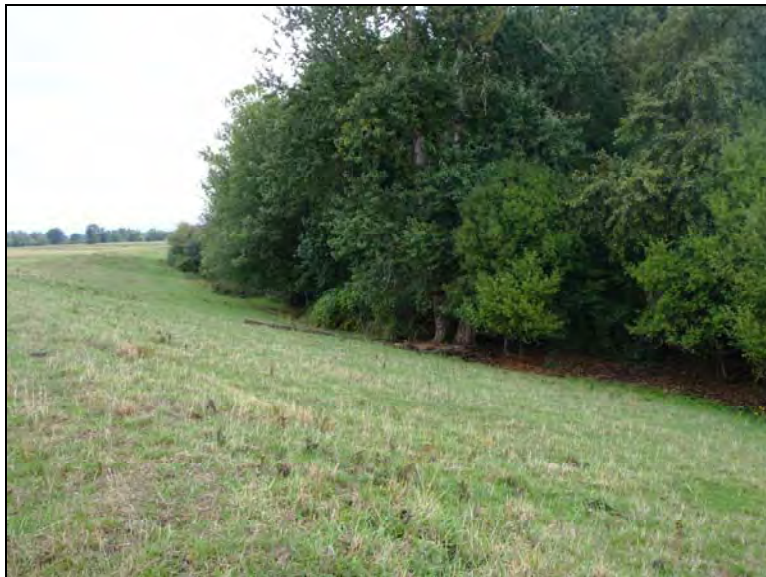
Inspect ID: SAUC_2011_a_0016 **Title:** USACE_CENWP_SAUC_2011_a_0016_1.jpg
Caption: View of approximately 400 linear feet of trees and vegetation on the landside of the levee at Station 485+00.

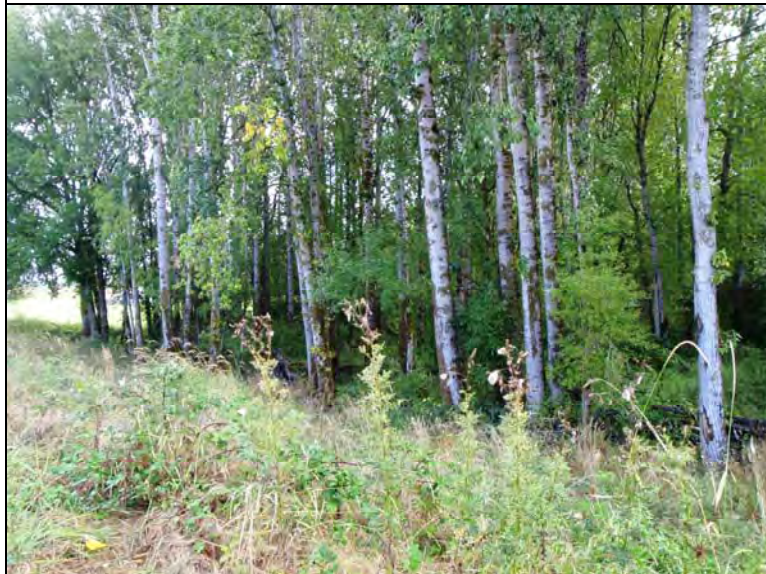
Inspect ID: SAUC_2011_a_0028 **Title:** USACE_CENWP_SAUC_2011_a_0028_1.jpg
Caption: View of a section of levee on USF&WL property where trees were cut back to 15 feet from levee toe in 2011.

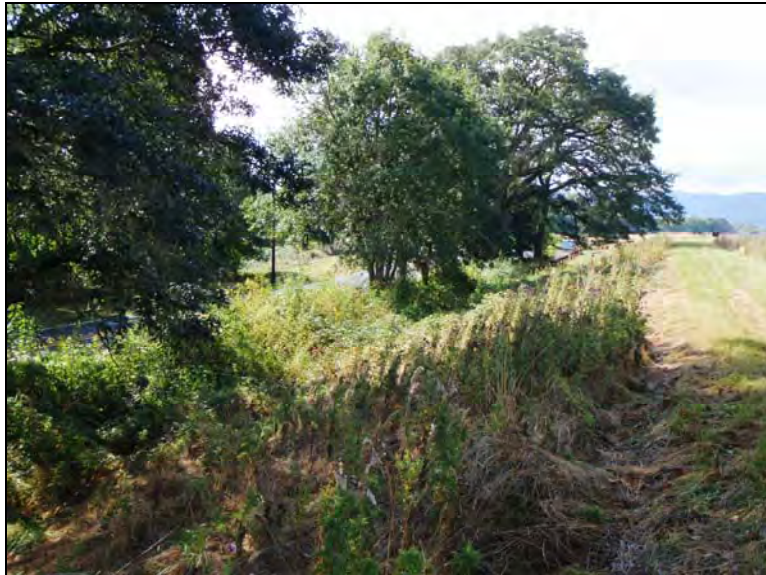
Inspect ID: SAUC_2011_a_0001 **Title:** USACE_CENWP_SAUC_2011_a_0001_1.jpg
Caption: View of scattered large trees (up to 36" in diameter) including a large oak listed in the 2010 periodic inspection along the land side of the levee toe. There are also heavy brush and a fence engulfed in brush. Station 518+00 to 600+00

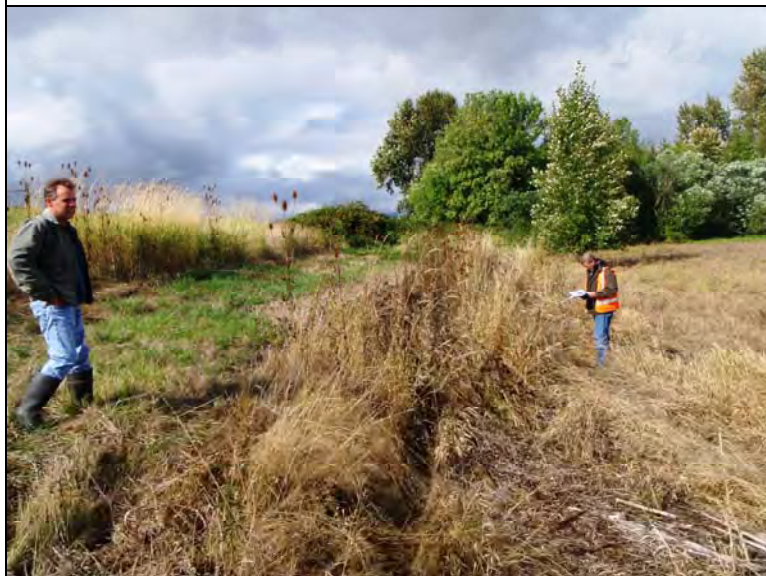
Inspect ID: SAUC_2011_a_0033 **Title:** USACE_CENWP_SAUC_2011_a_0033_1.jpg
Caption: View of old slump or erosion (200 feet long, max depth 2-3 feet, average depth 1.5 feet) near the riverward toe of the levee at Station 538+00

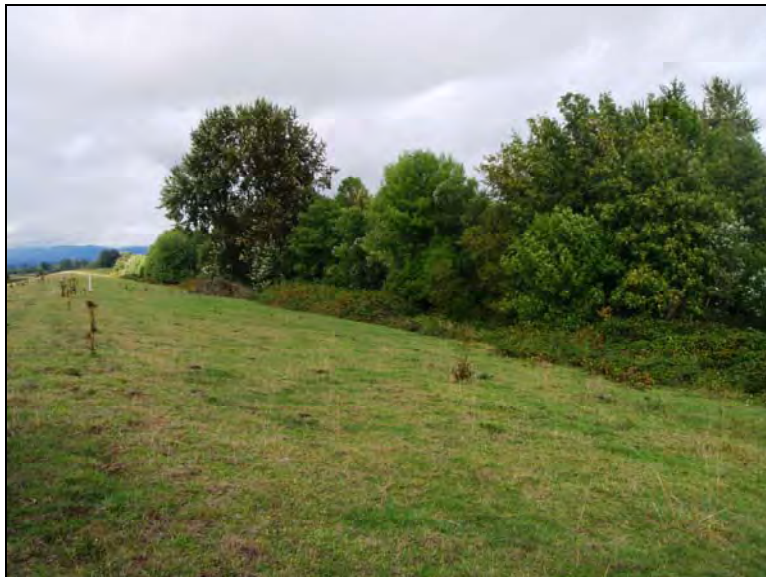
Inspect ID: SAUC_2011_a_0035 **Title:** USACE_CENWP_SAUC_2011_a_0035_1.jpg
Caption: View of fence with heavy brush along the river side levee slope. There are scattered medium-sized to large diameter deciduous trees in the brush. Station 540+00 to 557+00

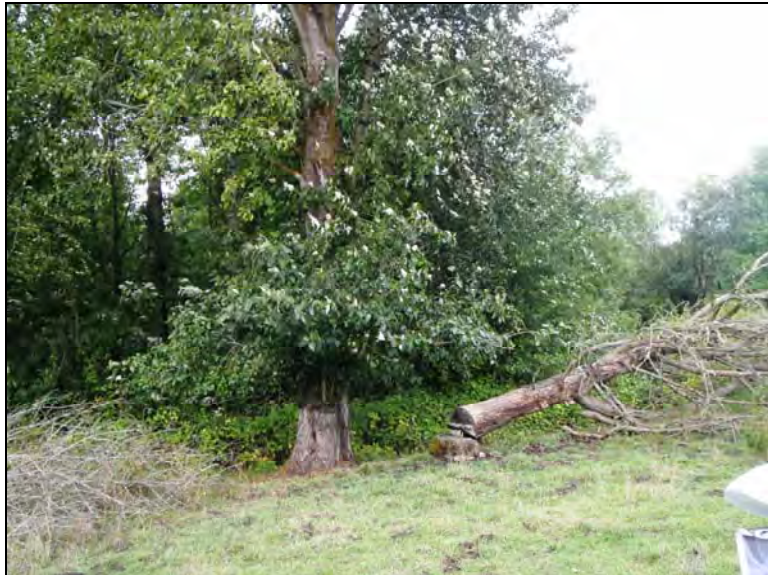
Inspect ID: SAUC_2011_a_0037 **Title:** USACE_CENWP_SAUC_2011_a_0037_1.jpg
Caption: View of large cotton wood trees at river side of the levee. Station 541+00

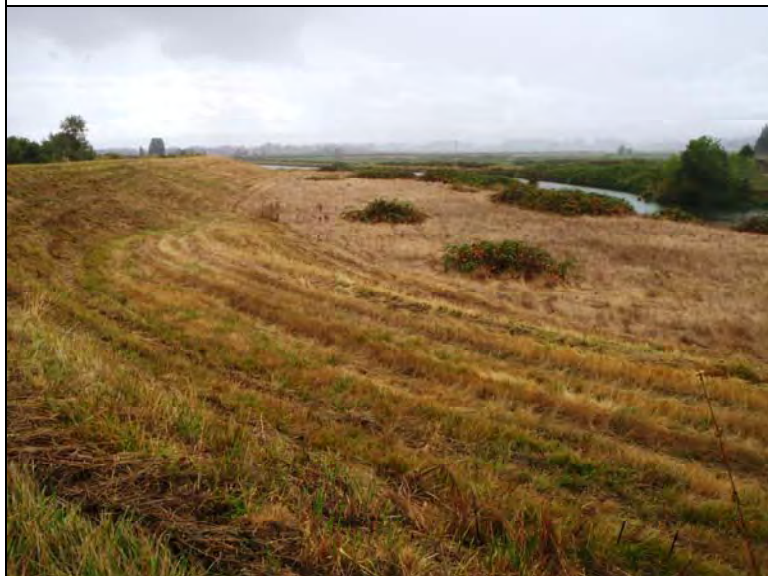
Inspect ID: SAUC_2011_a_0045 **Title:** USACE_CENWP_SAUC_2011_a_0045_1.jpg
Caption: View of access road from landside levee slope. Road may actually be top/transition from landward reinforcement fill. Station 594+00

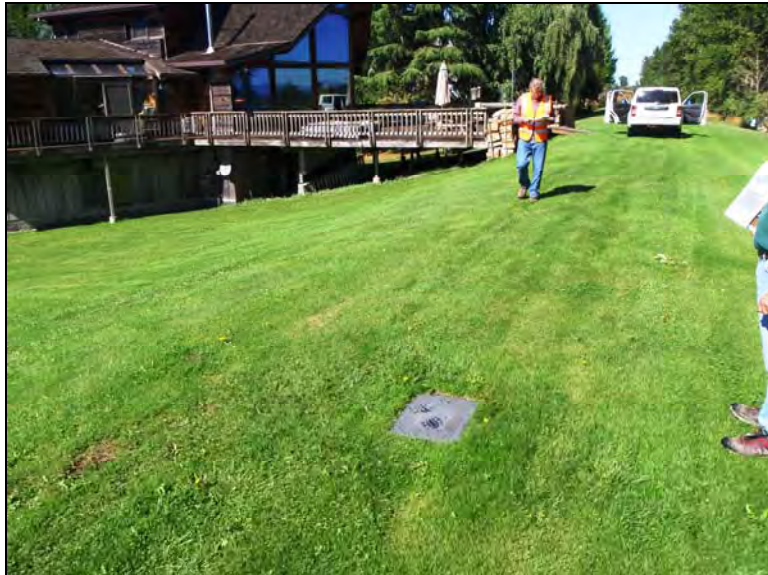
Inspect ID: SAUD_2011_a_0007 **Title:** USACE_CENWP_SAUD_2011_a_0007_1.jpg
Caption: View of access plate for a buried electrical cable crossing of the levee at Station 328+00.

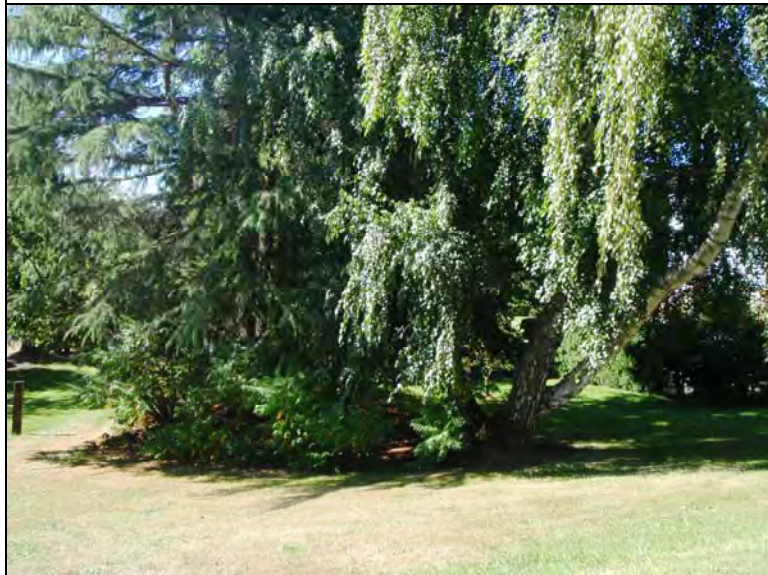
Inspect ID: SAUD_2011_a_0010 **Title:** USACE_CENWP_SAUD_2011_a_0010_1.jpg
Caption: View of two large fir and aspen trees and other smaller trees on the land side of the levee slope and toe at Station 330+00.
