DEPARTMENT OF THE ARMY
CORPS OF ENGINEERS, PORTLAND DISTRICT
PO BOX 2946
PORTLAND OR 97208-2946

SUBJECT: Routine Inspection Results, Sauvie Island Flood Damage Reduction System, U.S. Army Corps of Engineers (USACE) Assigned System Rating.

Flood Damage Reduction Segment / System Inspection Report

1. Levee segment / system and district: (name of the segment / system and levee district) Multnomah Channel Segment, Sauvie Island Flood Damage Reduction Project, Sauvie Island Drainage Improvement Company

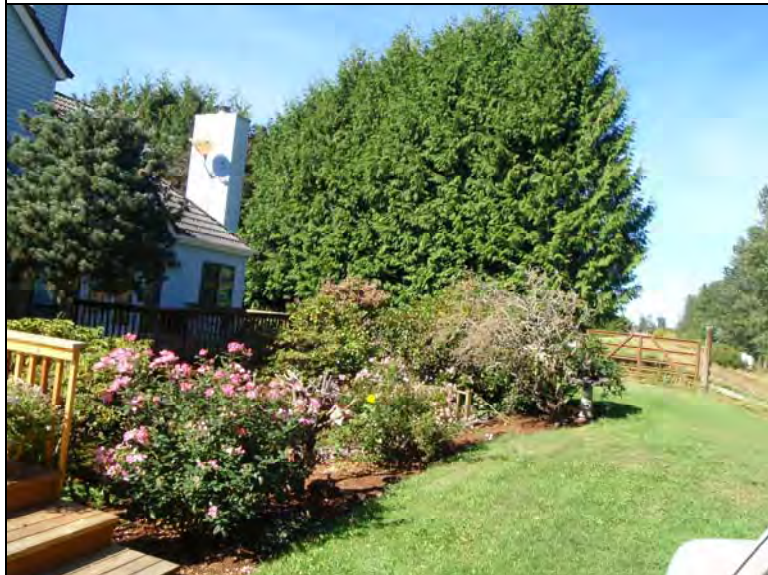
Inspect ID: SAUD_2011_a_0011 **Title:** USACE_CENWP_SAUD_2011_a_0011_1.jpg
Caption: View of landscaping bushes on the landward levee slope at Station 330+00.

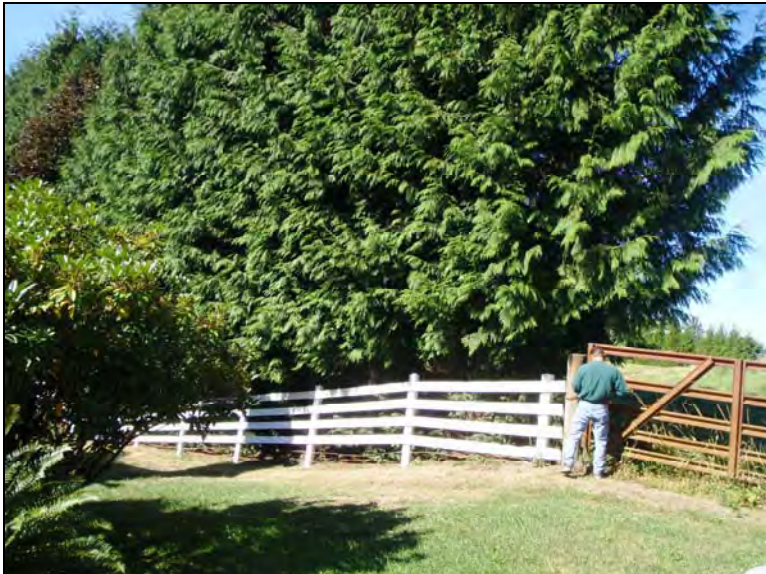
Inspect ID: SAUD_2011_a_0013 **Title:** USACE_CENWP_SAUD_2011_a_0013_1.jpg
Caption: View of several large trees (12-18" diameter) on the landward levee slope along a fenceline at Station 331+00.

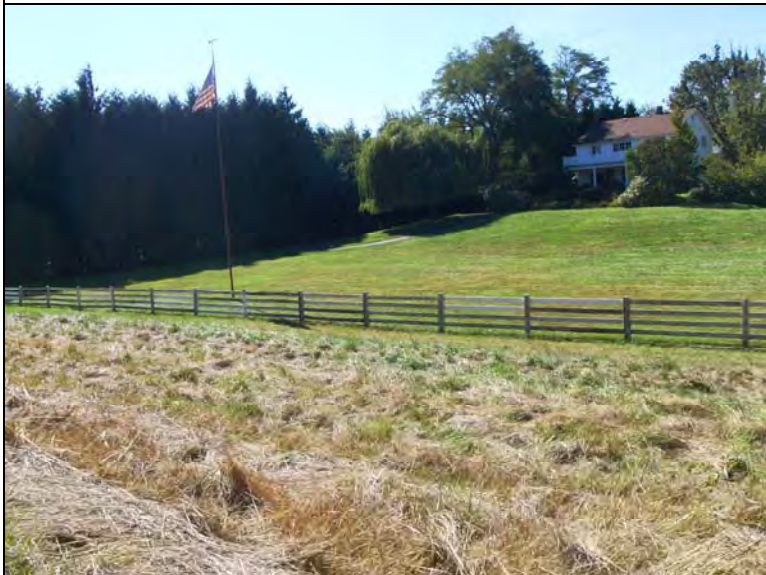
Inspect ID: SAUD_2011_a_0017 **Title:** USACE_CENWP_SAUD_2011_a_0017_1.jpg
Caption: View of 250 linear feet of wood fence along the landward side of the levee toe at Station 332+00.

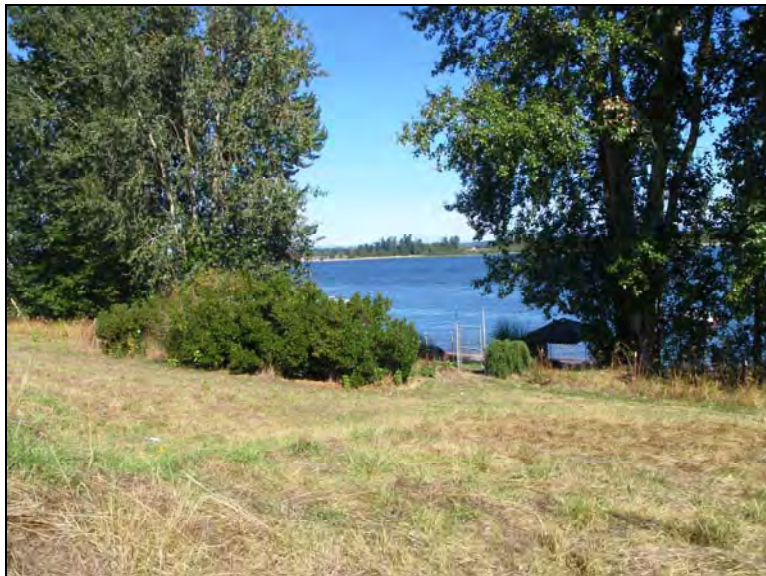
Rated Item	Rating	Rating Guidelines	Location/Remarks/Recommendations
			<p>SAUD_2011_a_0015: Fence along riverward toe of levee, with some brush and trees along fenceline.: Review and permit per current guidelines (M)</p> <p>SAUD_2011_a_0018: Trailer with fence and shrubs on riverward slope of levee.: Review and permit per current guidelines. (M)</p> <p>SAUD_2011_a_0020: Gate on crest, fence down both slopes.: Review and permit per current guidelines (M)</p> <p>SAUD_2011_a_0021: House on land side within 15 feet of toe.: Review and permit per current guidelines (U)</p> <p>SAUD_2011_a_0022: Locked gate and fence crossing levee crest and both slopes.: Review and permit per current guidelines (M)</p> <p>SAUD_2011_a_0024: Power poles along land side levee toe: Review and permit per current guidelines (M)</p> <p>SAUD_2011_a_0027: Fiber optic cable crossing through levee.: Review and permit per current guidelines (M)</p> <p>SAUD_2011_a_0028: Petroleum pipeline crossing over levee not indicated on drawings.: Review and permit per recent guidelines. (U)</p> <p>SAUD_2011_a_0033: Power pole at riverward toe of levee.: Review and permit per current guidelines (M)</p> <p>SAUD_2011_a_0032: Natural gas pipeline through/under levee with access road over levee at same location. 2 - 16" high pressure gas lines indicated on CLW-99-42/6.: None (A)</p> <p>SAUD_2011_a_0037: Farm equipment and various farming supplies, including multiple fuel tanks, located at land side levee toe.: Review and permit per current guidelines (U)</p> <p>SAUD_2011_a_0039: Access road from land side slope of levee. Not indicated on drawings.: Review and permit per current guidelines. (M)</p> <p>SAUD_2011_a_0040: Small road ramps on land side and river side of levee. Not indicated on drawings.: Review and permit per current guidelines (M)</p> <p>SAUD_2011_a_0041: Fill materials (soil) placed on land side levee slope (approx. 180' along crest and 100' out from crest):. Review and permit per current guidelines (M)</p> <p>SAUD_2011_a_0043: Small pumphouse located at riverward toe of levee. Indicated on CLW-99-42/6.: No action required. (A)</p> <p>SAUD_2011_a_0044: Fence and gate (open) on land side levee slope with minor vegetation growth at toe.: Remove or</p>

Inspect ID: SAUD_2011_a_0015 **Title:** USACE_CENWP_SAUD_2011_a_0015_1.jpg
Caption: View of fence along the riverward toe of the levee with some brush and trees along the fence at Station 331+00 to 335+00.

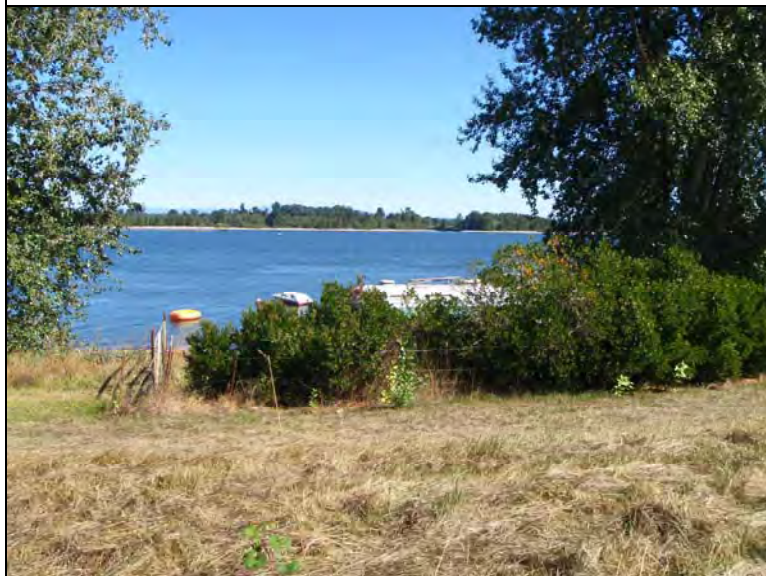
Inspect ID: SAUD_2011_a_0018 **Title:** USACE_CENWP_SAUD_2011_a_0018_1.jpg
Caption: View of trailer with fence and shrubs on the riverward slope of the levee at Station 333+00.

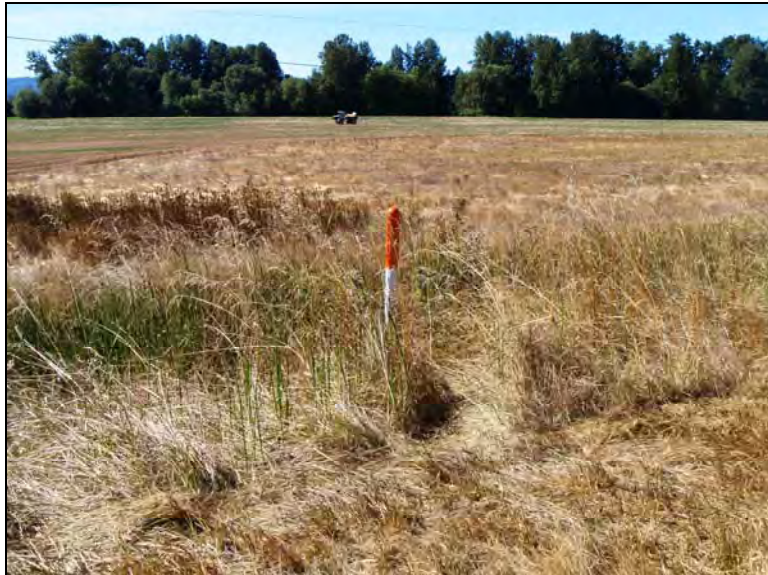
Inspect ID: SAUD_2011_a_0027 **Title:** USACE_CENWP_SAUD_2011_a_0027_1.jpg
Caption: View of marker for a fiber optic crossing of the levee at Station 345+00.

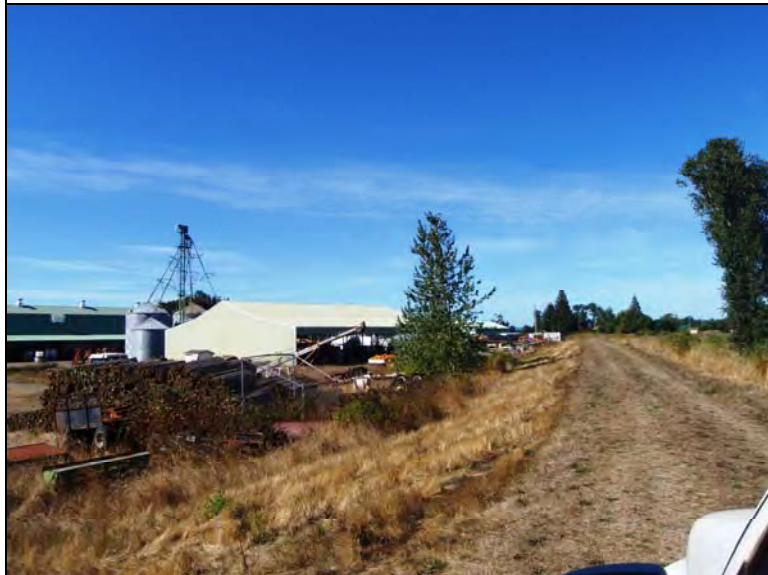
Inspect ID: SAUD_2011_a_0037 **Title:** USACE_CENWP_SAUD_2011_a_0037_1.jpg
Caption: View of farm equipment and various farming supplies along the landward toe of the levee at Station 365+00 to 370+00.

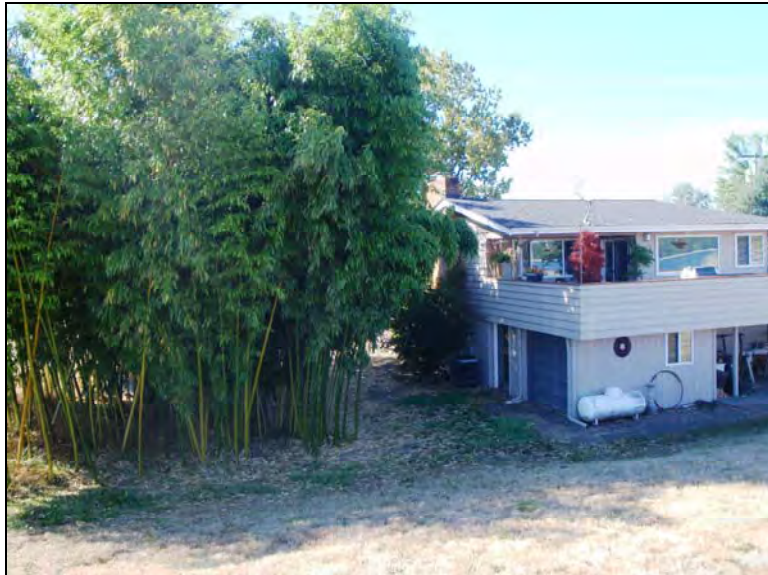
Inspect ID: SAUD_2011_a_0051 **Title:** USACE_CENWP_SAUD_2011_a_0051_1.jpg
Caption: View of house and bamboo on landward levee toe at Station391+00. House is not shown on drawings.

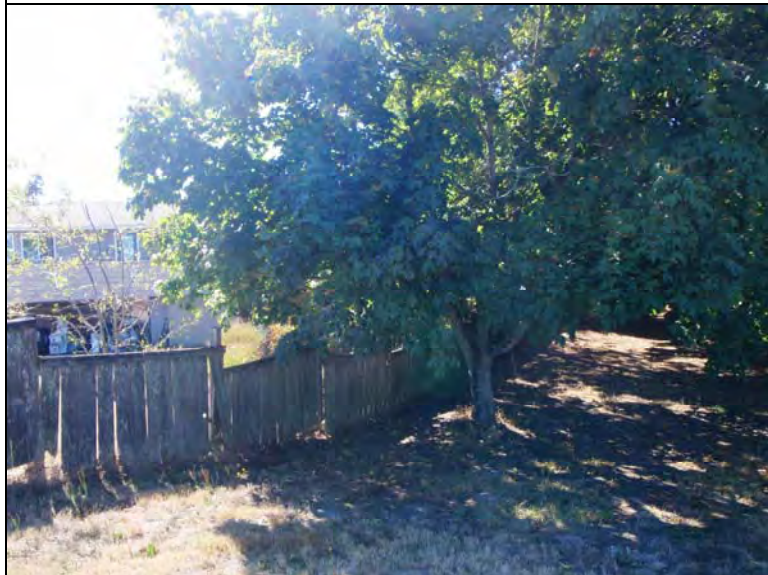
Inspect ID: SAUD_2011_a_0054 **Title:** USACE_CENWP_SAUD_2011_a_0054_1.jpg
Caption: View of one 12-14" diameter tree at land side levee toe; gate (on crest) and fence on both landside and riverside levee slopes. Station 391+50

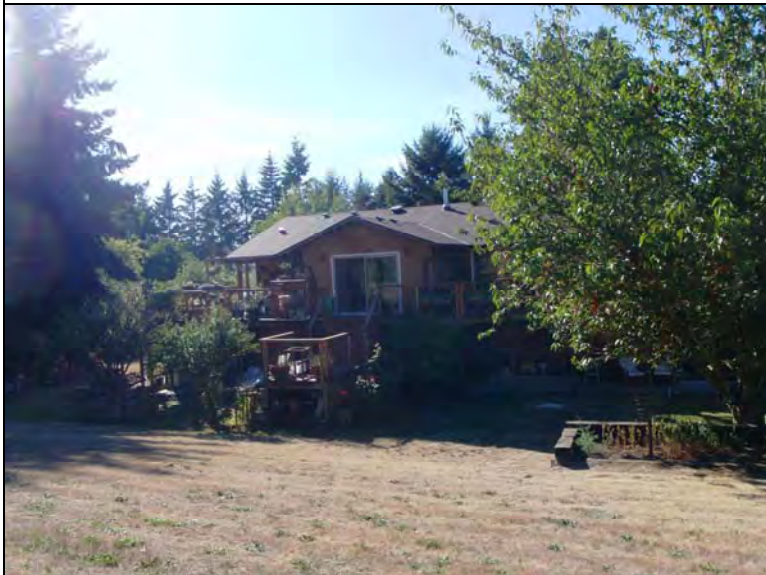
Inspect ID: SAUD_2011_a_0078 **Title:** USACE_CENWP_SAUD_2011_a_0078_1.jpg
Caption: View of five deciduous trees at the landward levee toe. Station 410+00.

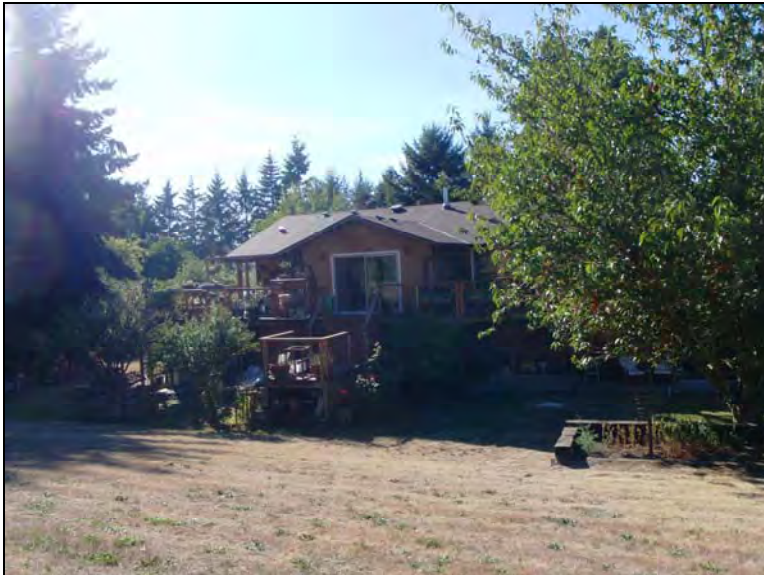
Inspect ID: SAUD_2011_a_0077 **Title:** USACE_CENWP_SAUD_2011_a_0077_1.jpg
Caption: View of stairs to house at toe of levee that are within 15 feet of the landward levee toe. Station 410+00

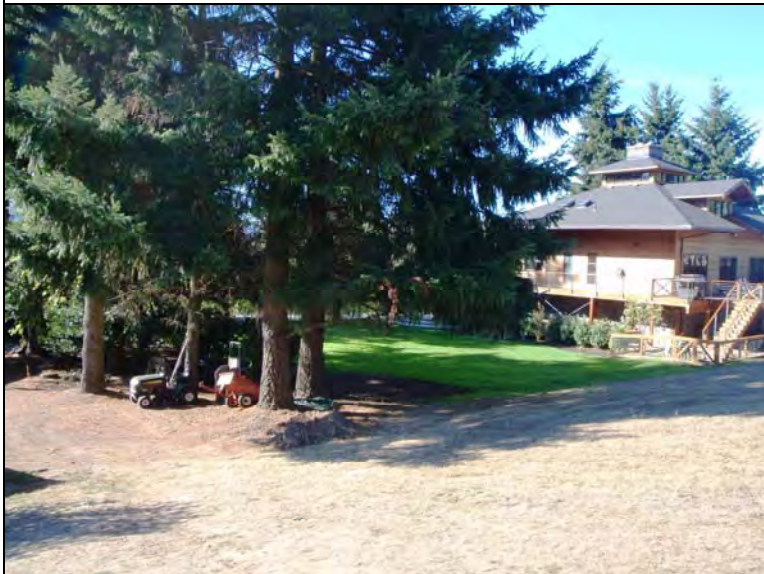
Inspect ID: SAUD_2011_a_0080 **Title:** USACE_CENWP_SAUD_2011_a_0080_1.jpg
Caption: View of two large fir trees on the landward levee toe at Station 412+00.

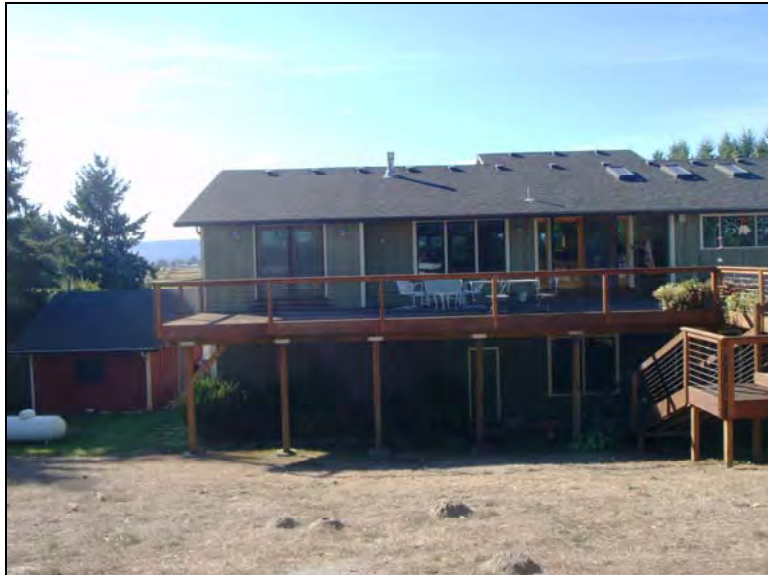
Inspect ID: SAUD_2011_a_0083 **Title:** USACE_CENWP_SAUD_2011_a_0083_1.jpg
Caption: View of walkway and propane tank on the land side of the levee. There is a water line on the walkway and also stairs on the riverside of the levee at this location. Station 415+00

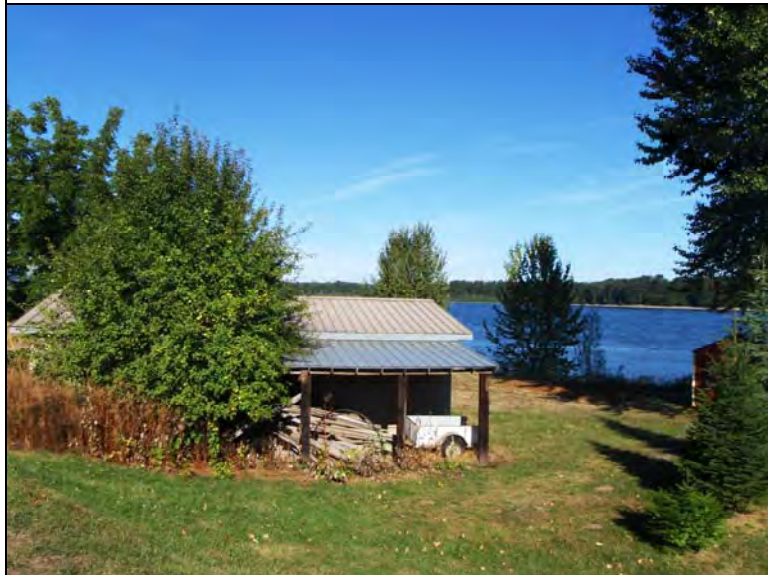
Inspect ID: SAUD_2011_a_0084 **Title:** USACE_CENWP_SAUD_2011_a_0084_1.jpg
Caption: View of shed, power pole, and 8" diameter tree at the riverward toe of the levee. Station 416+00

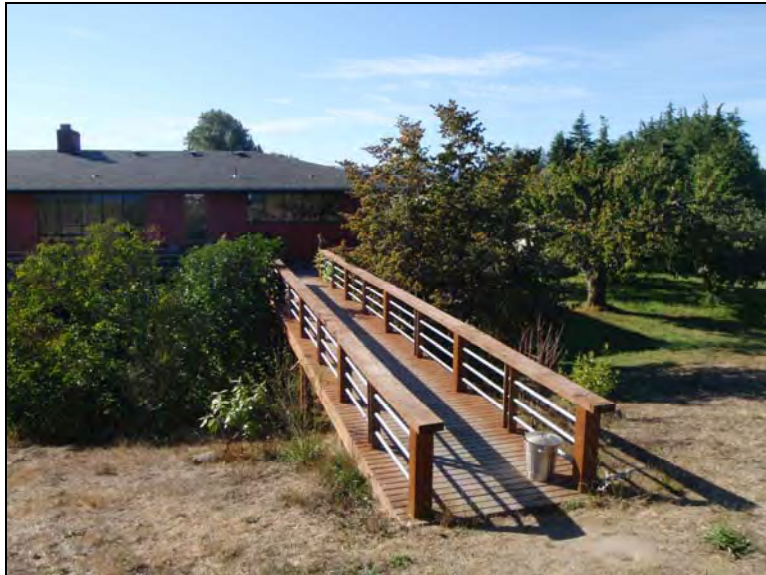
Inspect ID: SAUD_2011_a_0088 **Title:** USACE_CENWP_SAUD_2011_a_0088_1.jpg
Caption: View of walkway onto levee crest and small trees at the landward toe of the levee on both sides of the walkway. Station418+00

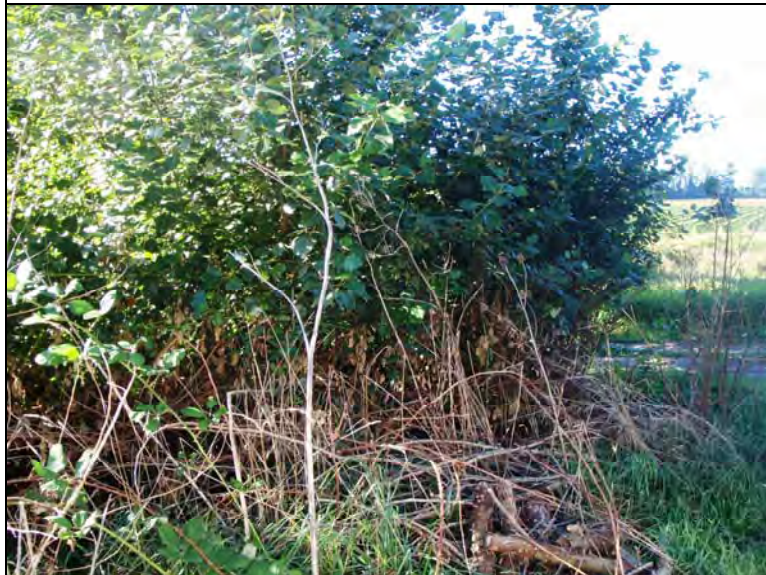
Inspect ID: SAUD_2011_a_0093 **Title:** USACE_CENWP_SAUD_2011_a_0093_1.jpg
Caption: View of brush and small trees (6-24" diameter) on the landward levee slope at Station 424+50.

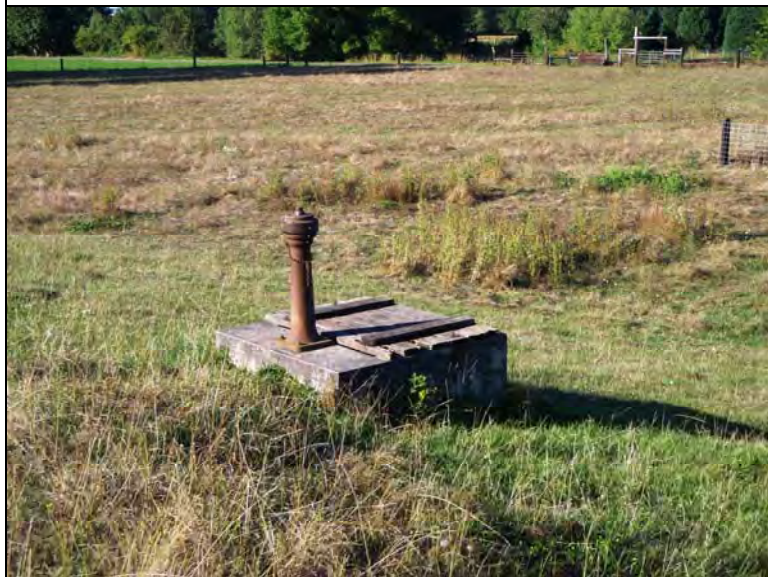
Inspect ID: SAUD_2011_a_0106 **Title:** USACE_CENWP_SAUD_2011_a_0106_1.jpg
Caption: View of abandoned 36" fresh water inlet at Station 453+00.

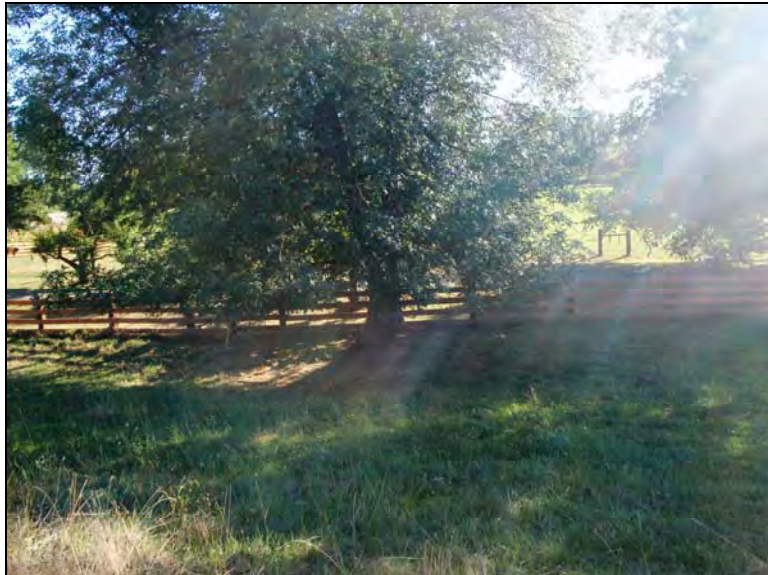
Inspect ID: SAUD_2011_a_0112 **Title:** USACE_CENWP_SAUD_2011_a_0112_1.jpg
Caption: View of one large tree on the landward toe of the levee at Station 458+00.
